Cavity status; recent KEK activities

(2) Local grinding, then 100 μ m EP and anneal for MHI-010 cavity

(3) Local grinding of FNAL cavities was finished; TB9RI026 and AES001

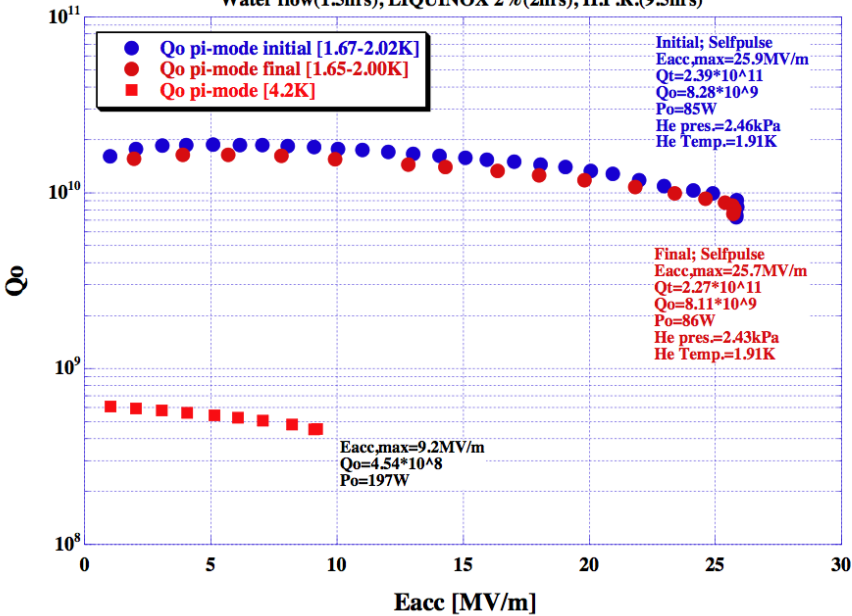
STF Baseline Cavity #10 2nd. Vertical Test 06/17/2010
Low Current Density EP-II(20 μ m) with N2 gas,
Water flow(1.5hrs), LIQUINOX 2%(2hrs), H.P.R.(9.5hrs)

25.7MV/m
Q=8.11E9

heated by #1cell equator pits

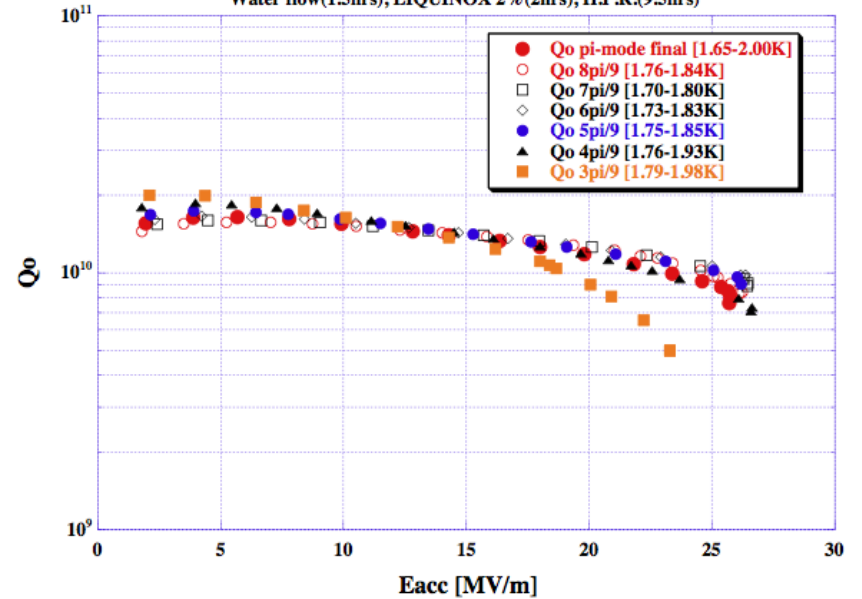
STF Baseline Cavity #10 2nd. Vertical Test 06/17/2010
Low Current Density EP-II(20 μ m) with N2 gas,
Water flow(1.5hrs), LIQUINOX 2%(2hrs), H.P.R.(9.5hrs)

Cell 1&9[MV/m]	Cell 2&8[MV/m]	Cell 3&7[MV/m]	Cell 4&6[MV/m]	Cell 5[MV/m]	Comment
π Initial	25.9	25.9	25.9	25.9	25.9	Quench/selfpulse : Heat@1cell 340-0deg. equator Qo=8.28E9, Po=85W, X-ray 864 μ Sv/h
Final	25.7	25.7	25.7	25.7	25.7	Quench/selfpulse: Heat@1cell Qo=8.11E9, Po=86W X-ray 1.27 mSv/h
8 π /9	26.2	23.3	17.3	9.69	0	Quench/selfpulse: Heat@1cell 330-0deg. equator Qo=8.41E9, Po=42W X-ray 499 μ Sv/h
7 π /9	26.5	14.0	5.3	20.4	28.3	Quench/selfpulse: Heat@1cell Qo=9.11E9, Po=43W X-ray 255 μ Sv/h
6 π /9	26.3	0	26.3	26.3	0	Quench/selfpulse: Heat@1cell Qo=9.79E9, Po=46W X-ray 90 μ Sv/h
5 π /9	26.2	17.8	30.9	5.2	33.3	Quench/selfpulse: Heat@1cell Qo=9.05E9, Po=62W X-ray 30 μ Sv/h
4 π /9	26.6	34.8	15.2	38.6	0	Quench/selfpulse: Heat@1cell Qo=7.32E9, Po=110W X-ray 15 μ Sv/h
3 π /9	23.3	46.6	23.3	23.3	46.6	Power Limit: No heating point Qo=4.95E9, Po=207W X-ray 24 μ Sv/h
Eacc,max	26.6	>46.6	>30.9	>38.6	>46.6

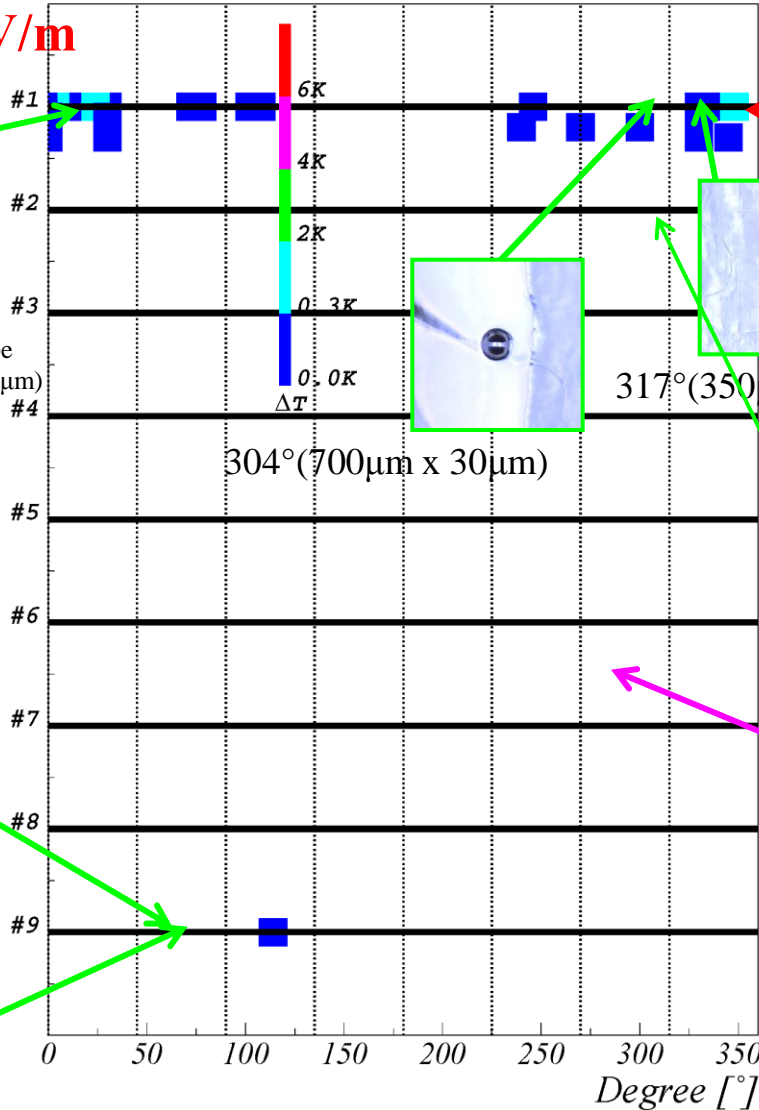
Comparison between T-mapping and Optical-inspection after 2nd V.T.

4~9π/9 @26~27MV/m

353°(400μm x 30μm)

24°(300μm x 30μm)

Cell#1側beampipe
268°(150μm x 12μm)

Cell#9側beampipe
114°(200μm x 20μm)

59°(200μm x 25μm)

65°(300μm x 30μm)

発熱箇所を中心付近にあるやつ
(場所によって凸凹の向きが
変わる)

317°(350μm x 30μm)

311°(200μm x 10μm)

283°(300μm x 45μm)

初登場！！
Cell#6-#7間のアイリス

比較的大きなサイズのdefect
のみを抜粋してある。

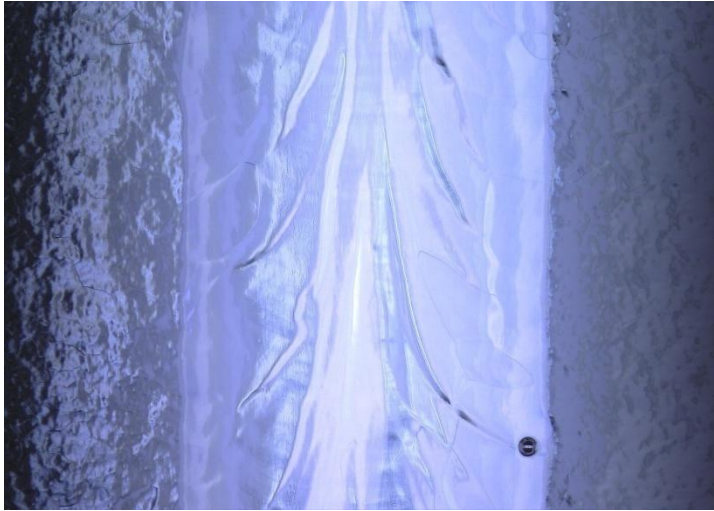
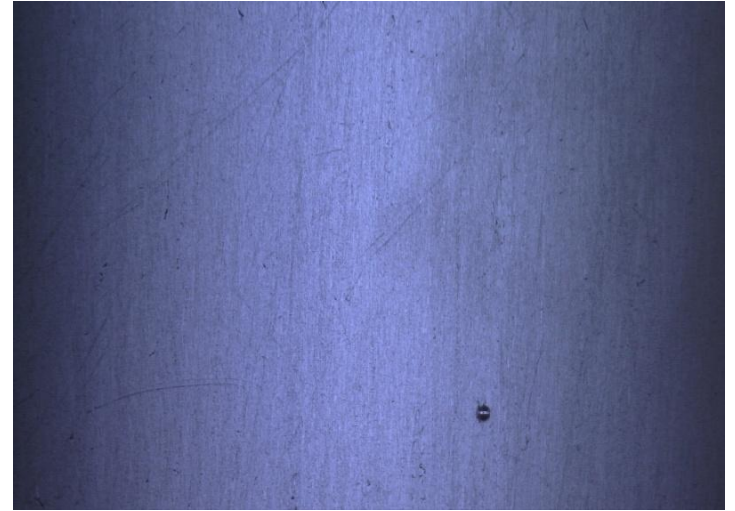
grinding by hand

evolution of grinding @Cell #1

after 2nd V.T. 304°(700μm x 30μm)

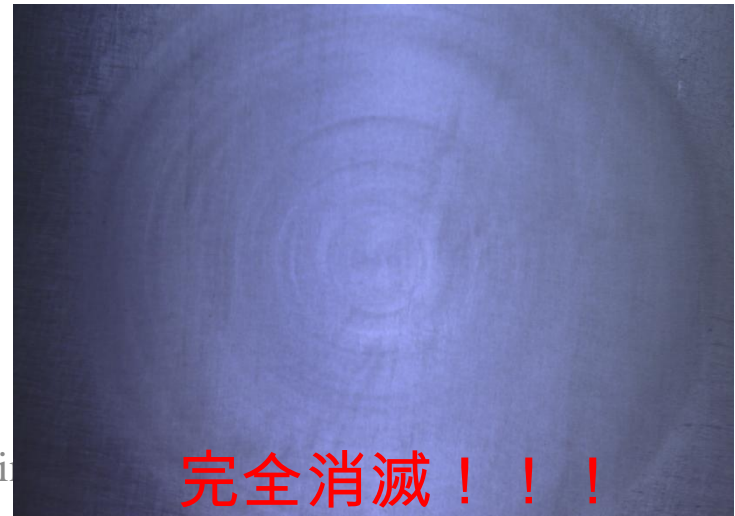
finish

完全消滅!!!

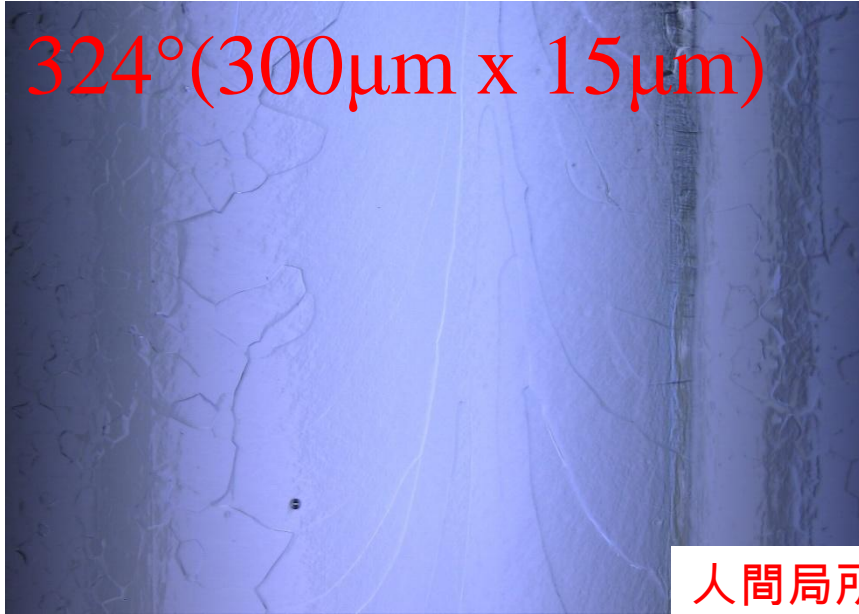
324°(300 μ m x 15 μ m)

New defects @Cell #1 after local grind & 100 μ m EP

これ以上削っても同様の事が再び起こると
想像されるためもう局所研磨は行わず、
このまま3回目の縦測定に臨むことにする。

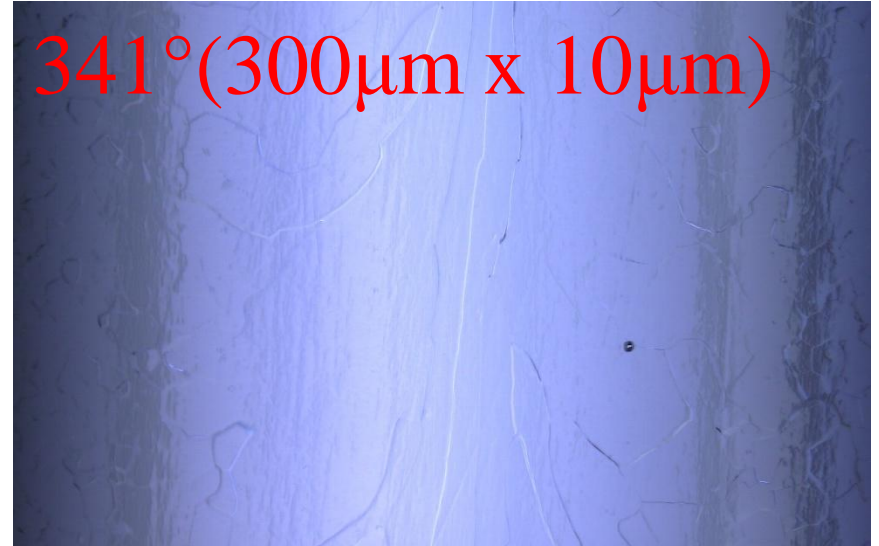
341°(300 μ m x 10 μ m)

人間局所研磨を施した所から現われた新たなdefect。
これまでと異なり、ビード端ではなく、
ビード中央付近にあるのが特徴である。

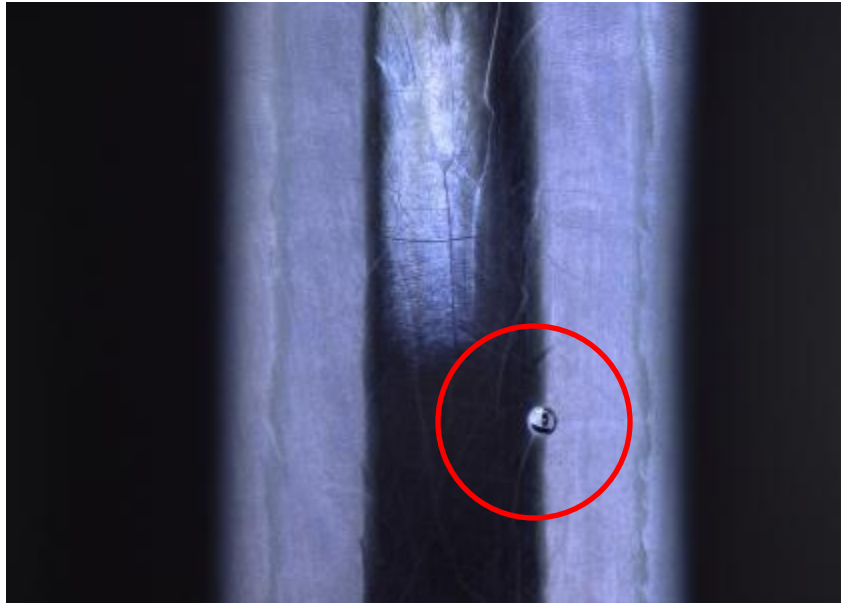
TB9RI 026: 8-9 iris, $t = 107$ deg. Pit-type
19.6MV/m field emission

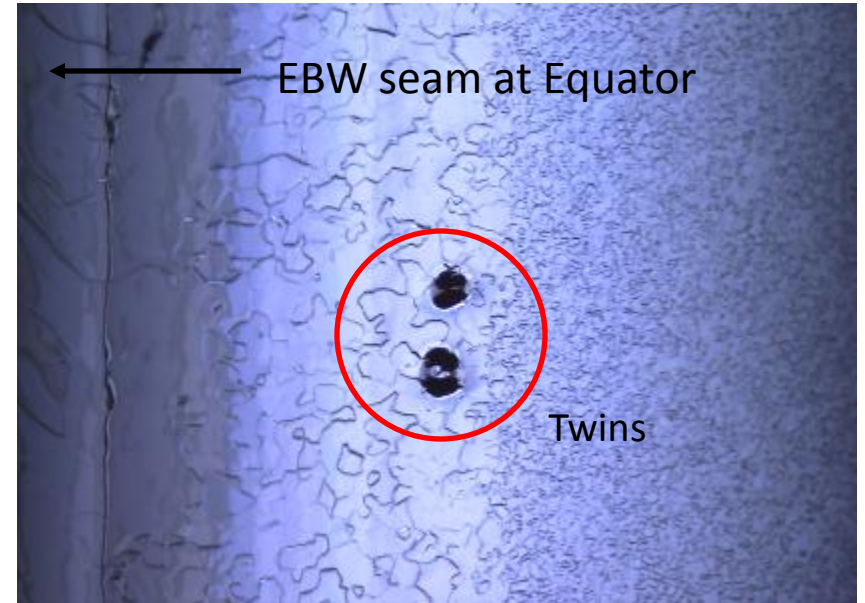
AES-001: 3-cell equator, $t = 169$ deg. Bump type
21.8MV/m quench

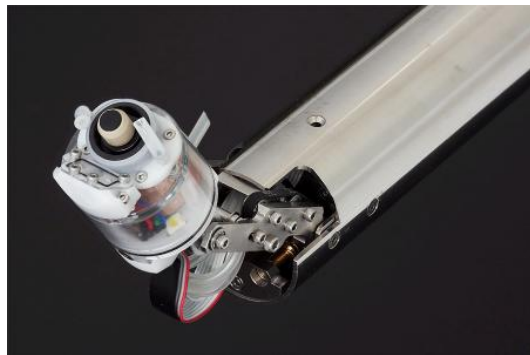
Grinder #3 used for Iris grinding.

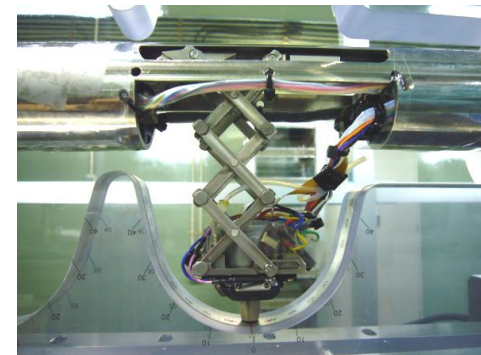
Grinder #1 used for Equator grinding.

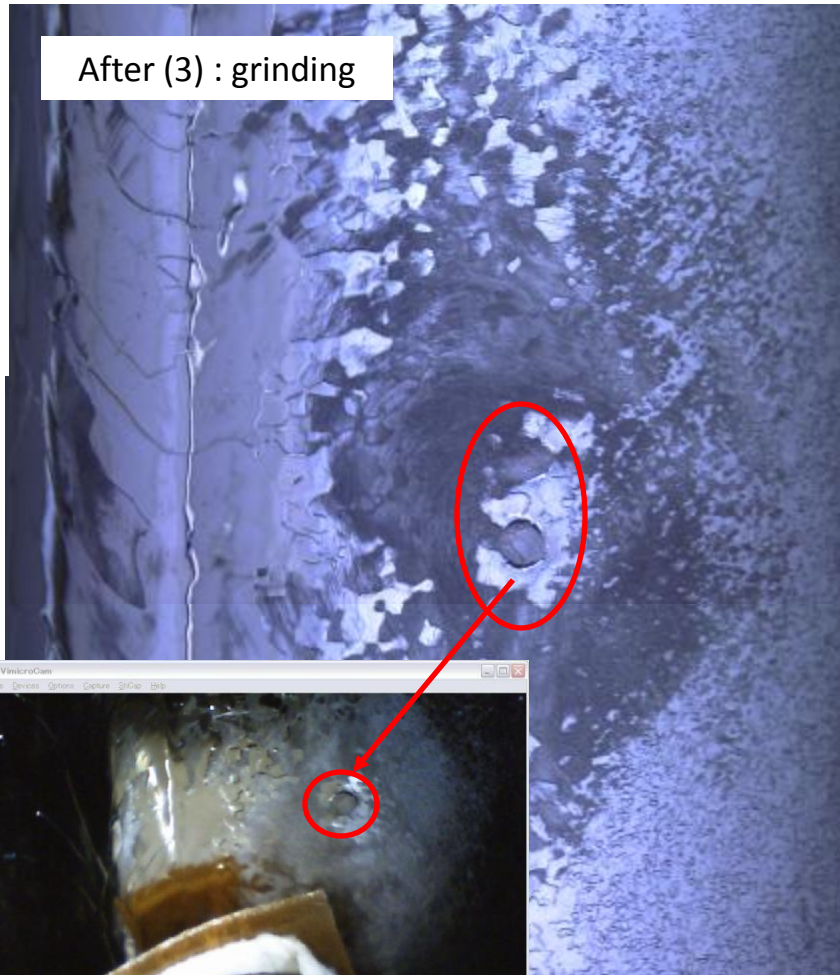
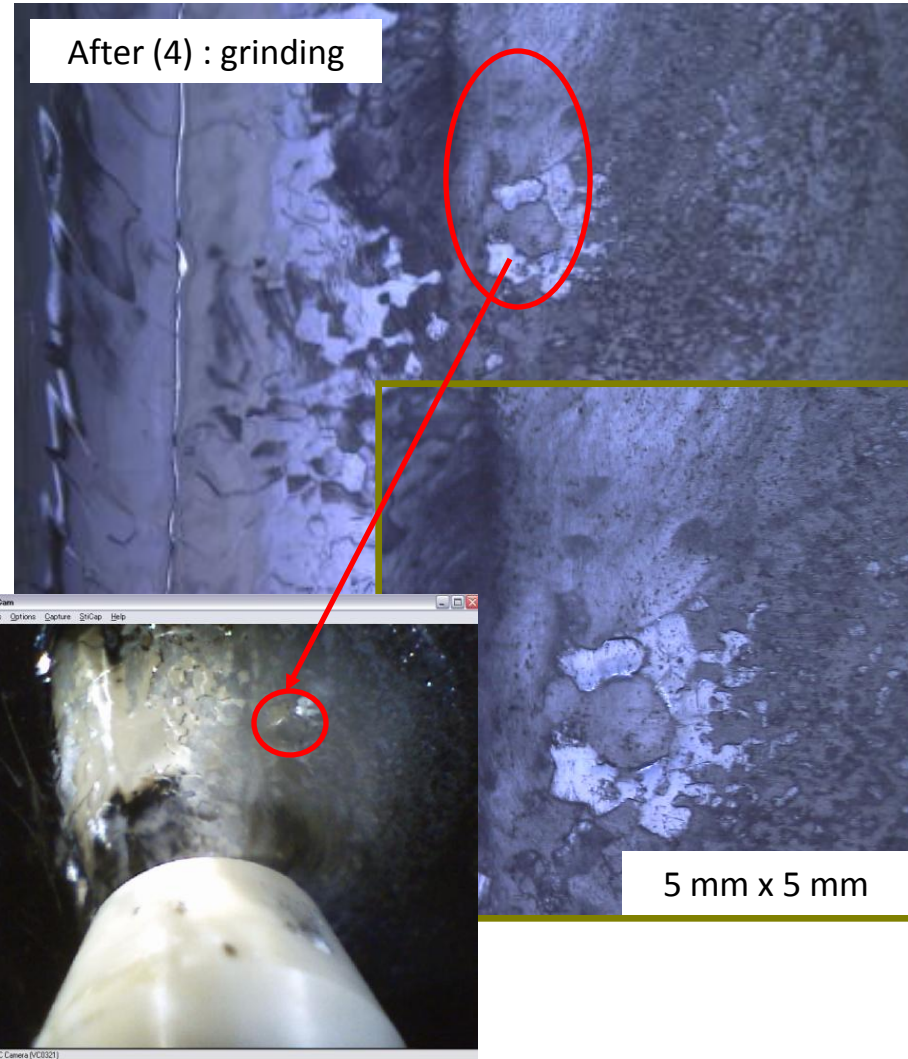
AES-001 : Grinding (2)

Two bumps were removed completely.
