# Report from SNS on HOM Coupler

**May 18, 2006**  
**ILC technical status meeting**

**SANG-HO KIM**  
**ASD/SNS**

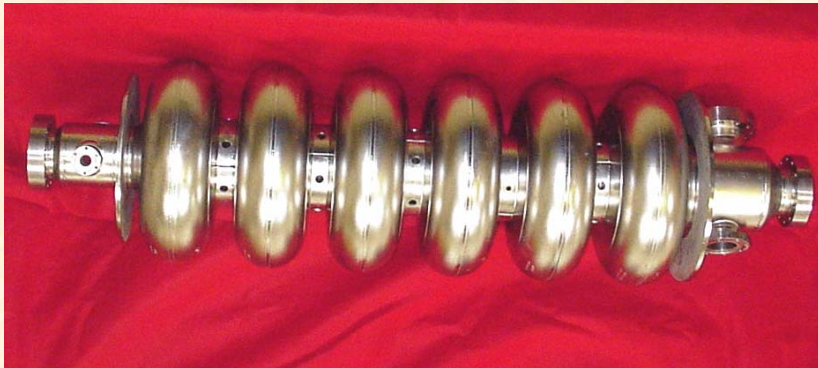
# SNS SRF cavity

Major Specifications:  
 $E_a = 10.1, 15.9$  MV/m  
at  $\beta = 0.61, 0.81$

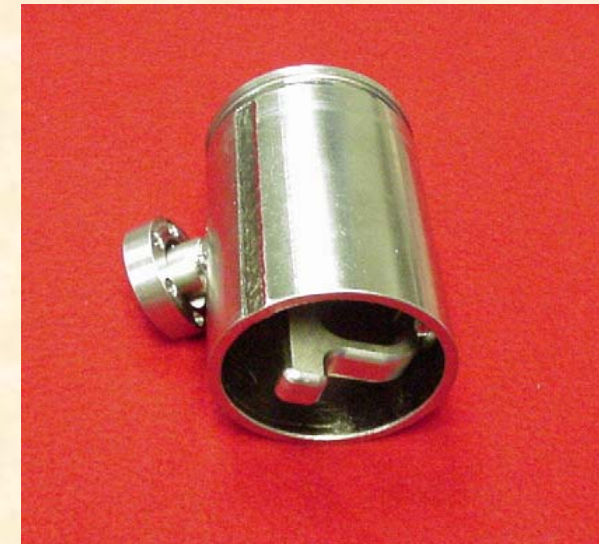
# HOM coupler

- Baseline cavities have coaxial HOM coupler at each side
- Two cavities are not operational due to the HOM coupler
- Many installed cavities (~10) are showing abnormal signals
  - zero coupling and rep. rate dependent abnormal signal
  - electron loading
  - power level changes
- HOM coupler should not have problems with the fundamental mode

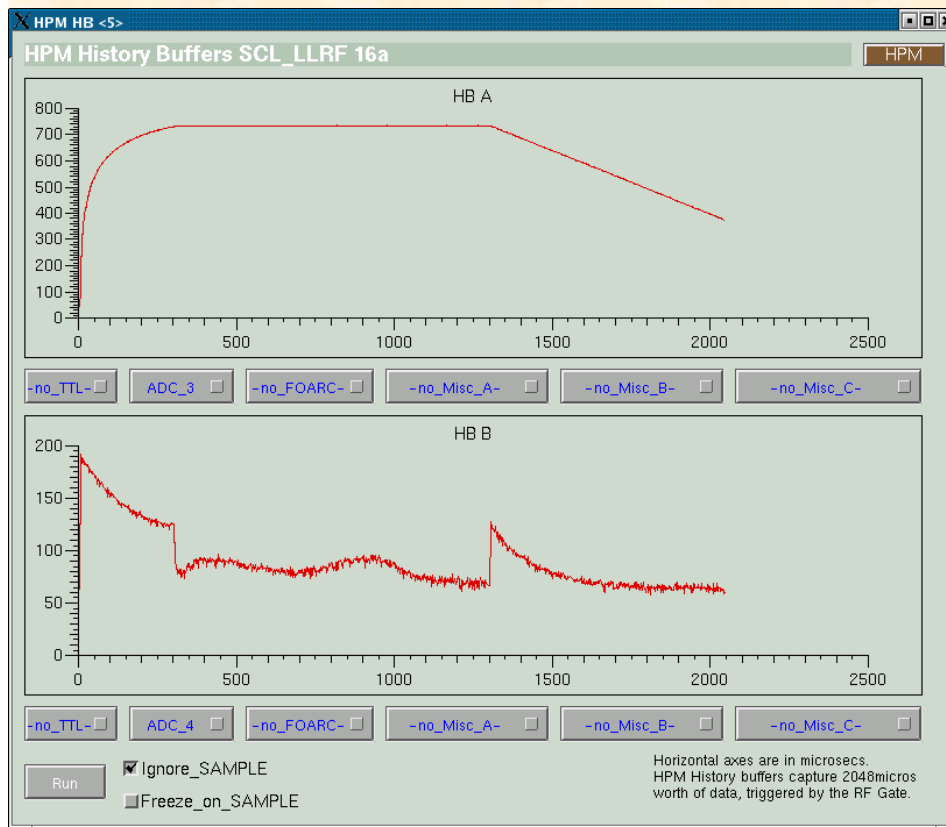
# Case (I)

Same cavity at the same gradient

1 Hz

10 Hz

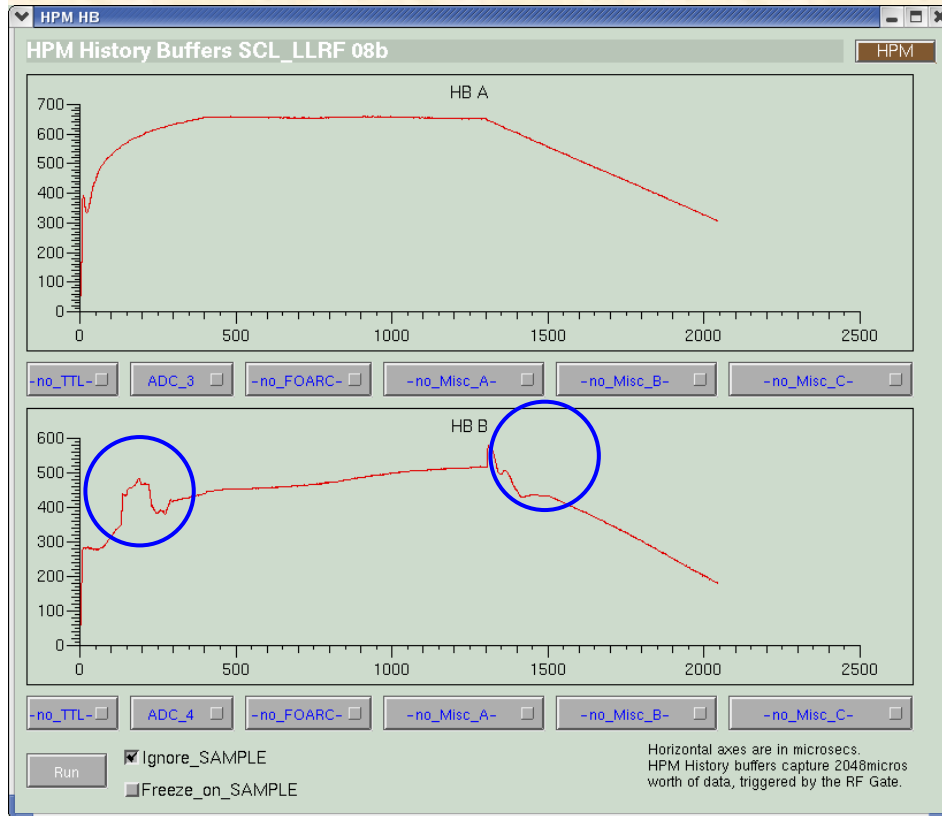
# Case (II)

## Electron Loading

It is not clearly seen here, but observed big spikes only from HOM signals (blue circled)  
→ vacuum excursion (trip)

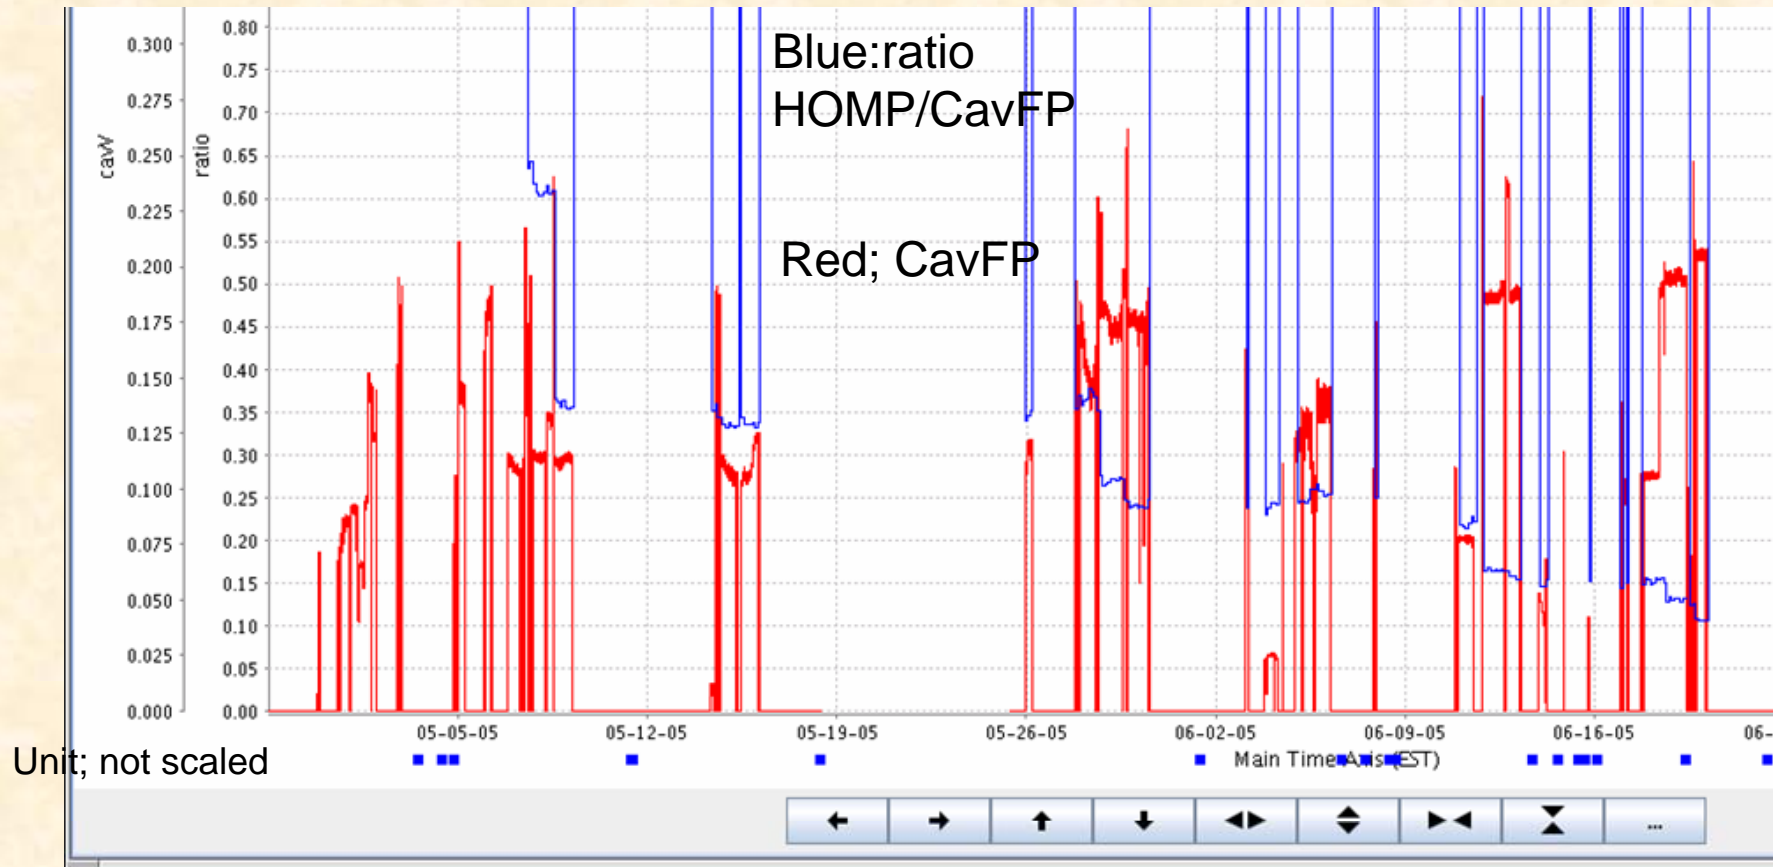
# Case (III)

## Coupling changes
