Disassembly Status of S1-G Cryomodule

Disassembly Plan of S1-G Cryomodule

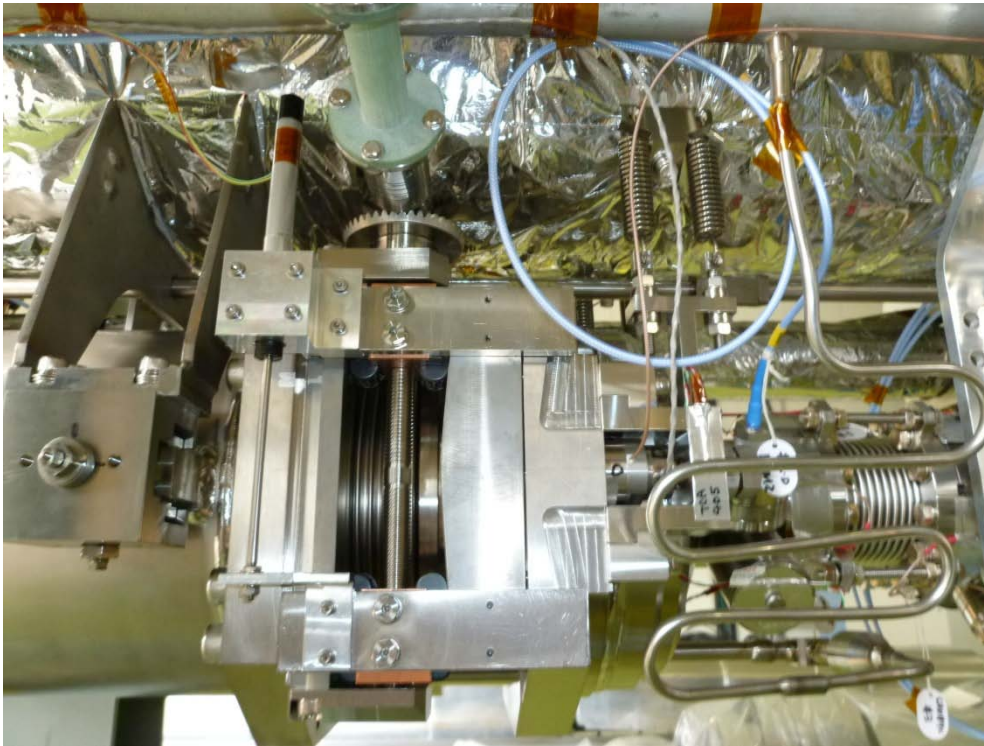
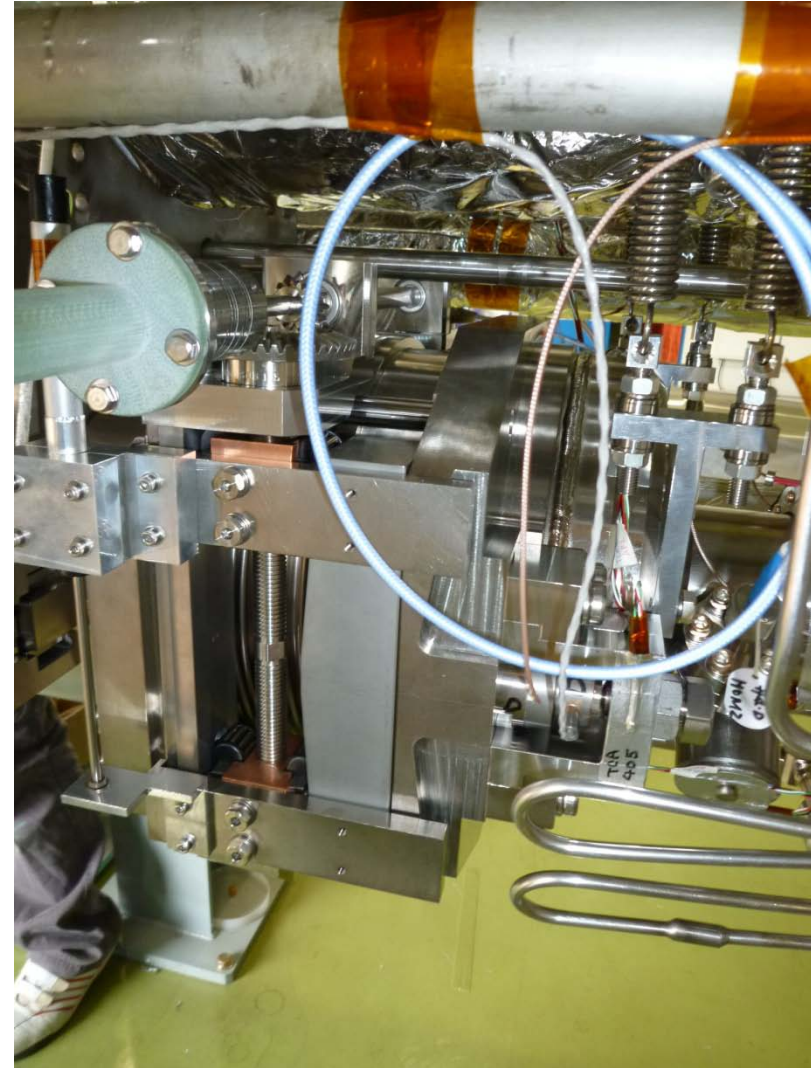
Check of Tuner system
(A4/MHI-09 cavity)

No visible trouble, but
rotation of drive shaft was not easy !!

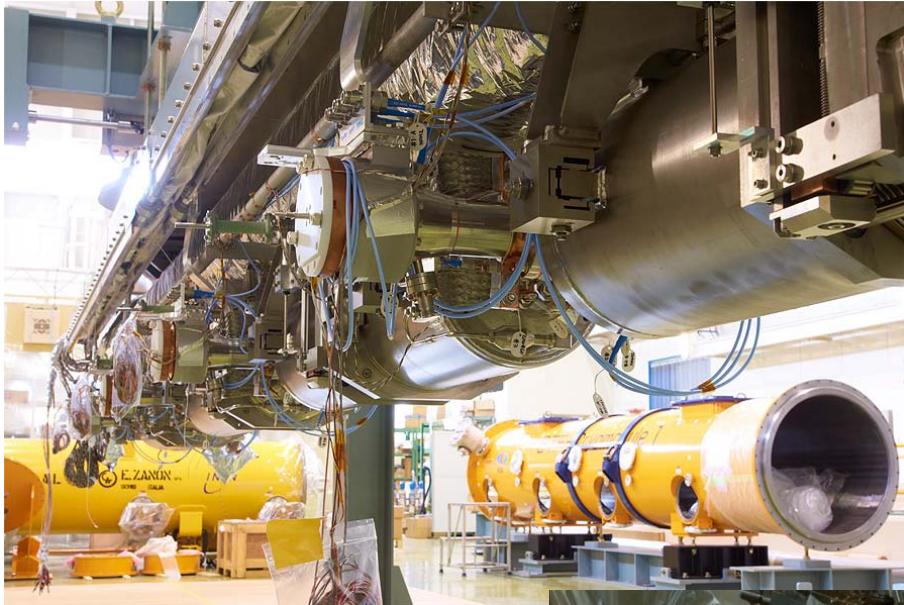
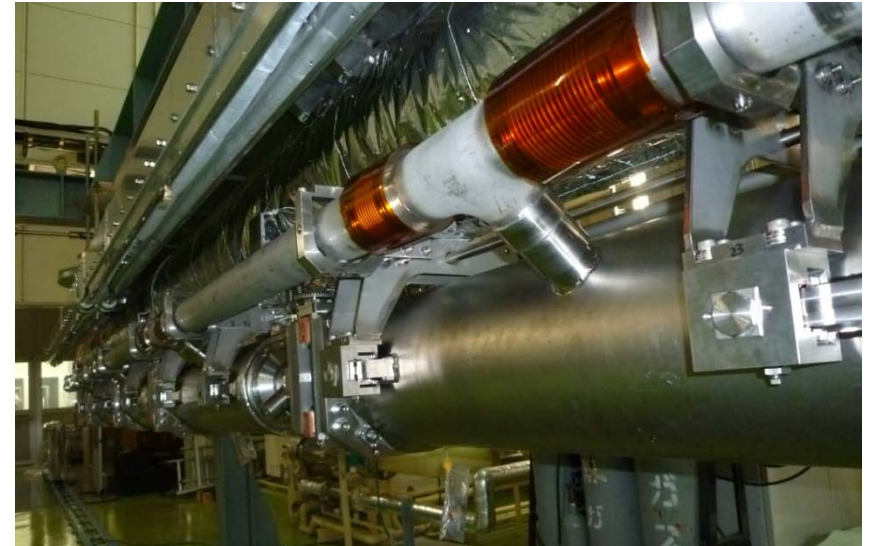
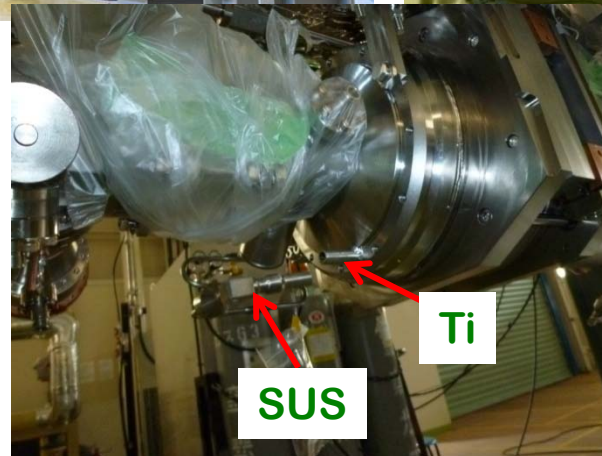
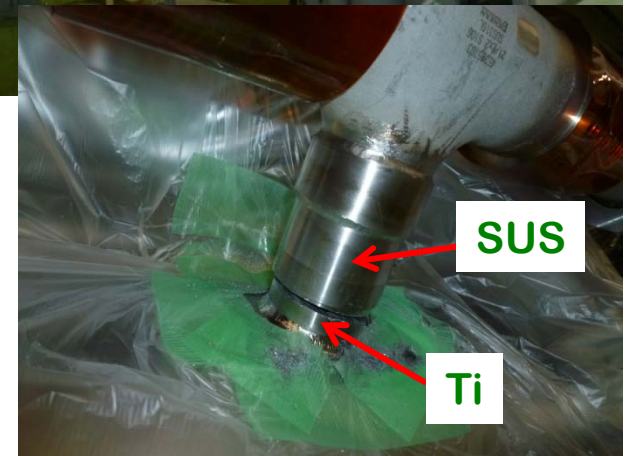
cutting of 2K Pipes (Ti) by saw

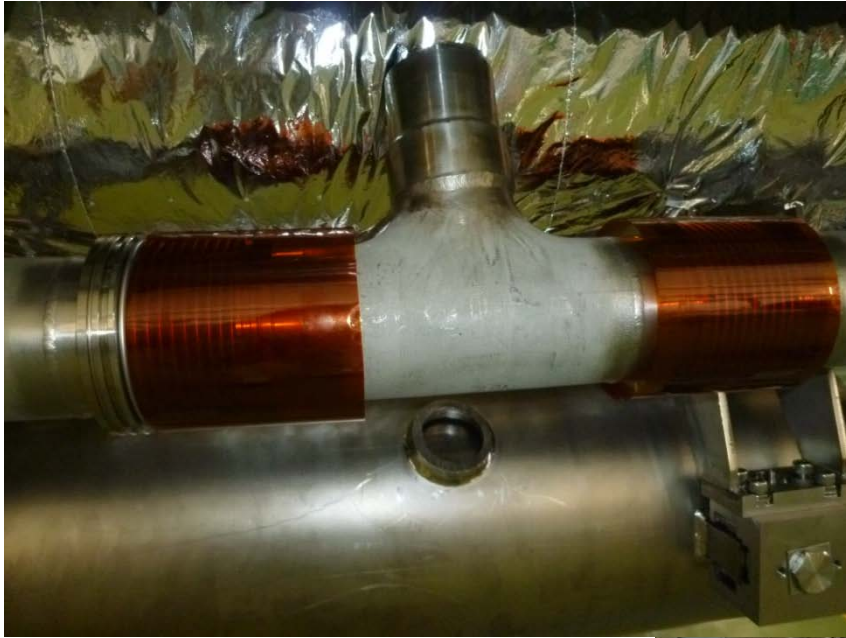
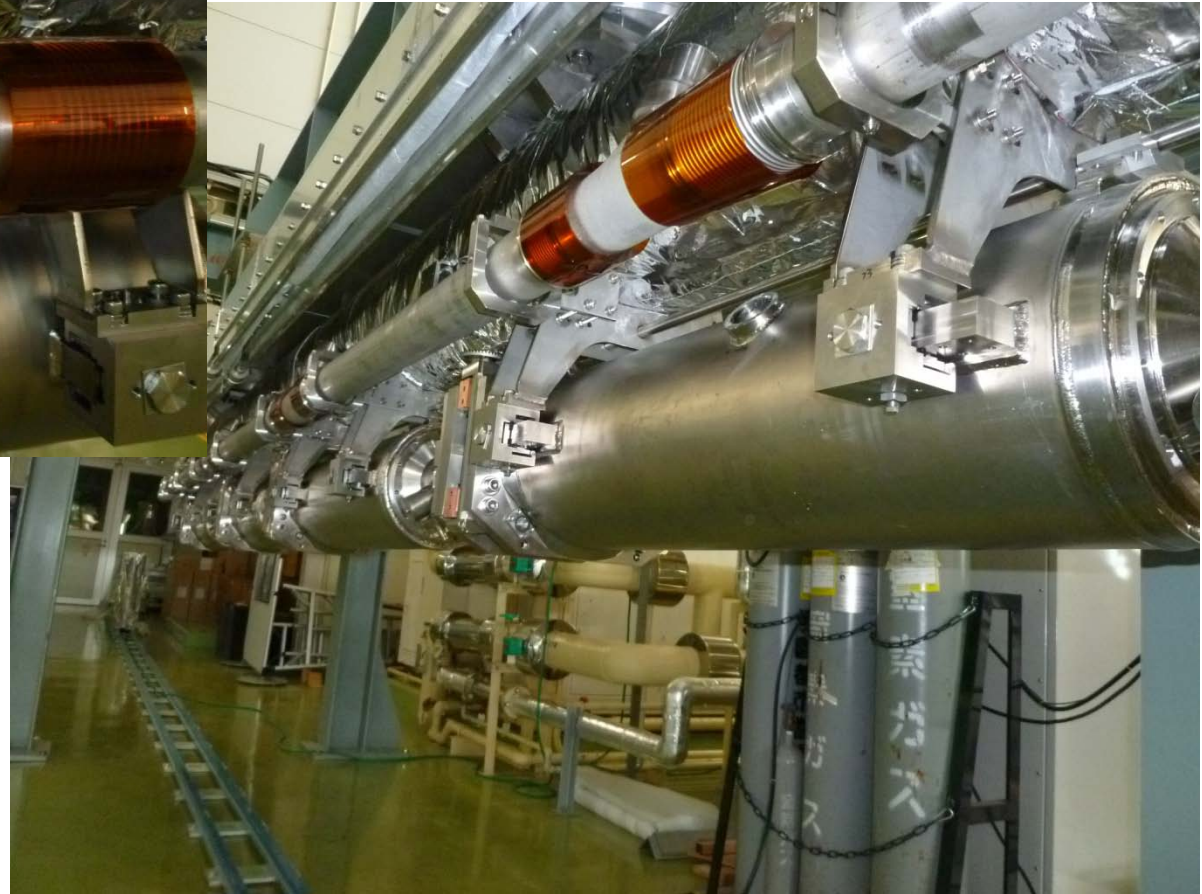
After cutting of 2K Pipes (Ti)

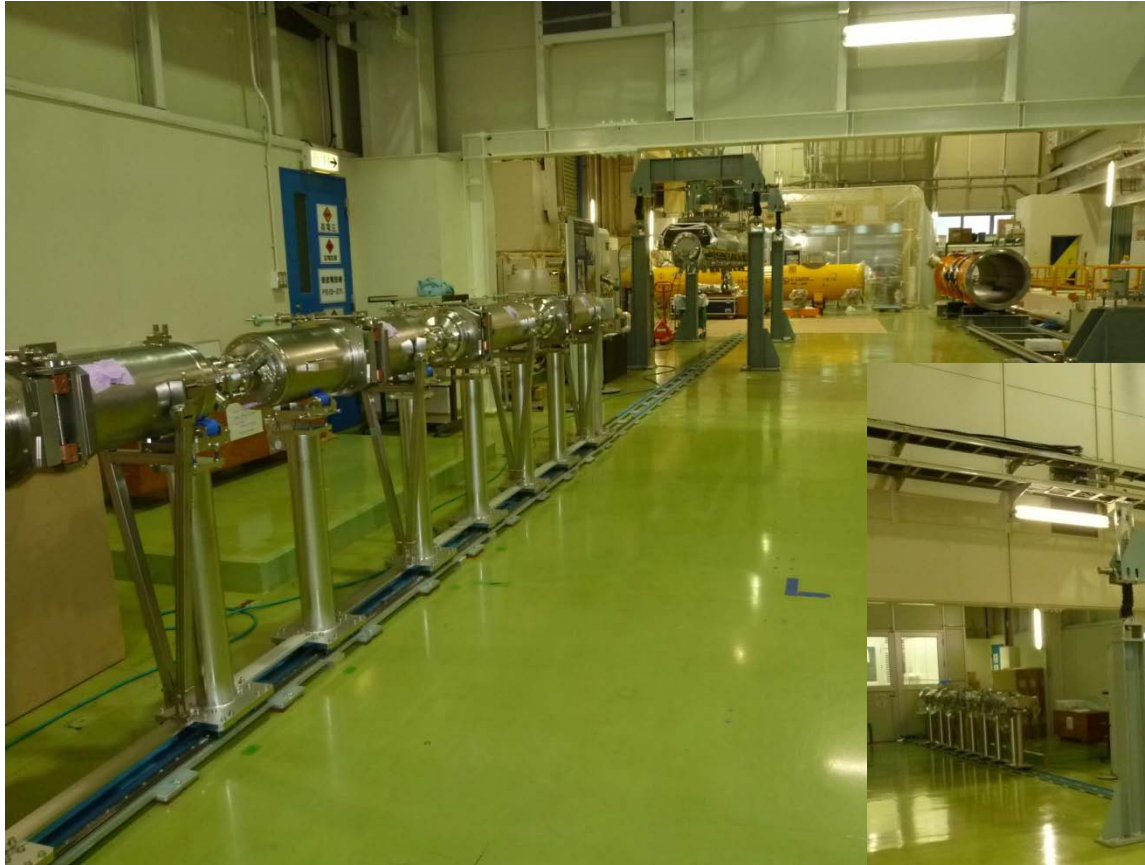
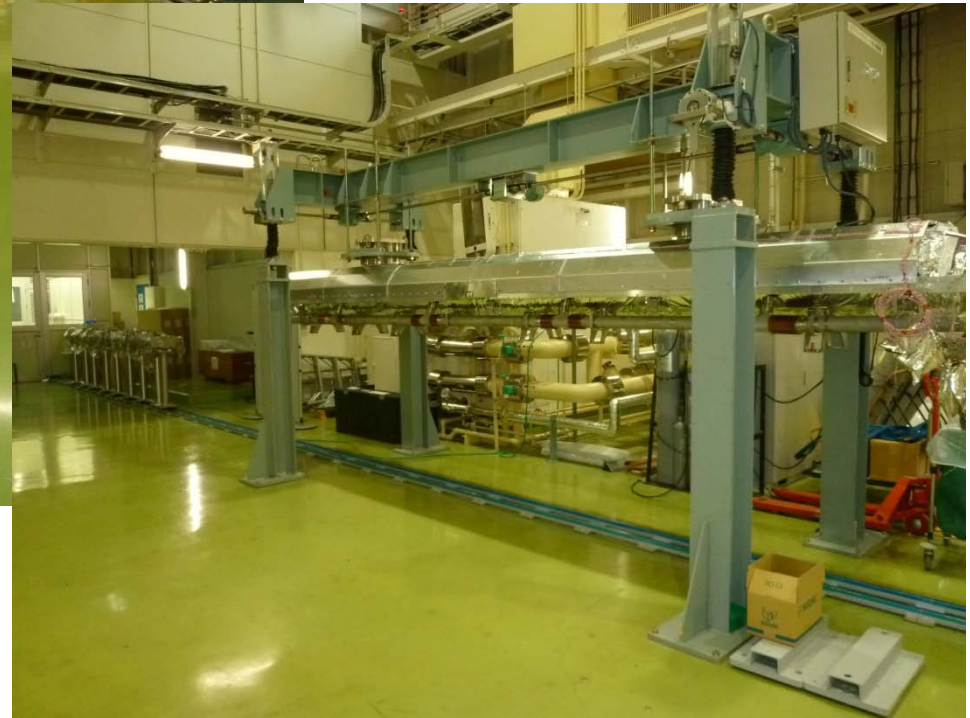
Release from GRP,
Setting on support posts,
Moving to preparation area

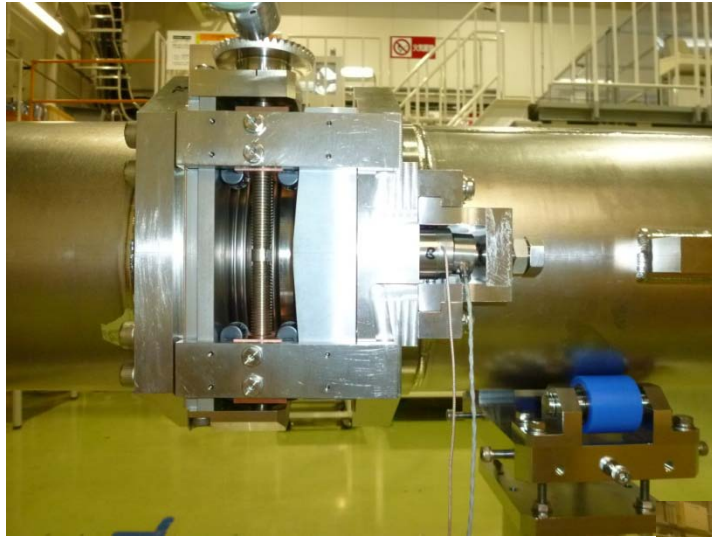
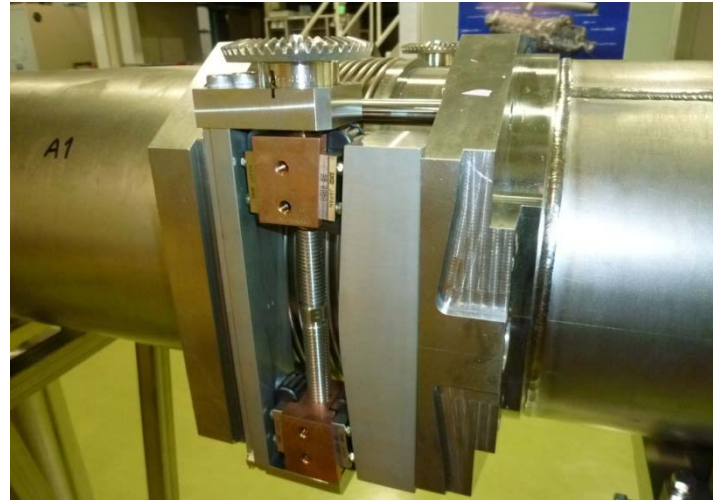
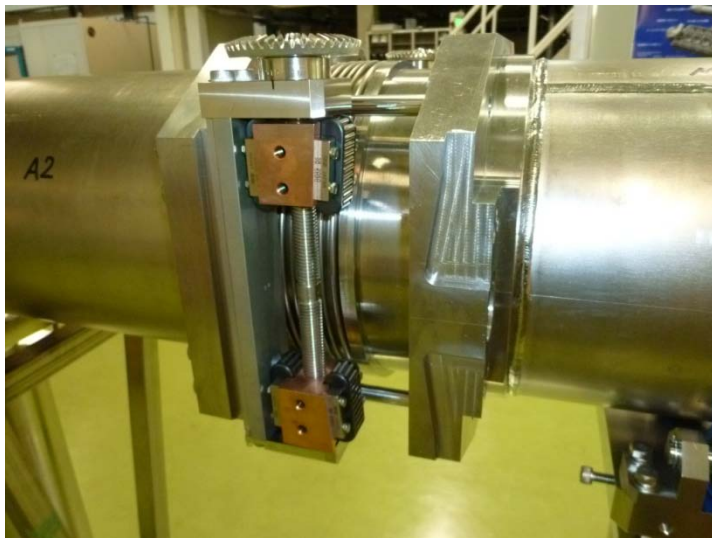
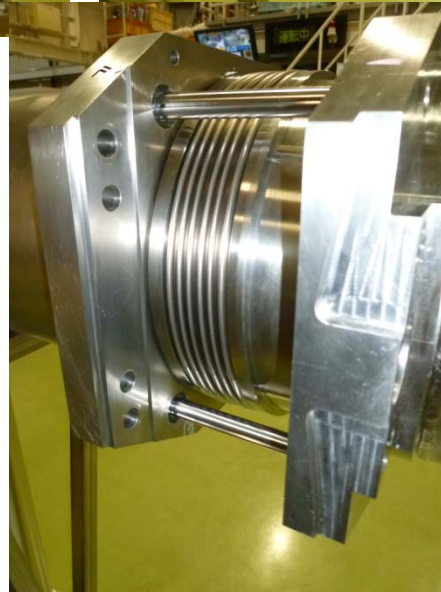
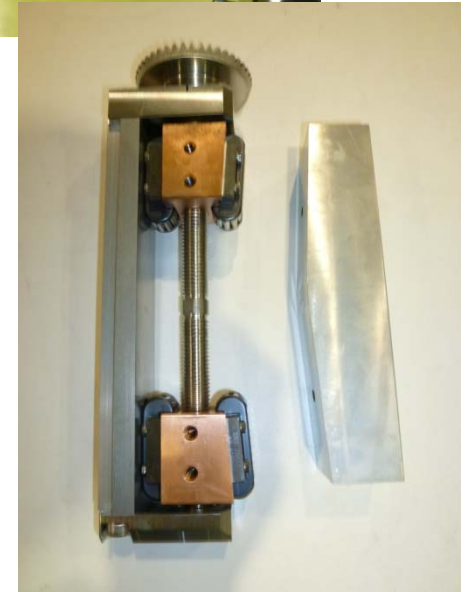
Disassembly of Slide-jack Tuner

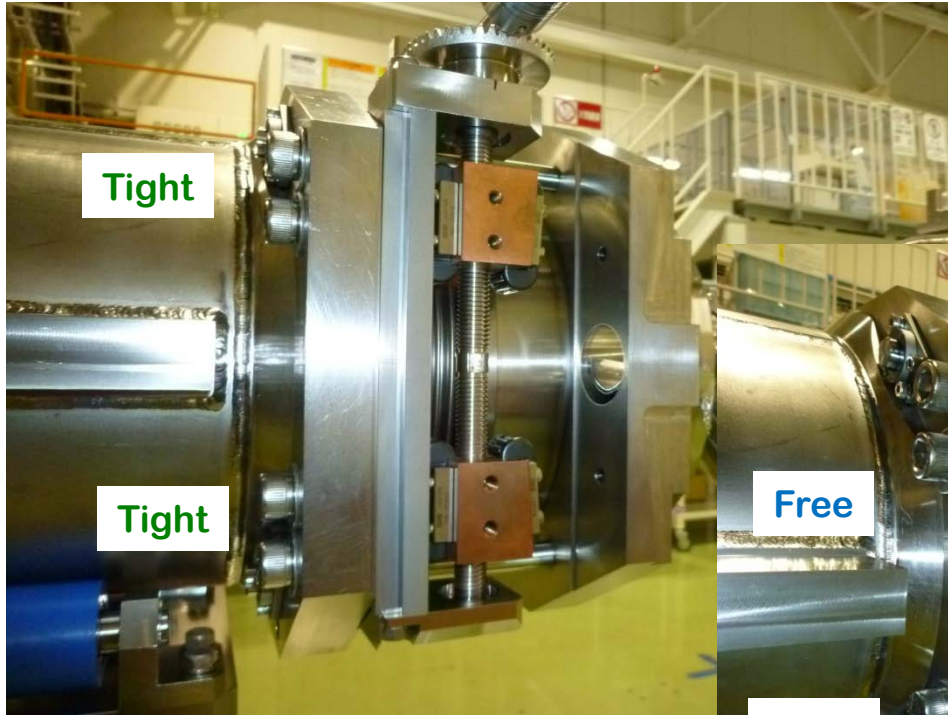
Re-assembly of Slide-jack Tuner

Rotation of drive shaft is not easy.

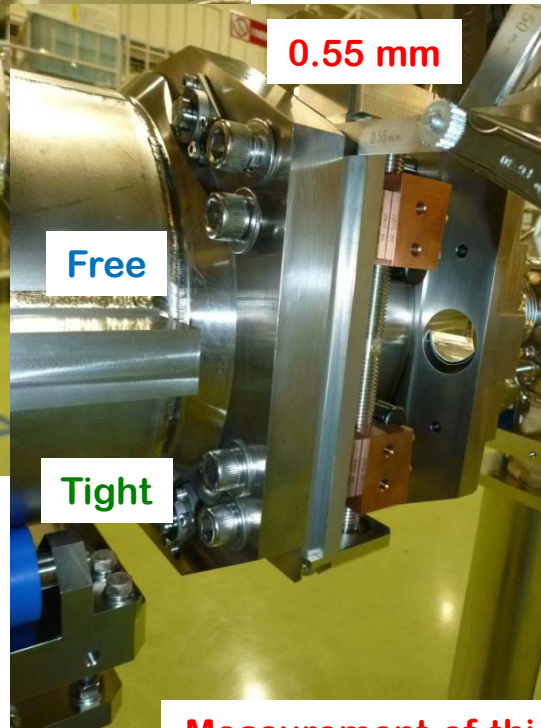
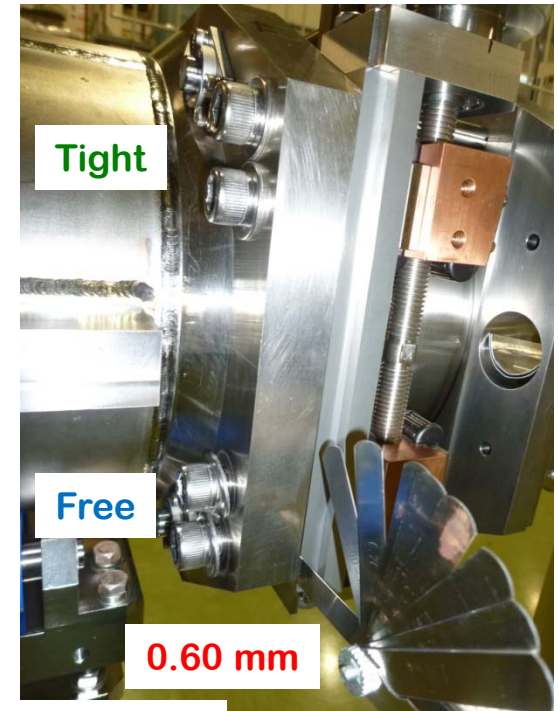
(A4/MHI-09 cavity)

Rotation of drive shaft is smooth !!

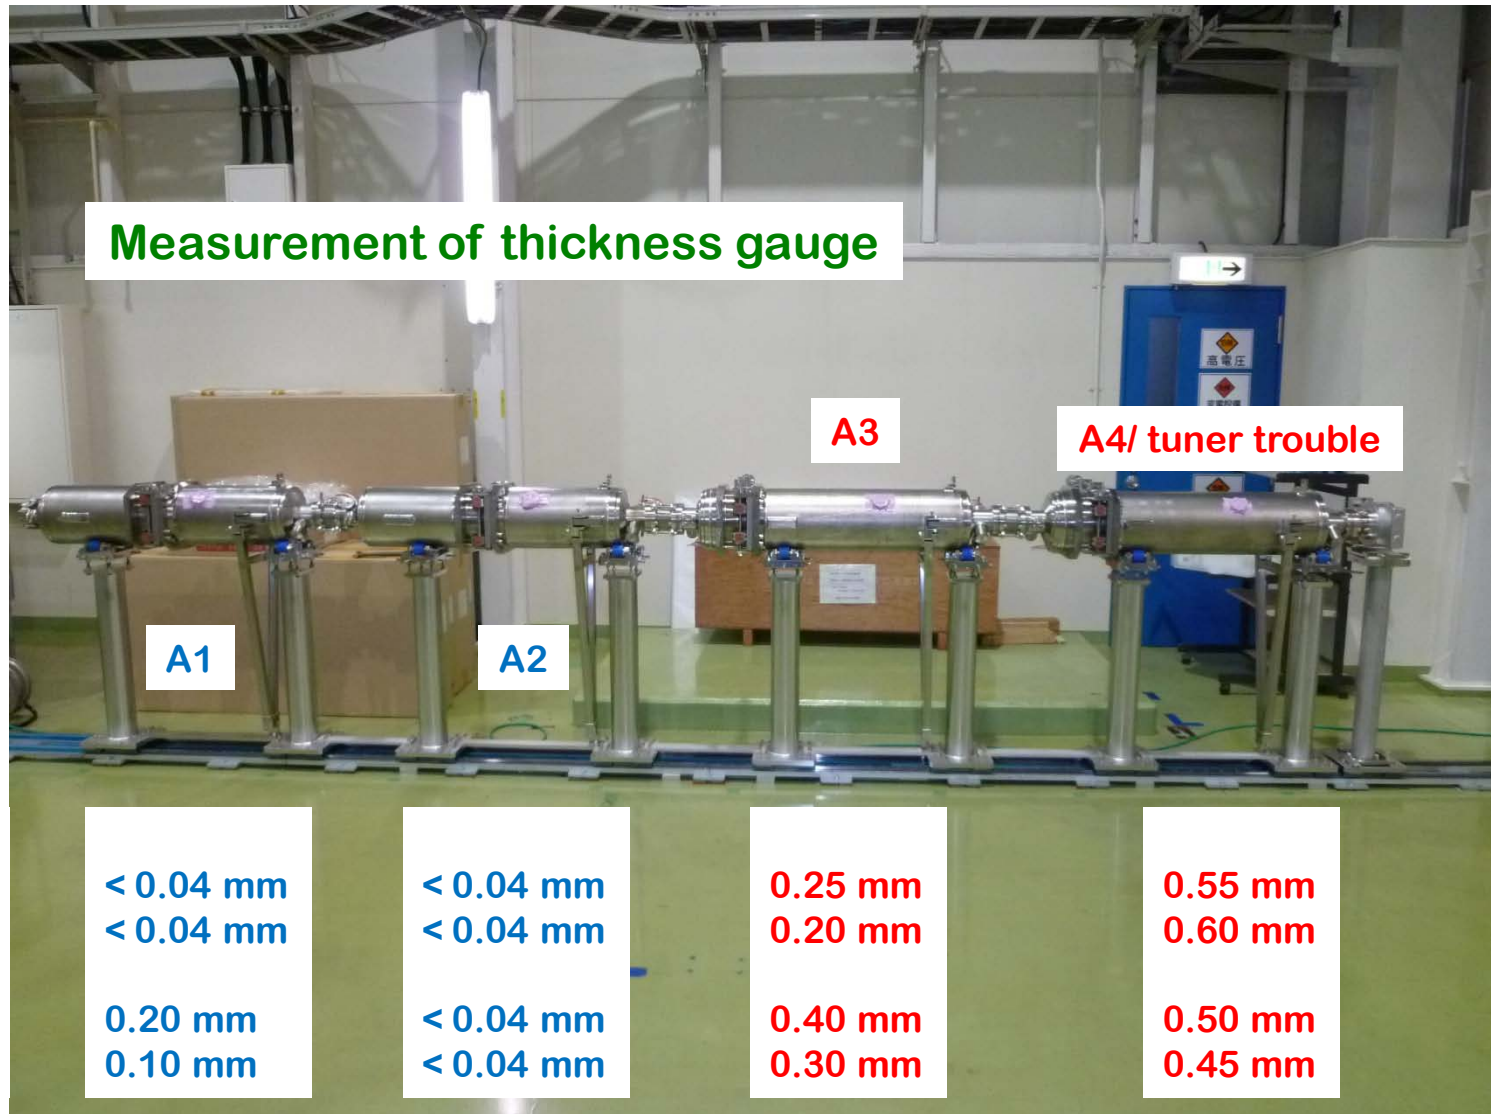
Measurement of thickness gauge

Check of Slide-jack Tuner

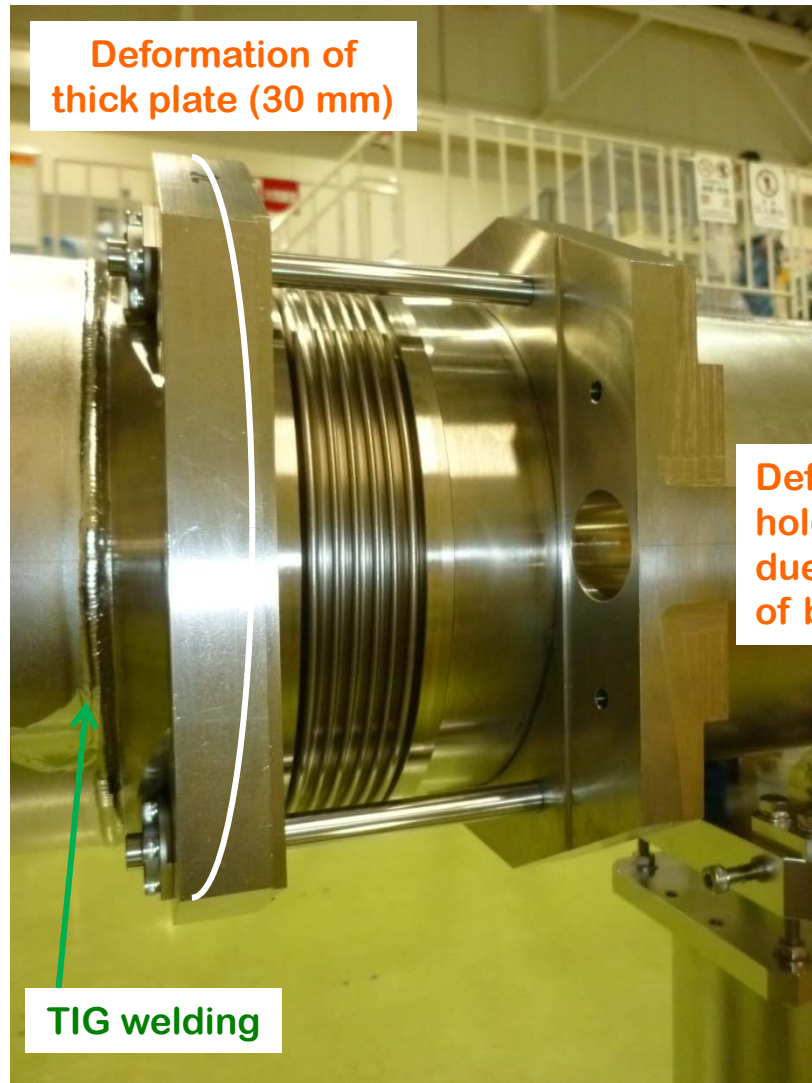
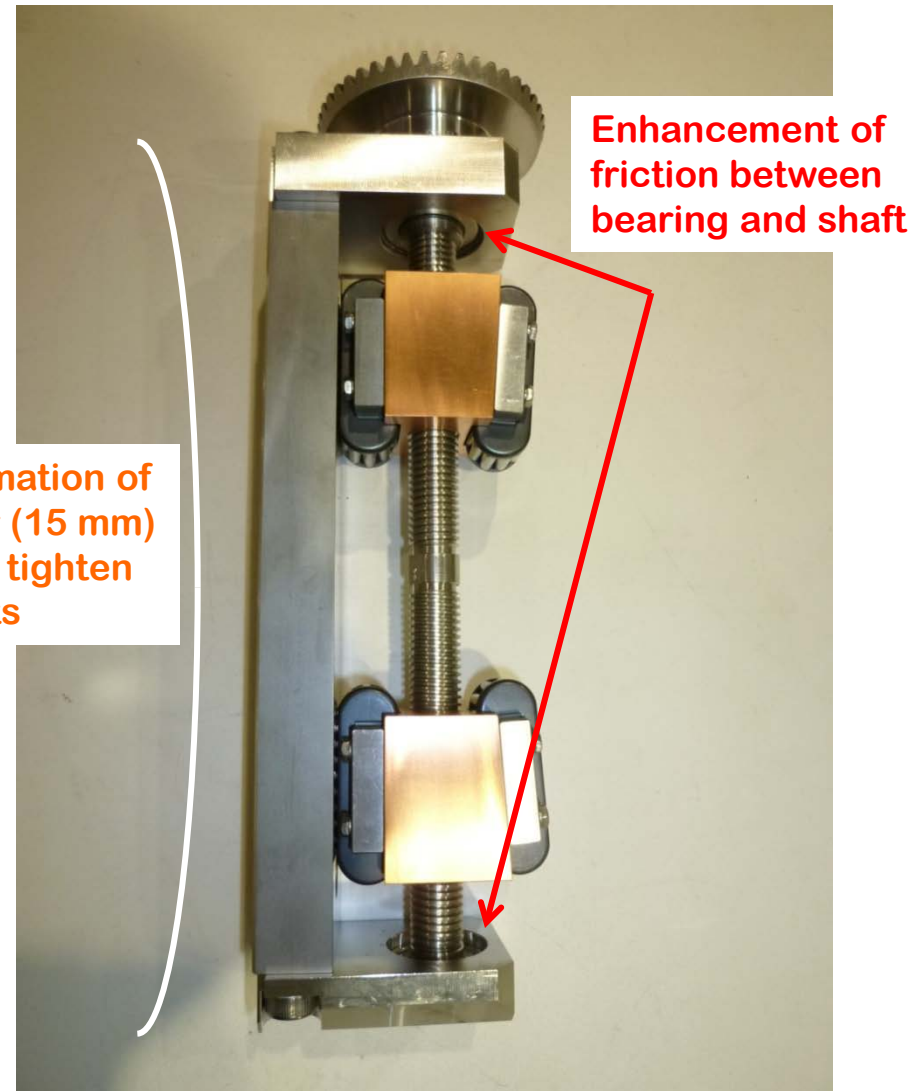
Check of Slide-jack Tuner
