S1-Global Module C couplers disassembly @STF/KEK

TTF3 type input power coupler

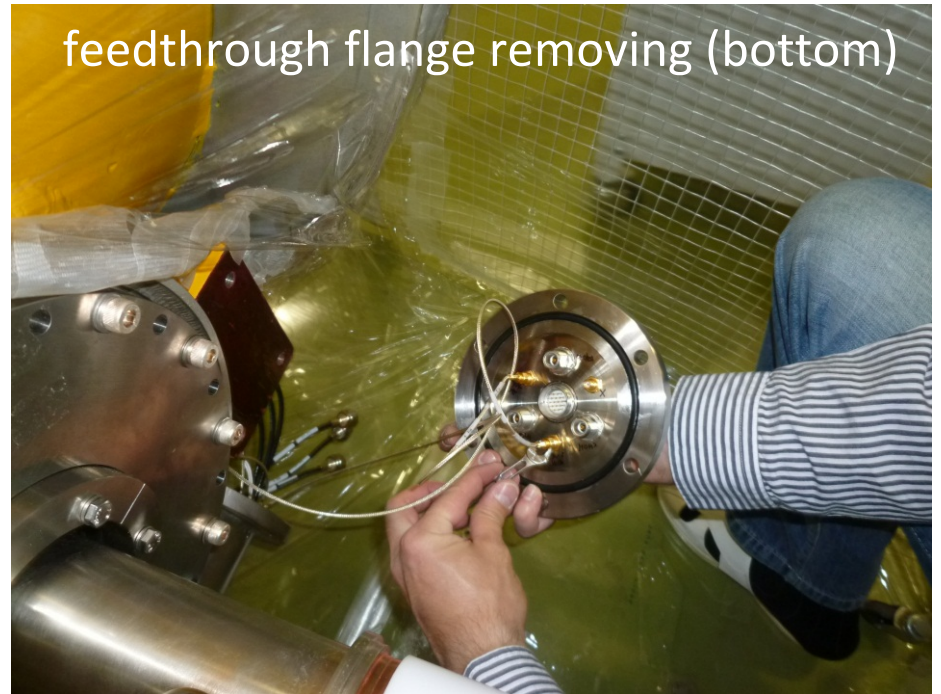
feedthrough flange removing (bottom)

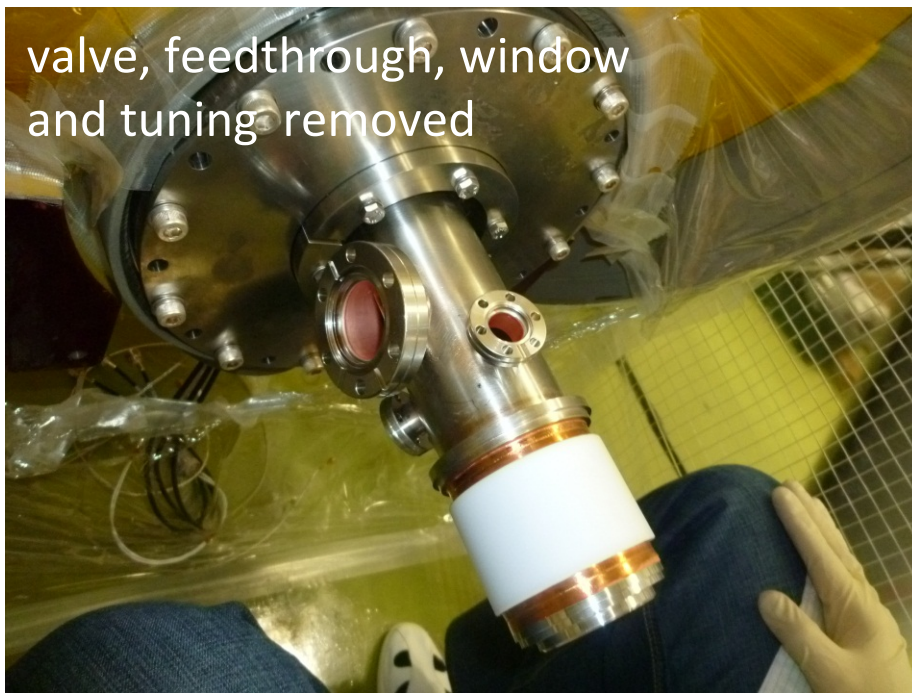
valve, feedthrough, window
and tuning removed

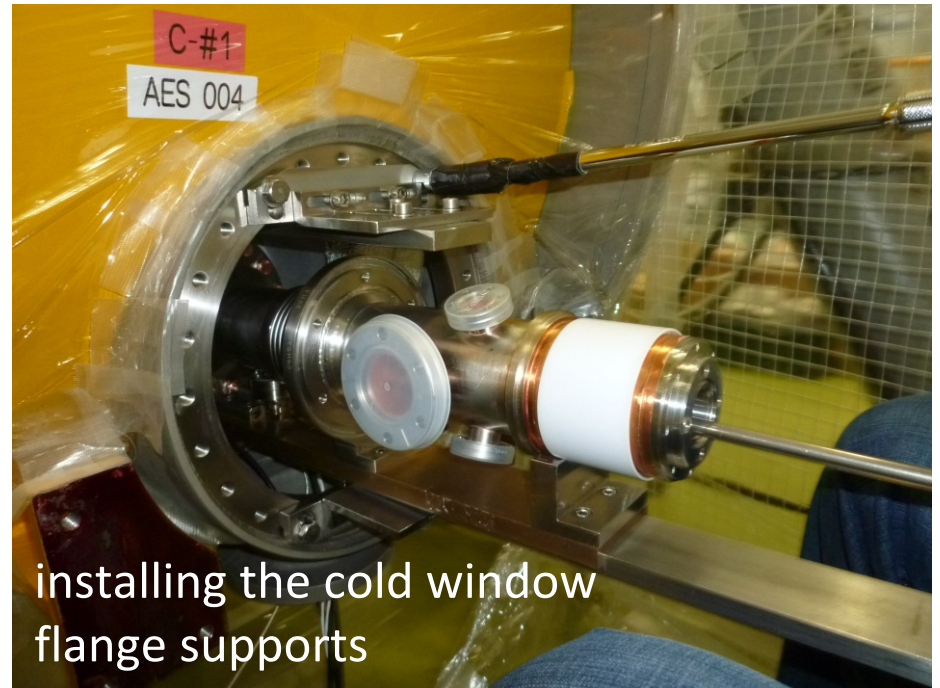
installing the cold window
flange supports

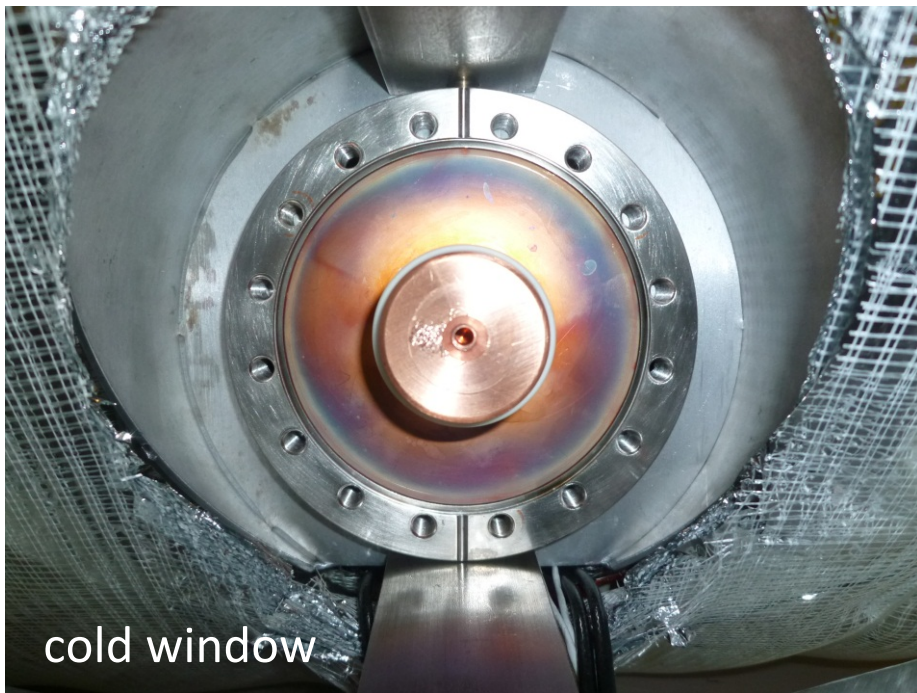
cold window

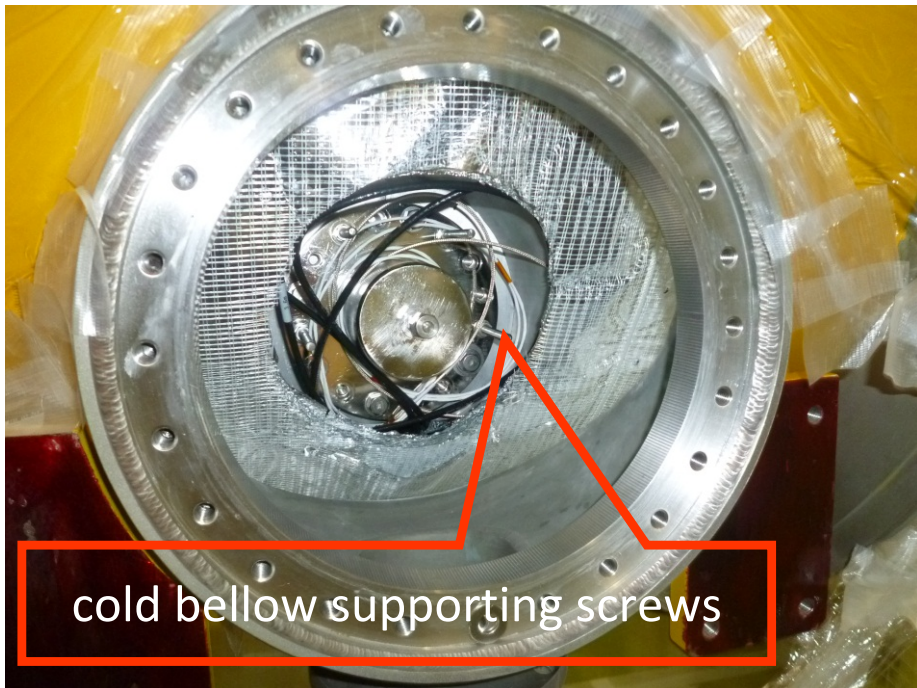
cold bellow supporting screws

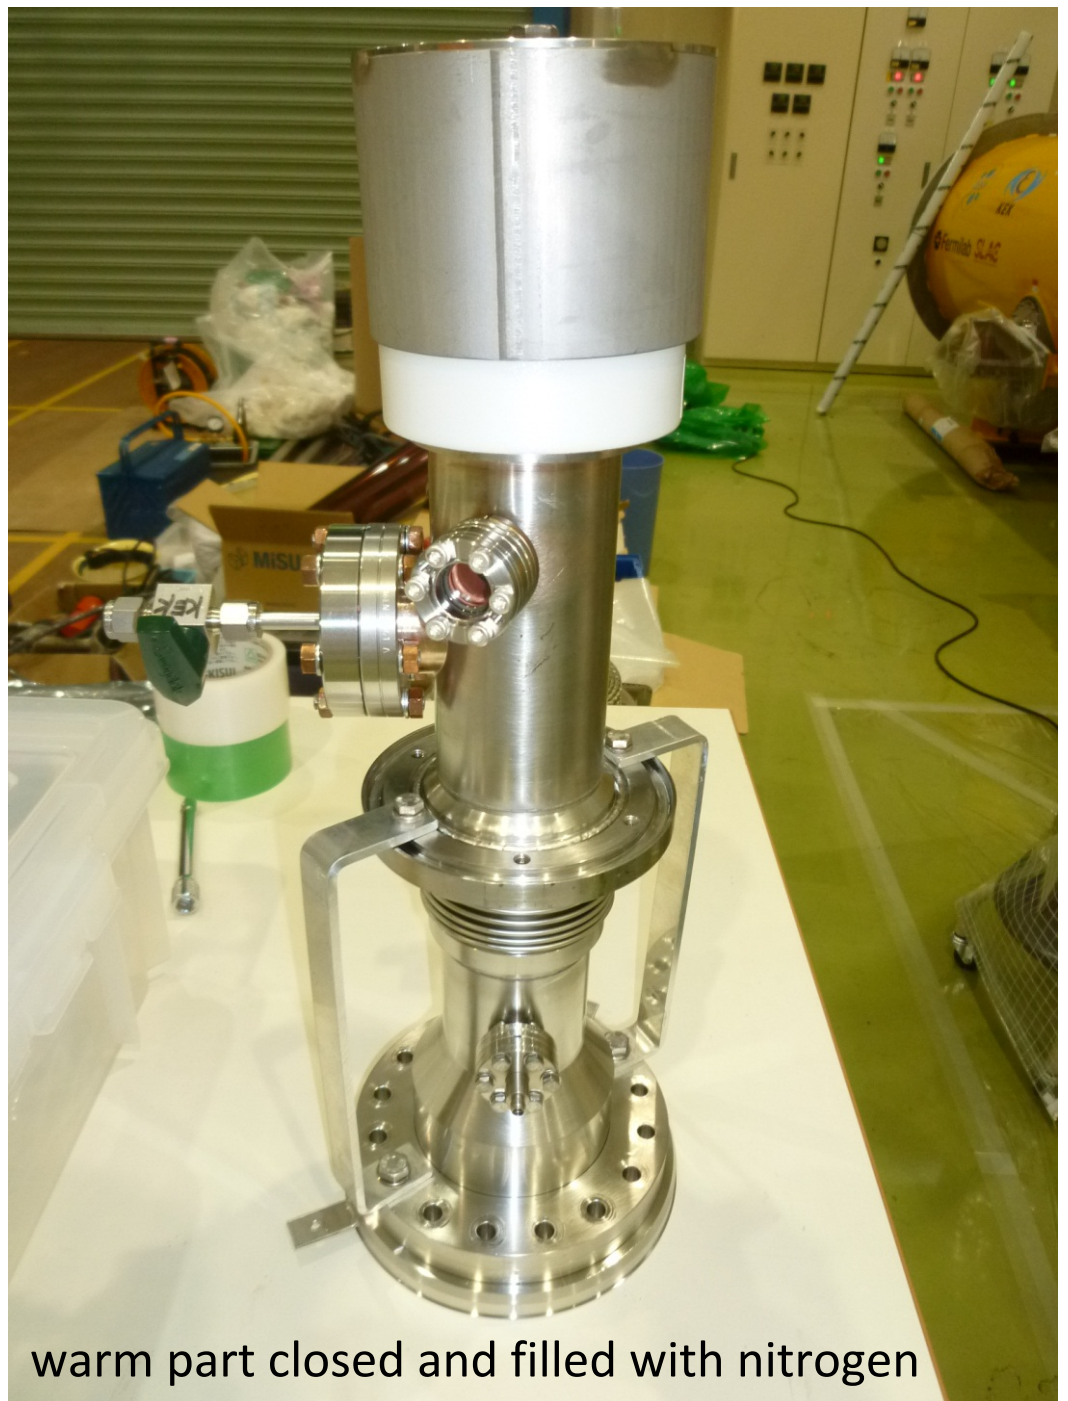
warm part closed and filled with nitrogen

pump/purge procedure:
filling with dry nitrogen

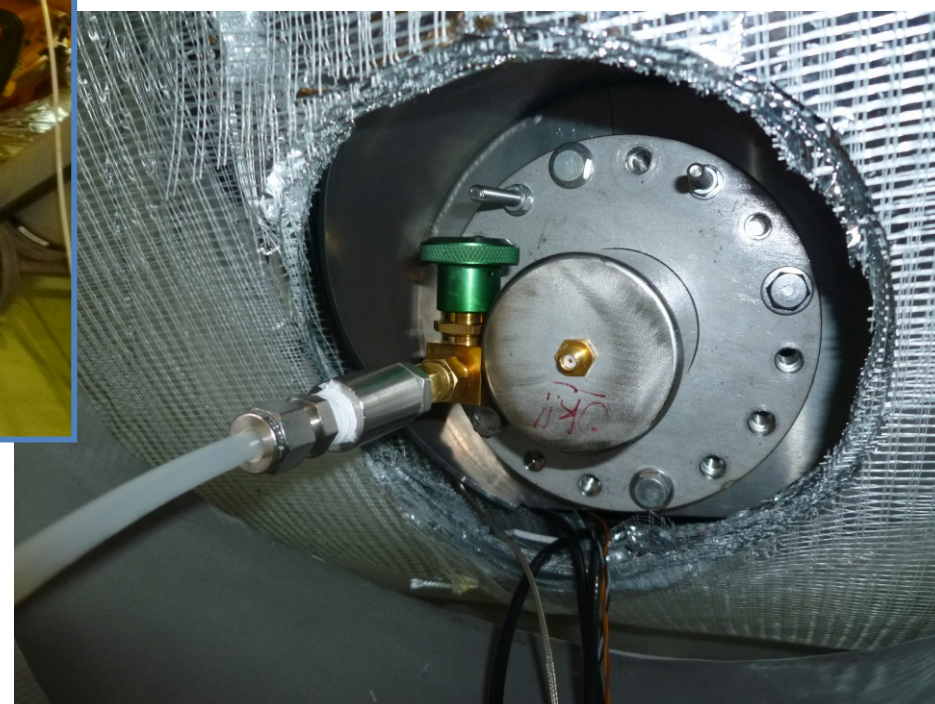
warm parts closed and filled with nitrogen,
cold parts closed with caps and also filled
with nitrogen for storage

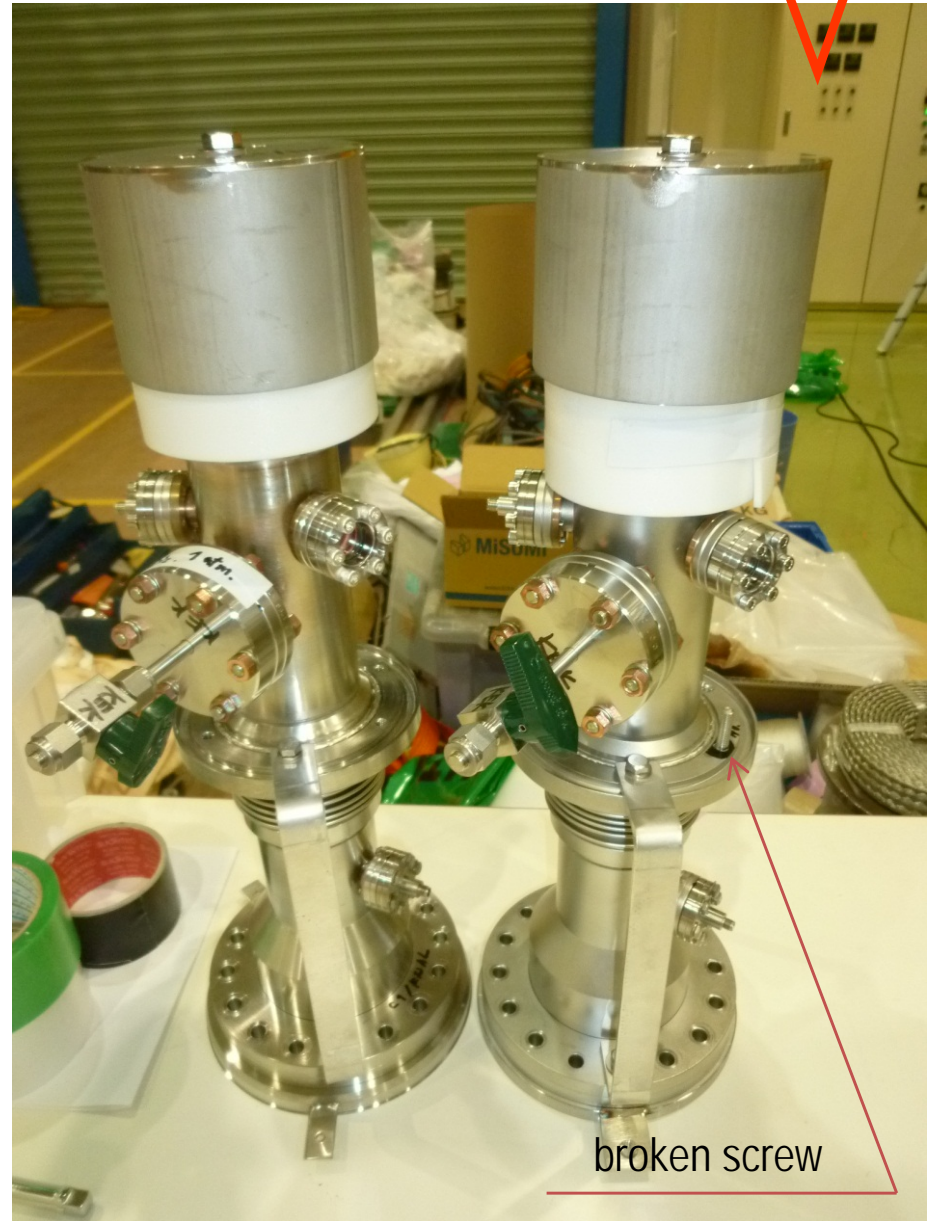
broken screw

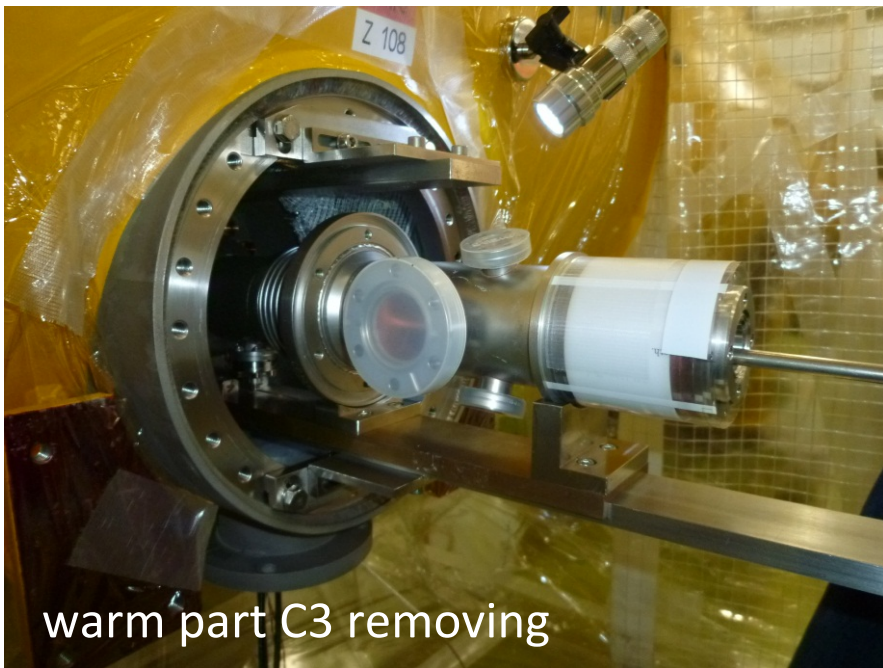
warm part C3 removing

Problem with warm part C3 inner conductor screw. The M5 screw was stuck/seized in the warm part inner conductor (not in the cold part). Removing (unscrewing) the screw with force caused strong bellow deformation. It was not clear where the screw stuck (cold/warm part) during the dismounting.

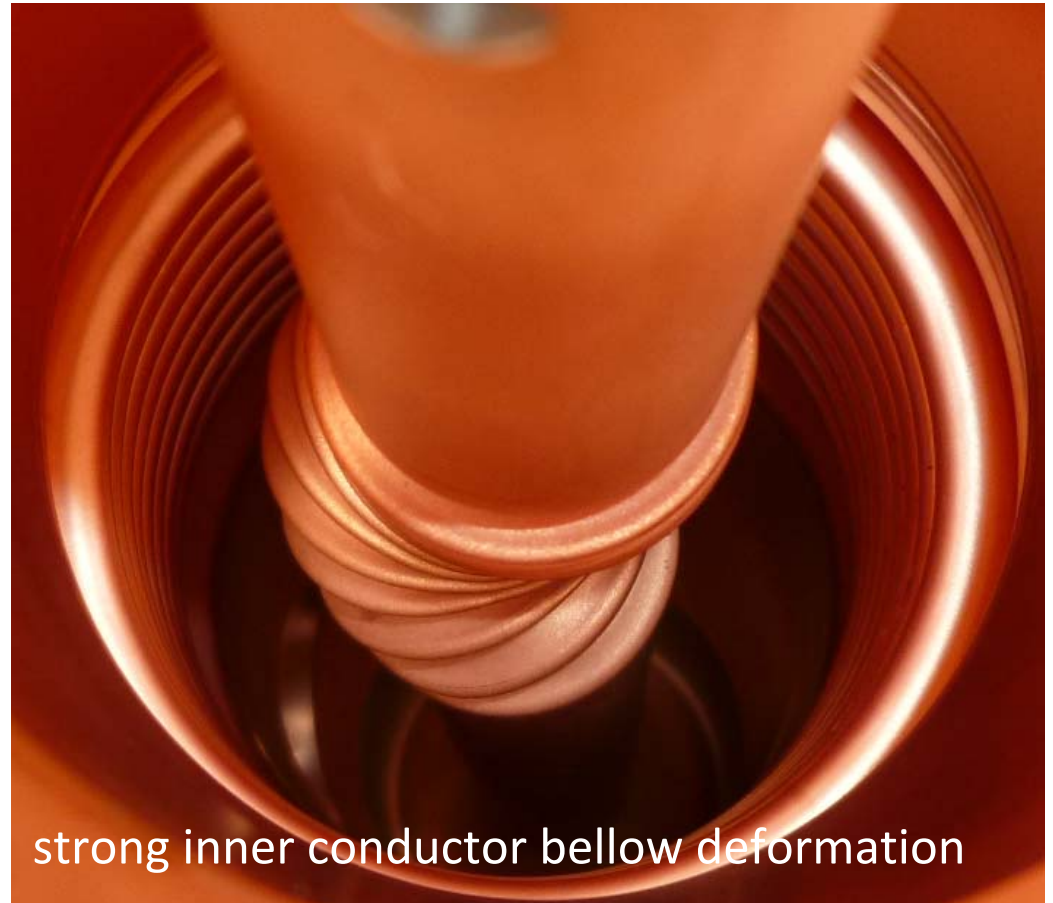
strong inner conductor bellow deformation
