# Industrialization of E-XFEL string and module assembly at CEA- Saclay

# CEA contribution

- CEA contributes to the E-XFEL Cold Linac construction through String Assembly (WP9), Module Assembly (WP3) and BPM (WP17)
- Accelerator Module Assembly (WP3-WP9) : assembly of 103 accelerator modules with 1 per week throughput ! operated by an industrial contractor on the Saclay site.

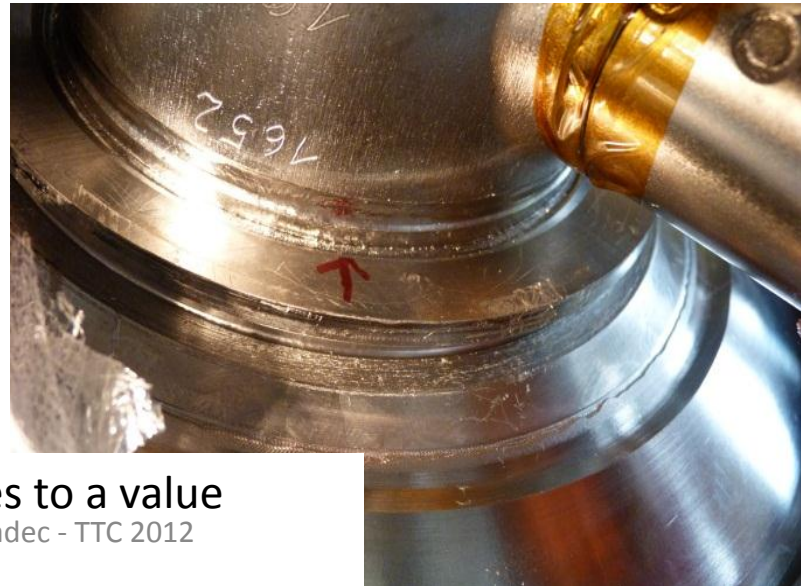
- PXFEL2\_2:
  - Leak on cavity 6 helium vessel (isolating vac and He circuit)
    - No exchange at CEA because of time constrain for XM-3
    - Not full penetration welding between the cones and the cavity.
    - For serie production, full penetration welding

Leak rate on cavity AC121 rises to a value higher than  $1 \text{ e-5mbar.l.s-1}$

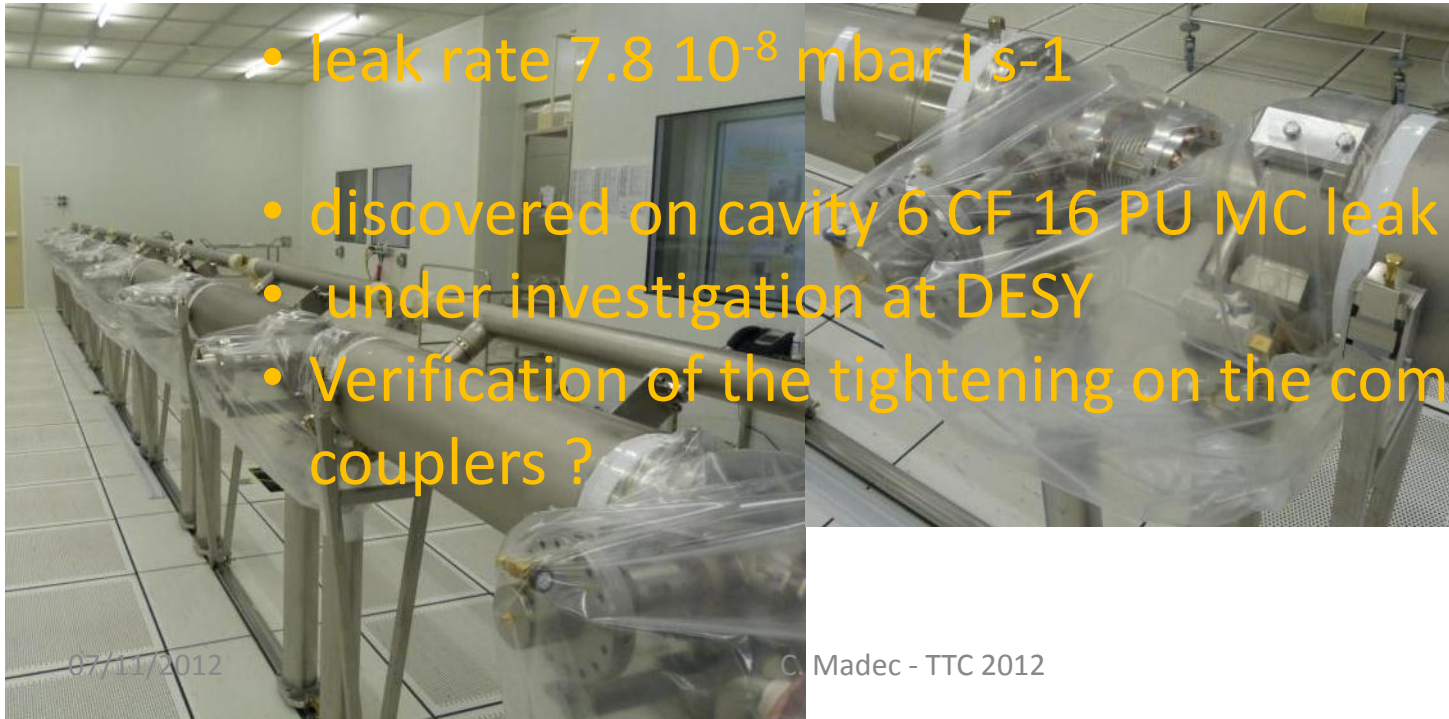
- PXFEL2\_2:
  - In situ leak appeared at the leak test of the cavity string before shipping (acceptance criteria) :

- leak detection before roll-out  $10^{-10}$  mbar.l.s-1
- leak rate  $7.8 \cdot 10^{-8}$  mbar l s-1

- discovered on cavity 6 CF 16 PU MC leak
- under investigation at DESY
- Verification of the tightening on the coming couplers ?
