VEP Status at Marui Galvanizing Co. Ltd/KEK

**LCWS14 at Belgrade / Serbia
7th Oct. 2014**

VEP Setups for 1 and 9 cell Cavities at Marui

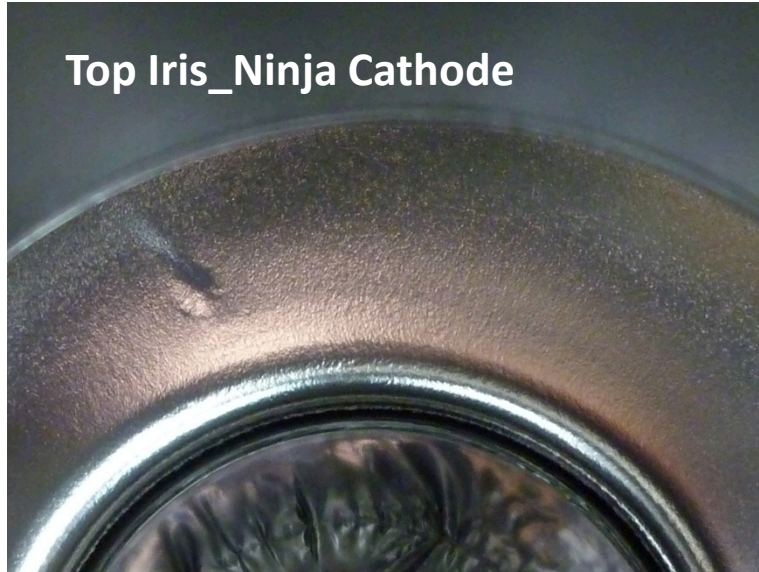
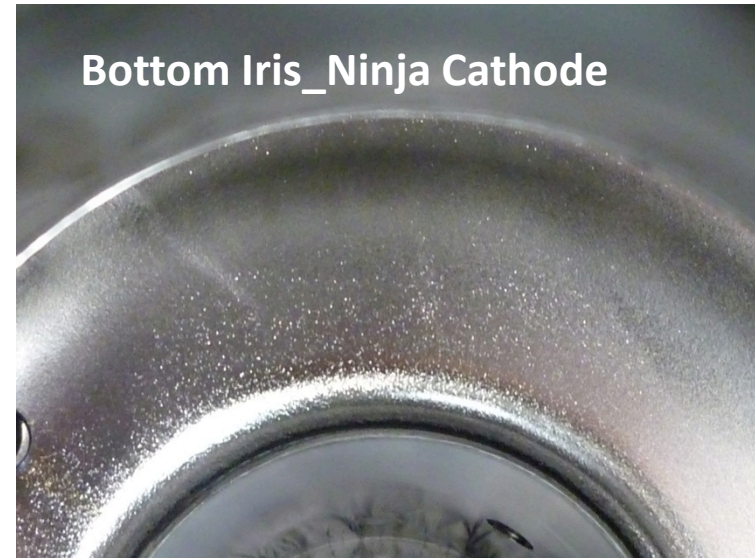
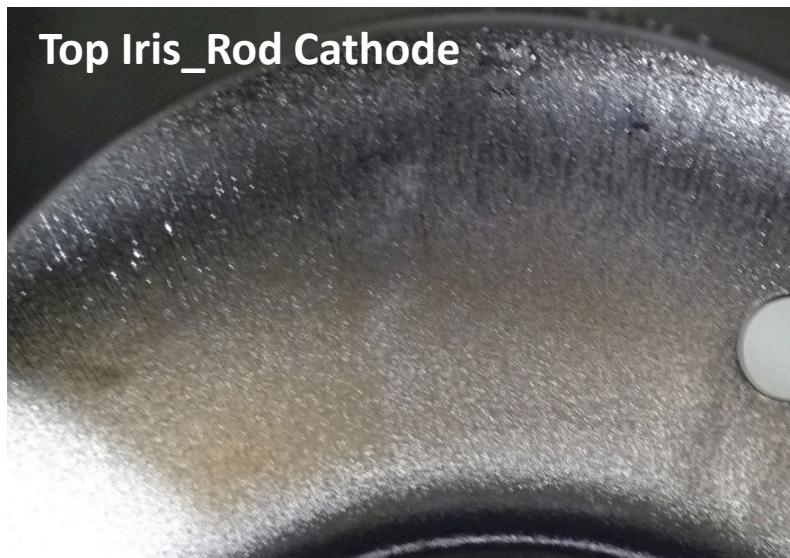
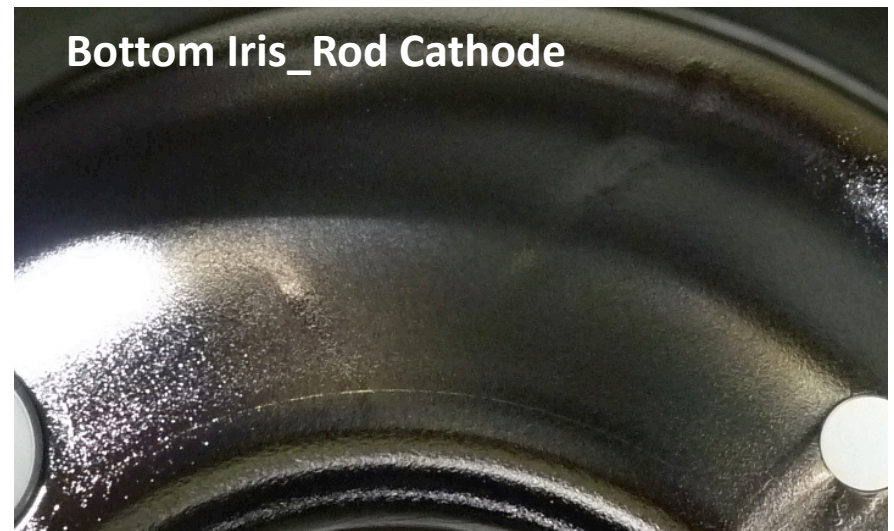
Cavity Irises

- The top iris surface was found to be rougher with vertical traces due to H_2 bubbles.

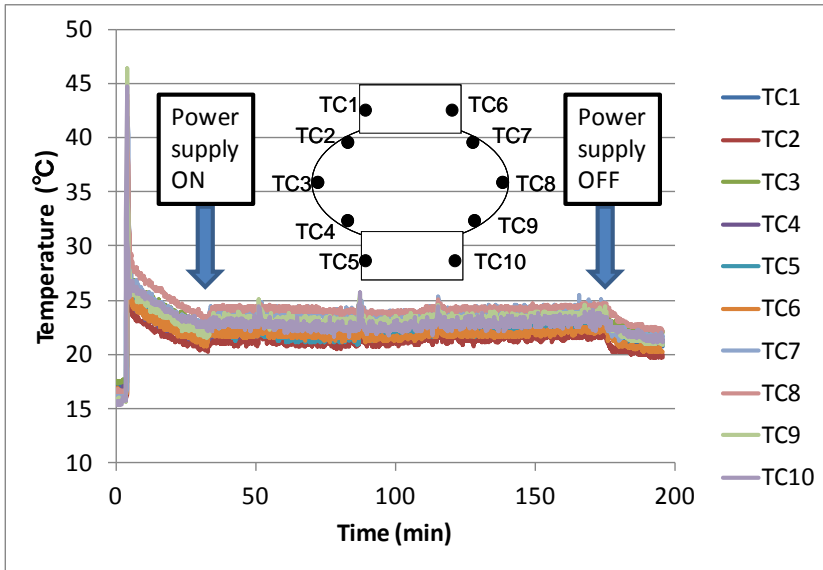
Temperature during VEP

- Cavity temperature was successfully kept around 20 – 25 °C at all measurement points.
- Current density was successfully kept around 25 mA/cm².
- Voltage drop occurred in this system.
(Power supply setting 5 – 6V → measured 4V)

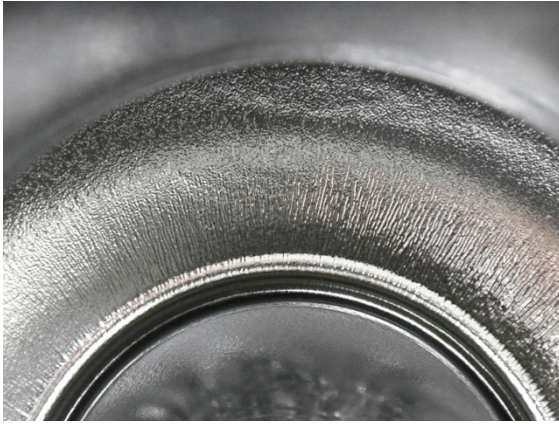
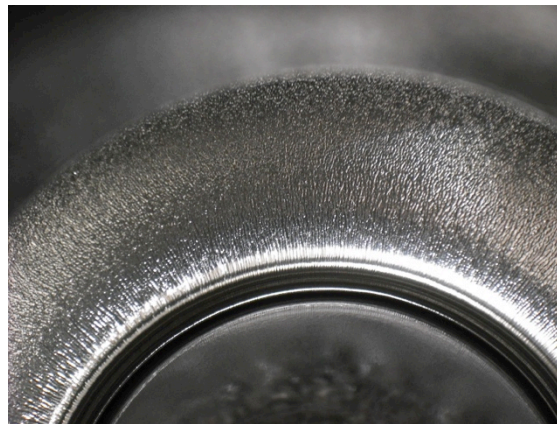
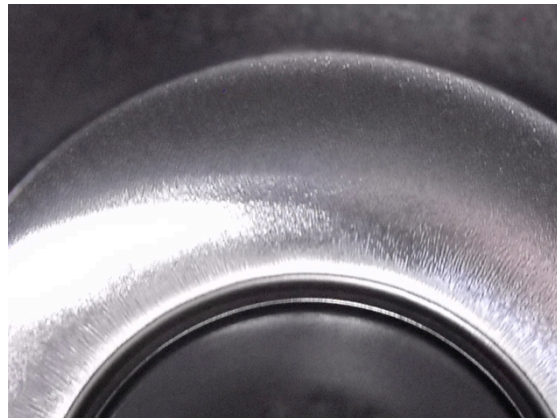
Inner surface inspection with a digital camera and an endoscope

- At macroscopic area, the surface became flatter and pits were disappeared.
- At microscopic area, crystal grain like pattern was appeared.
- Brightness was reduced little by check with eyes.

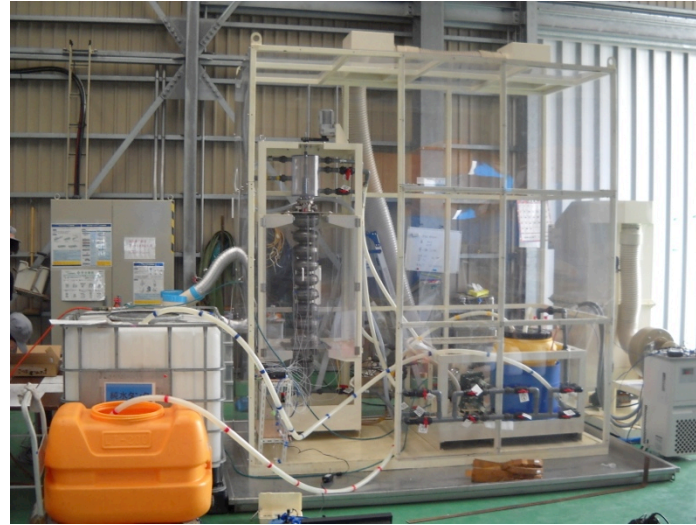
No cavity cooling system
