Homogeneous Removal of Nb 1-Cell Cavity using Vertical EP

Asian Linear Collider Workshop 2015

V Chouhan, S Kato, K Nii, T Yamaguchi and Y Ida
Marui Galvanizing Co., Ltd, Japan
& KEK

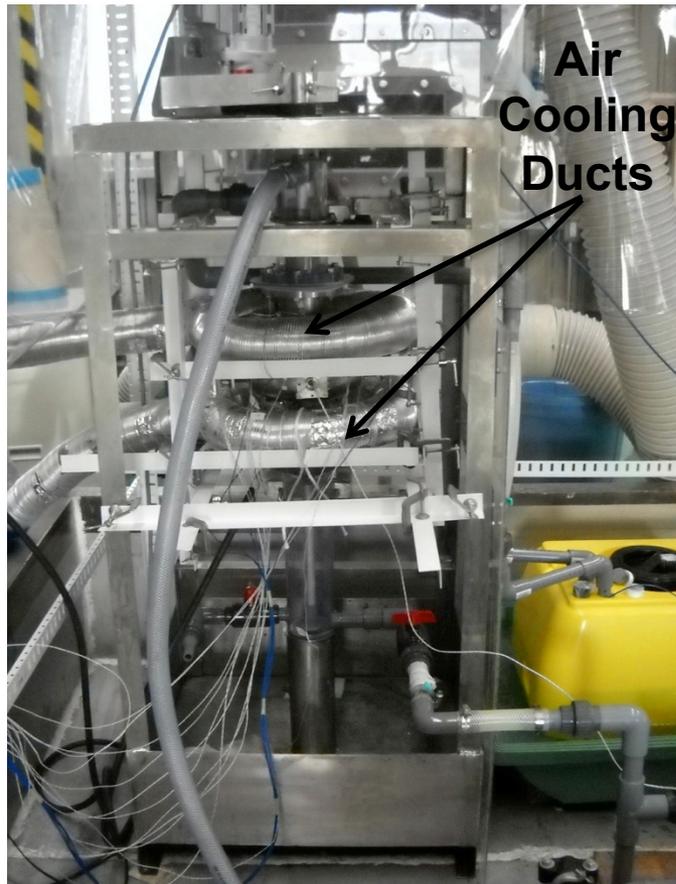
VEP Setup for 1-Cell

- We challenged to make the setups with PVC material for mass production and cost reduction.
- The 9-cell cavity VEP system can be used for VEP of 1-cell cavity also.
- System contains separate pipe lines and pumps for water and EP solution.
- EP solution and water can be flown from bottom to top and vice versa.

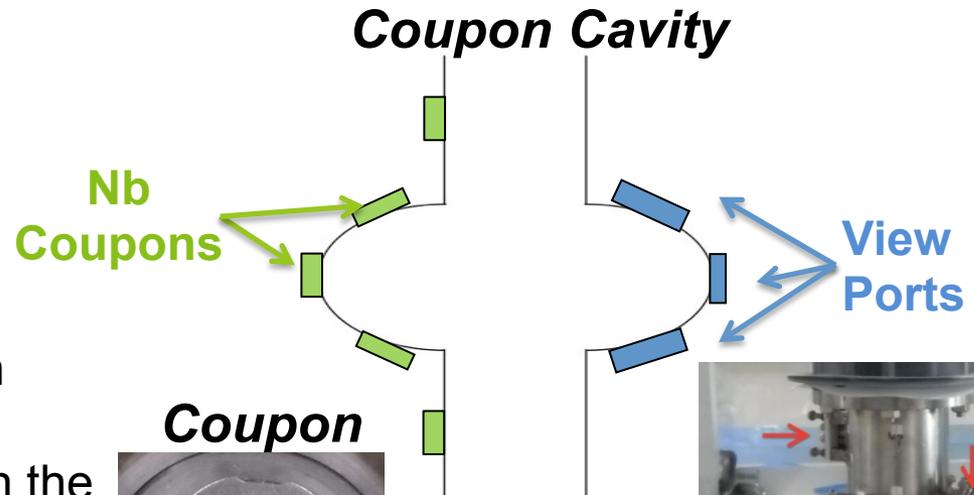
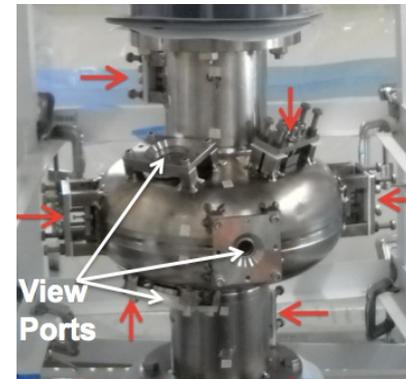
Coupon Cavity

- Cavity contains 6 coupons.
- EP current can be measured for individual coupon.
- Coupon surfaces are analyzed with several surface analytical tools.
- The cavity is having 4 view ports on the top iris, bottom iris and equator for light introduction and in-situ observation of cathode wings and H₂ bubbles.

Red Arrows Show Coupon Positions

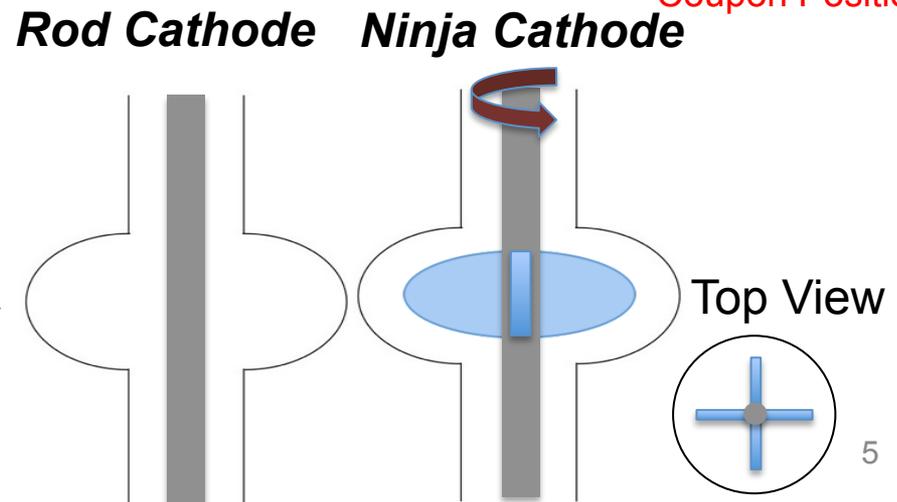
Ninja Cathode

- Marui Galvanizing developed a unique cathode called Ninja cathode.
- The Ninja cathode has 4 retractable Al wings for agitation and uniform EP over the cavity.

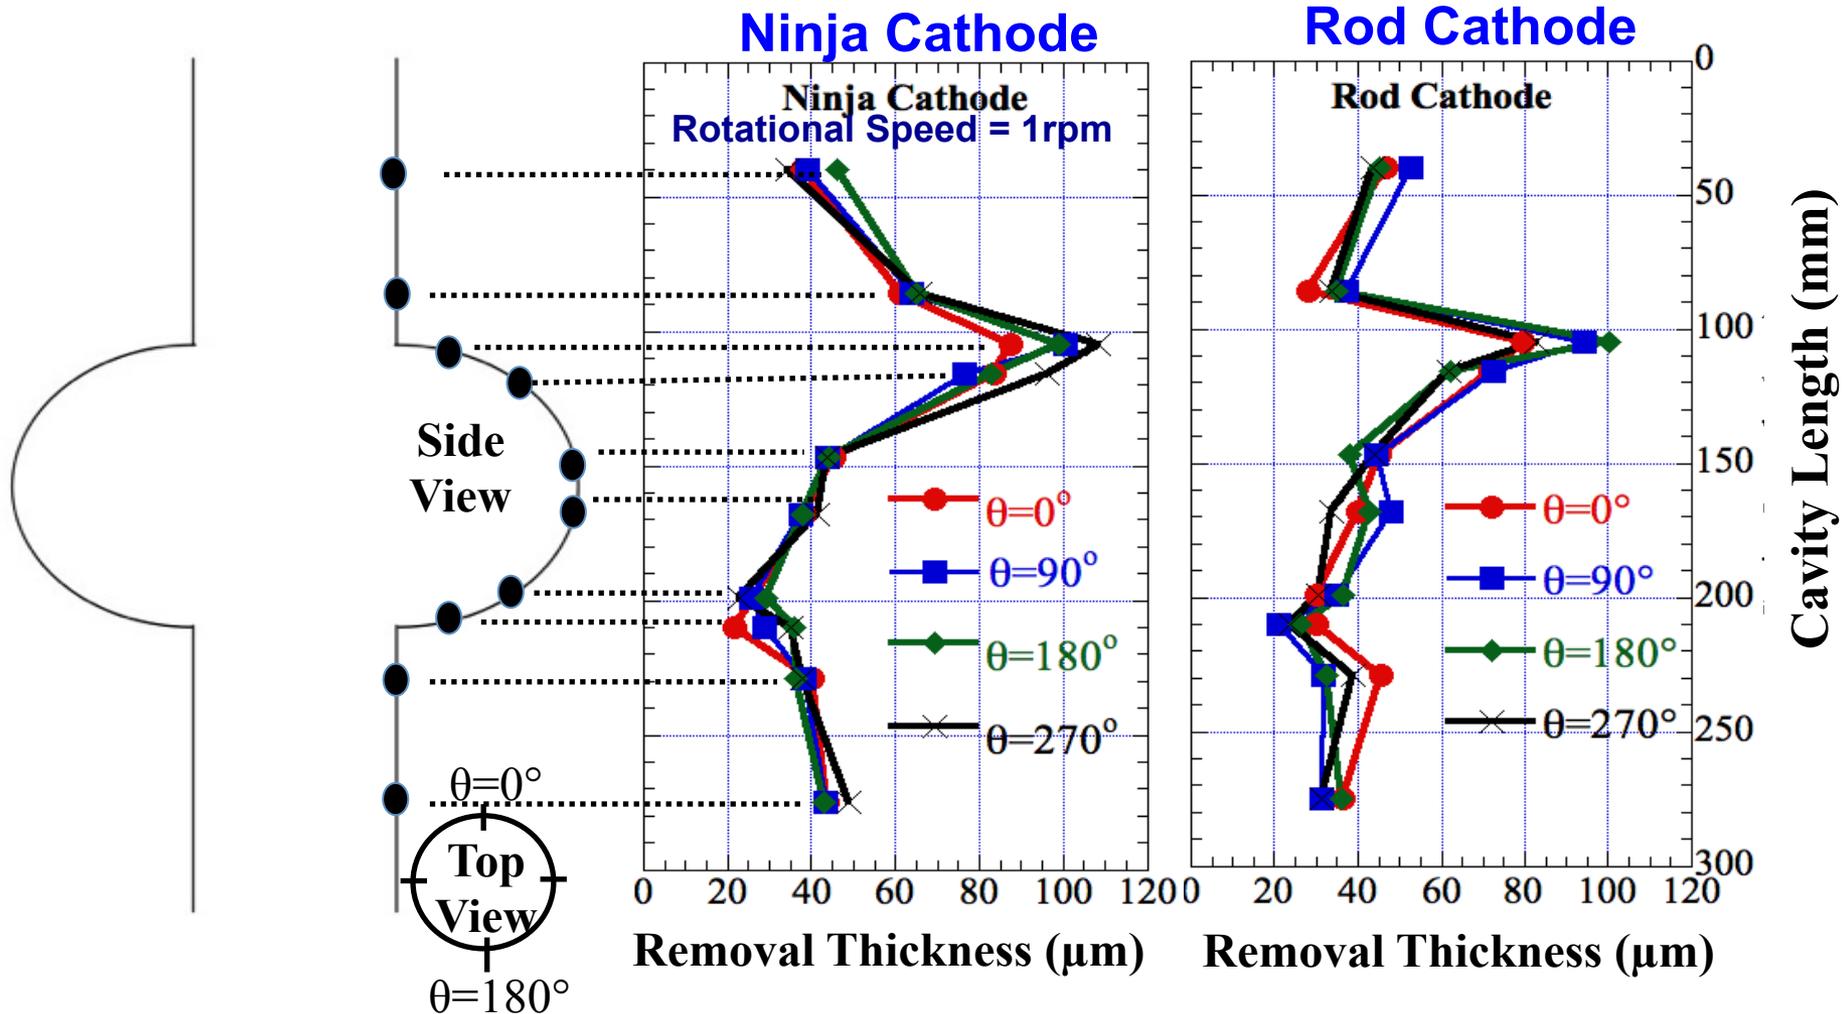
Inhomogeneous Removal Thickness with VEP

- Removal thickness was measured with ultrasonic thickness gauge.

- Removal thickness was the highest at the top iris and the lowest at the bottom iris.
- The higher EP rate on the top iris was due to H_2 bubbles attack and gravity which reduce viscous layer thickness on the top iris.

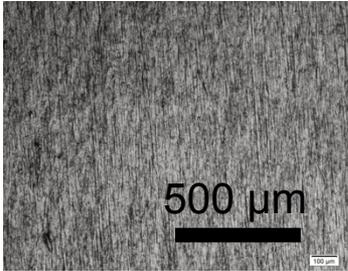
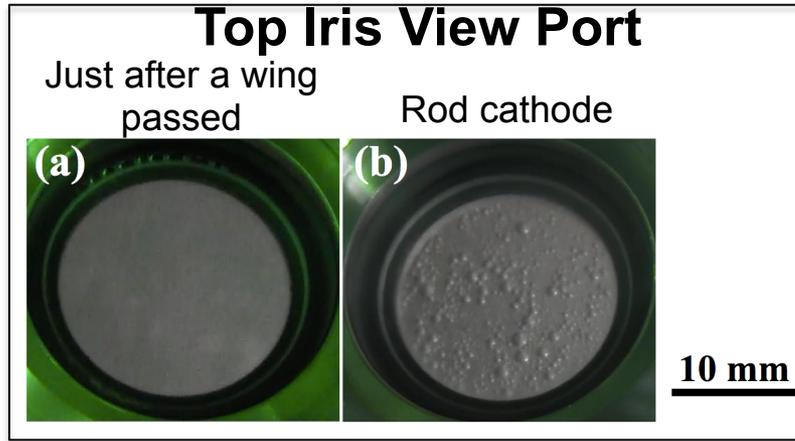
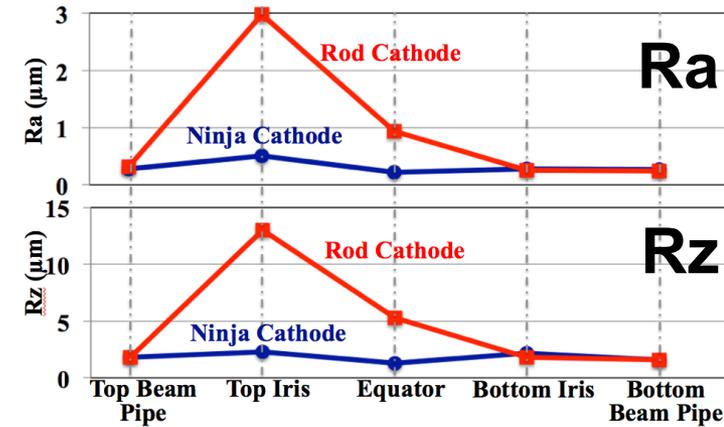
Roughness and Microscope Images of Coupons

Top Beam Pipe	Top Iris	Equator	Bottom Iris	Bottom Beam Pipe
NINJA					
ROD

- The rod cathode enhanced surface roughness at the top iris and equator.
- The bubbles attack on the top iris surface microscopically and make the surface rough.

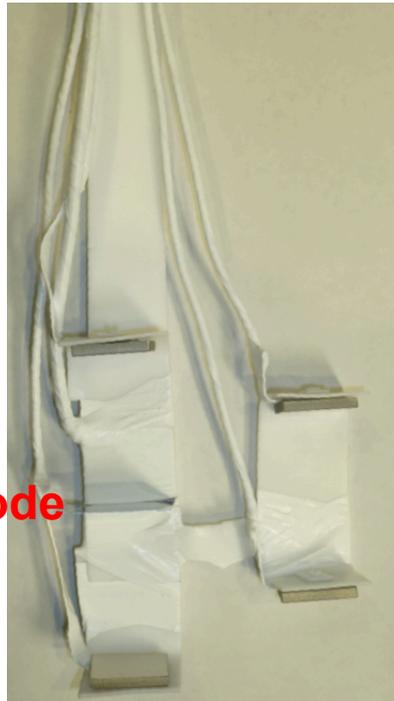
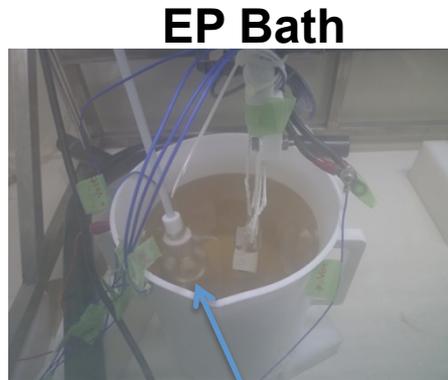
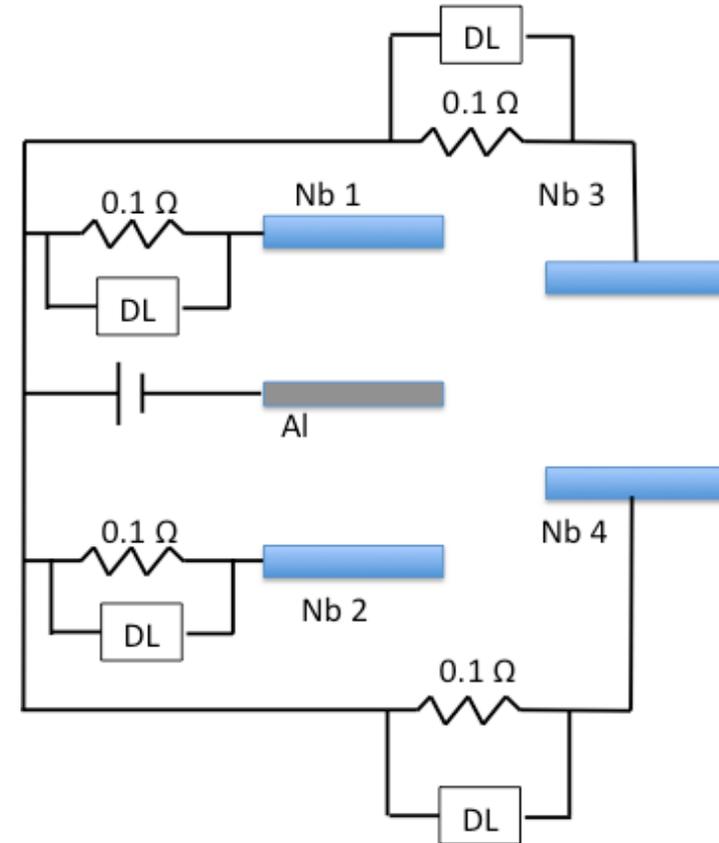
Sample Positions

❖ Lab EP experiments were performed with and without stirrer for comparison.

- EP Solution Temperature <math>< 22\text{ }^\circ\text{C}</math>
- Voltage: 11-14 V
- Average Current Density: 30-35 mA/cm²

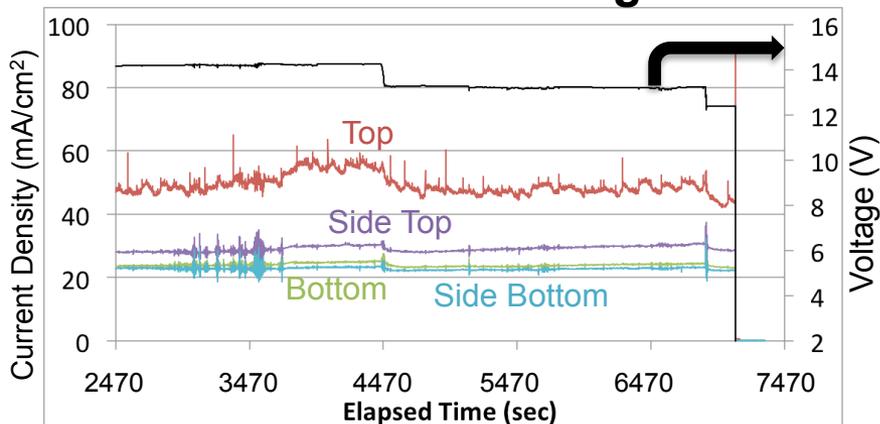
Without Stirring

- EP current for the top sample was the highest because of thin viscous layer occurred by direct hitting of bubbles.
- EP currents for the bottom and the side bottom were almost the same, meaning that gravity effect on viscous layer is not strong.

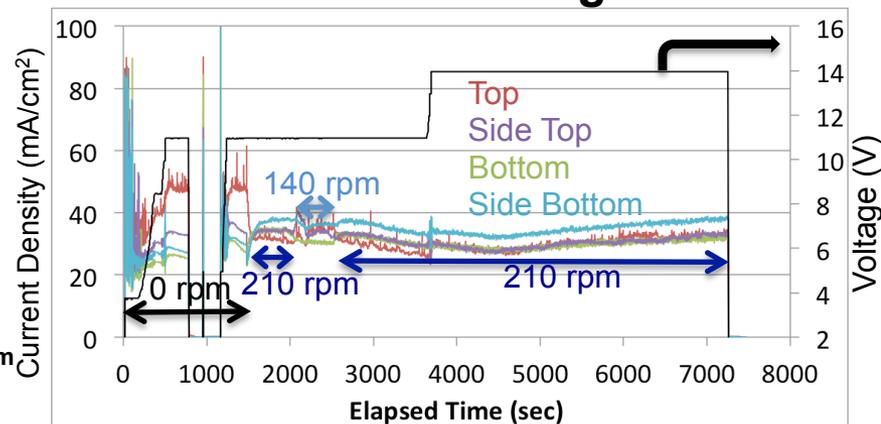
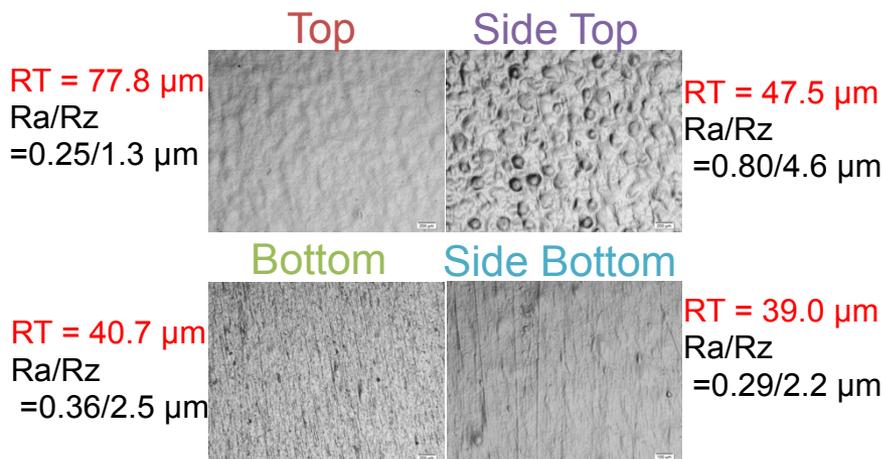
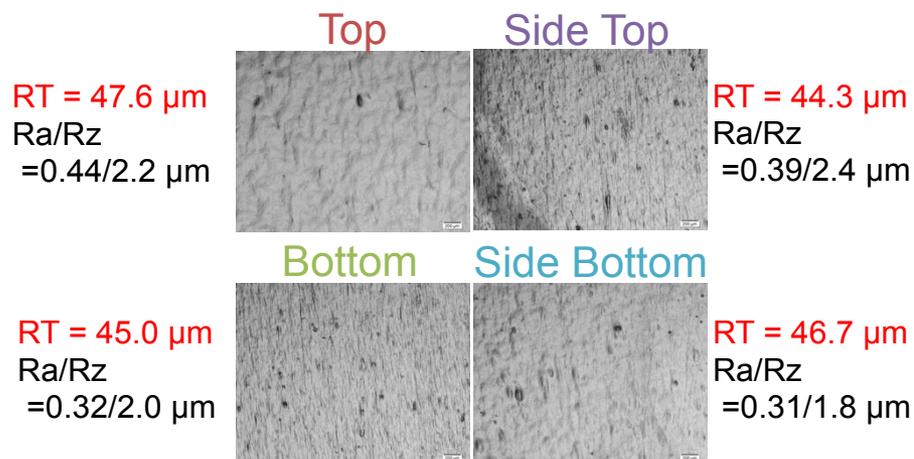
With Stirring

- Sample currents were found similar when the stirrer was used.
- The removal thickness was of course similar for all the 4 samples.
- The viscous thickness and the bubble hitting of each sample should be equivalent.

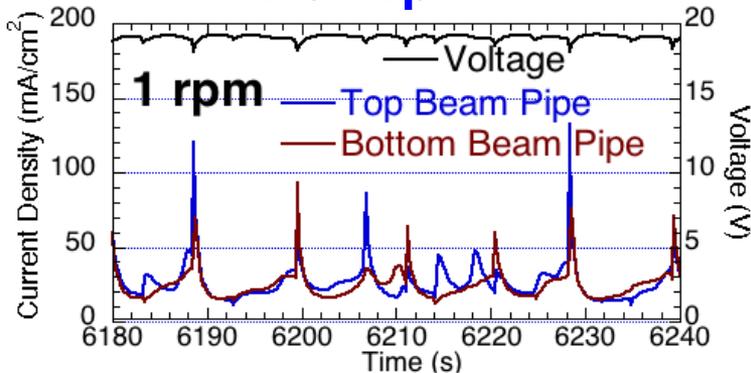
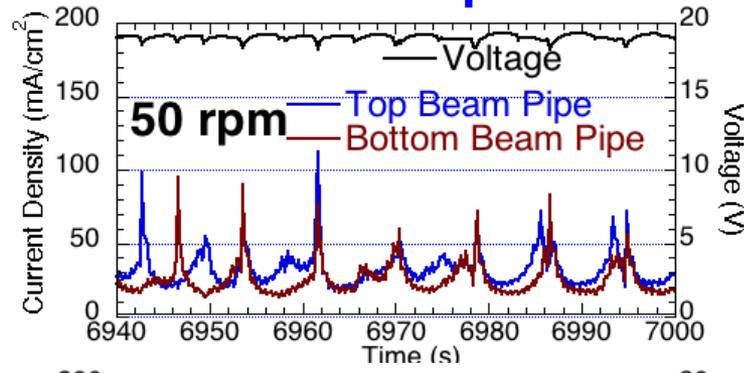
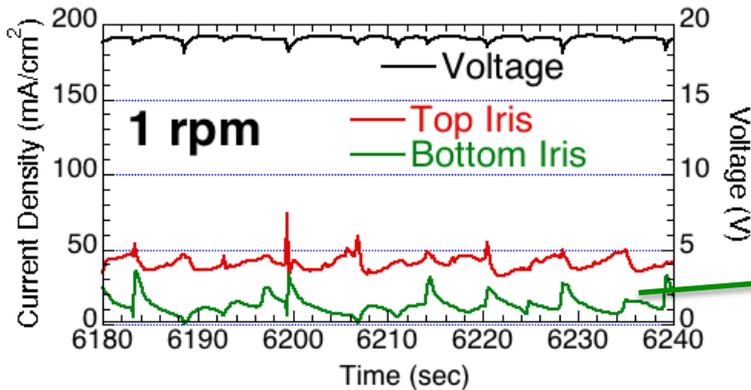
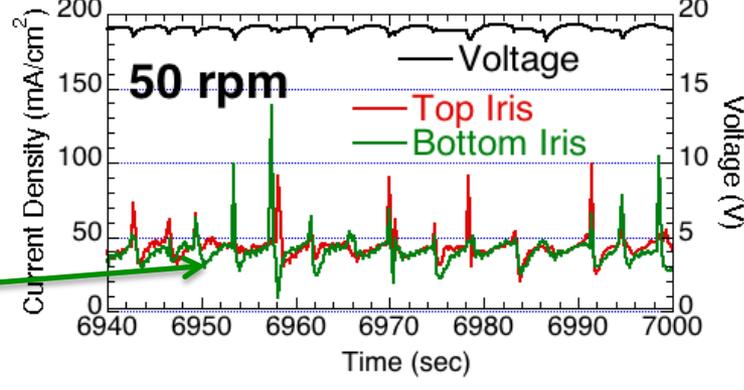
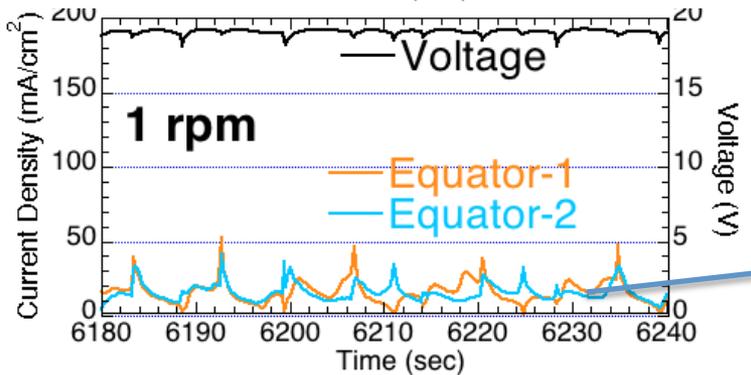
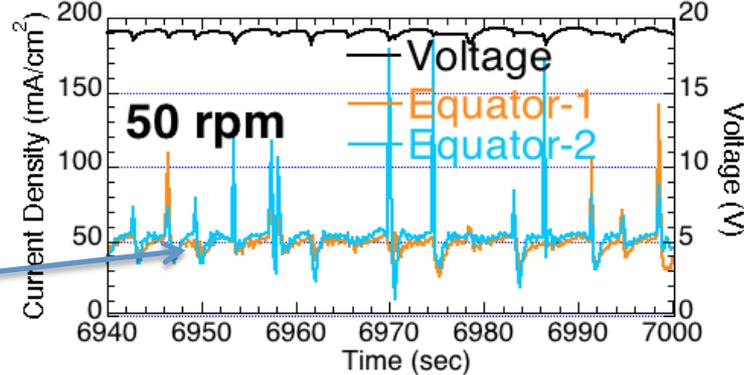
Coupon Current Profiles at 1 and 50 rpm

- The top iris coupon current was the highest at 1 rpm because of thin viscous layer on the top iris.
- The bottom iris current increased with increase in cathode rotational speed and became similar to the top iris current at 50 rpm.

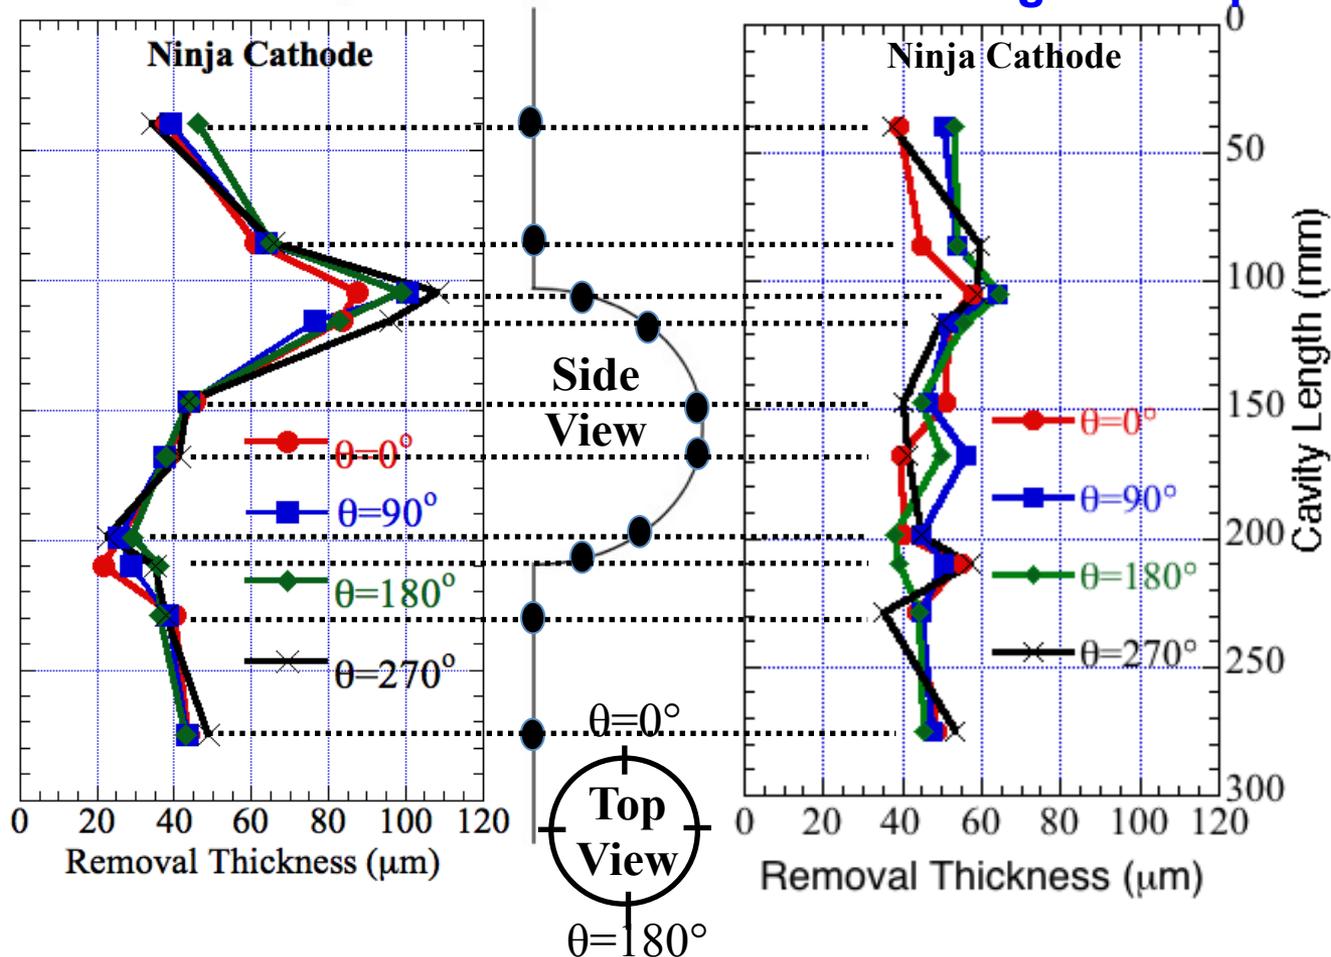
Removal Thickness of the Cavity and Coupons

- Average cavity removal thickness (from cavity weight loss) = 55 μm

- The removal thickness was almost homogeneous on entire cavity including the top and the bottom irises.
- The high rotation speed might generate uniform viscous layer on the surface of cavity cell since the high flow of EP solution remove H_2 bubbles from the top iris.

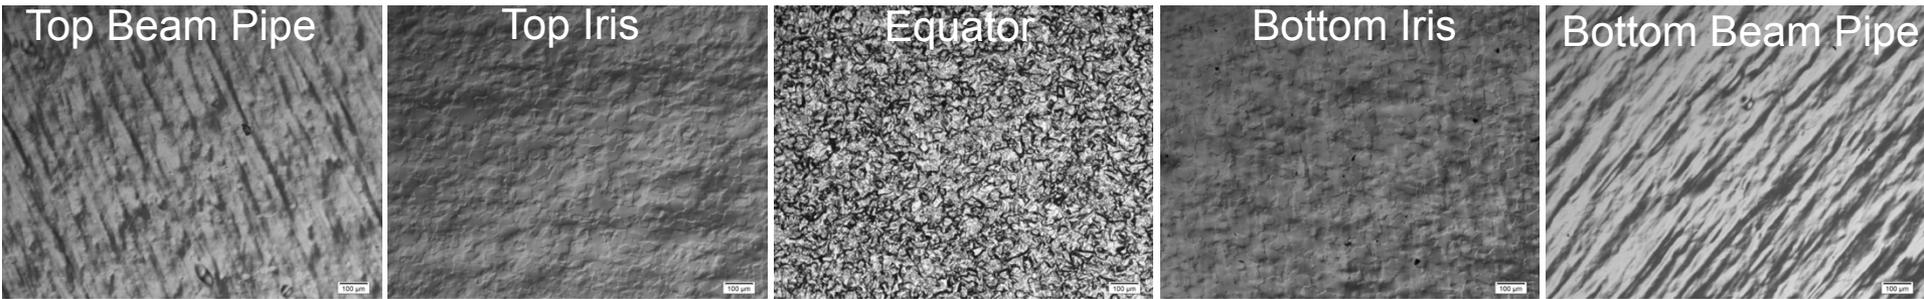
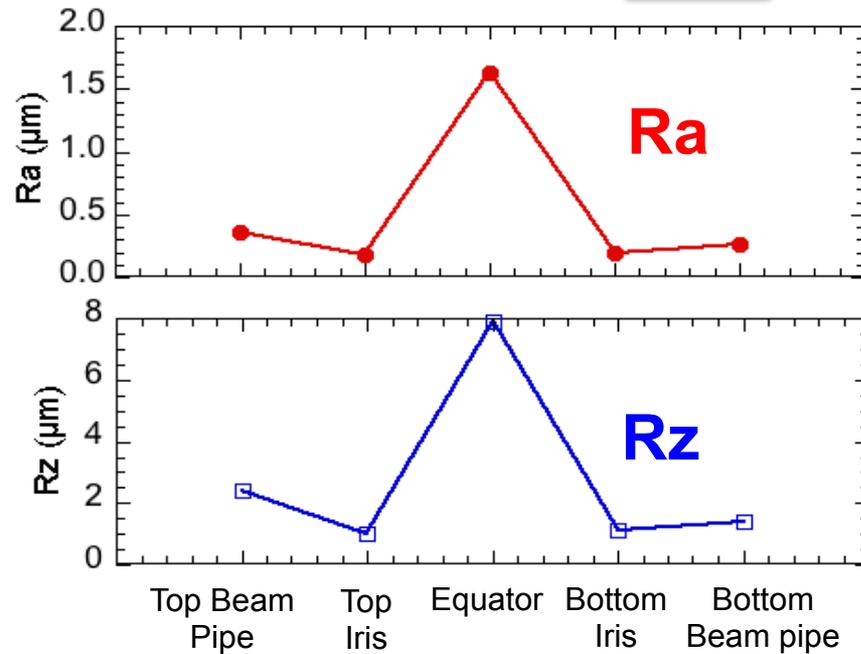
Surface of Coupons (50 rpm)

- All the coupons except equator were found very smooth and shiny after the VEP.
- This rough equator surface might be result of etching instead of polishing.
- Electric field on equator might be lower in absence of Al wings and the lower electric field might be cause of etching.
- High flow of acid on equator surface might disturb passive layer generation and shift polishing region to the higher voltage side.

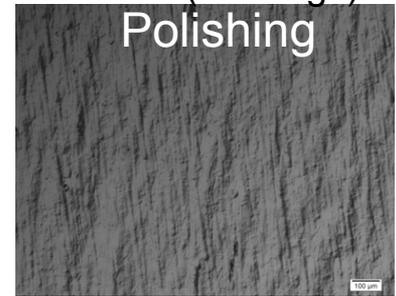
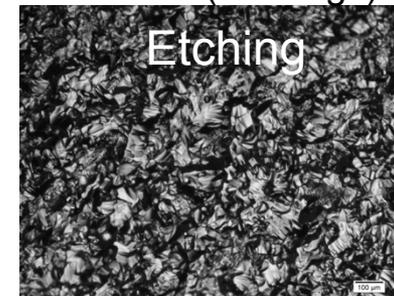
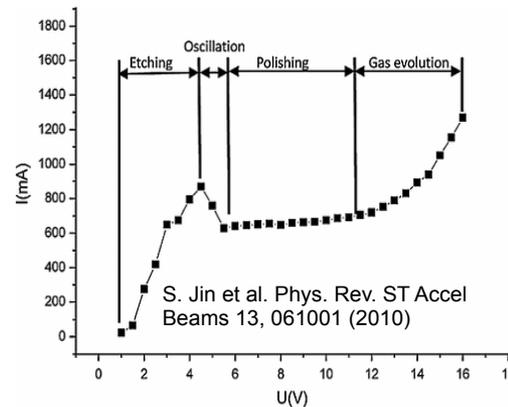
Equator surface with Al wing cathode

At 9 V (Al Wings)

At 3.1 V (Al Wings)

Etching of Nb gives rough surface.
