ILC E-driven e⁺ source

Rotation Target design and R&D

T. Omori, 28-May-2018

**Asian Linear Collider Workshop, ALCW2018, May 28th - June 1st,
Fukuoka International Congress Center, Fukuoka, Japan**

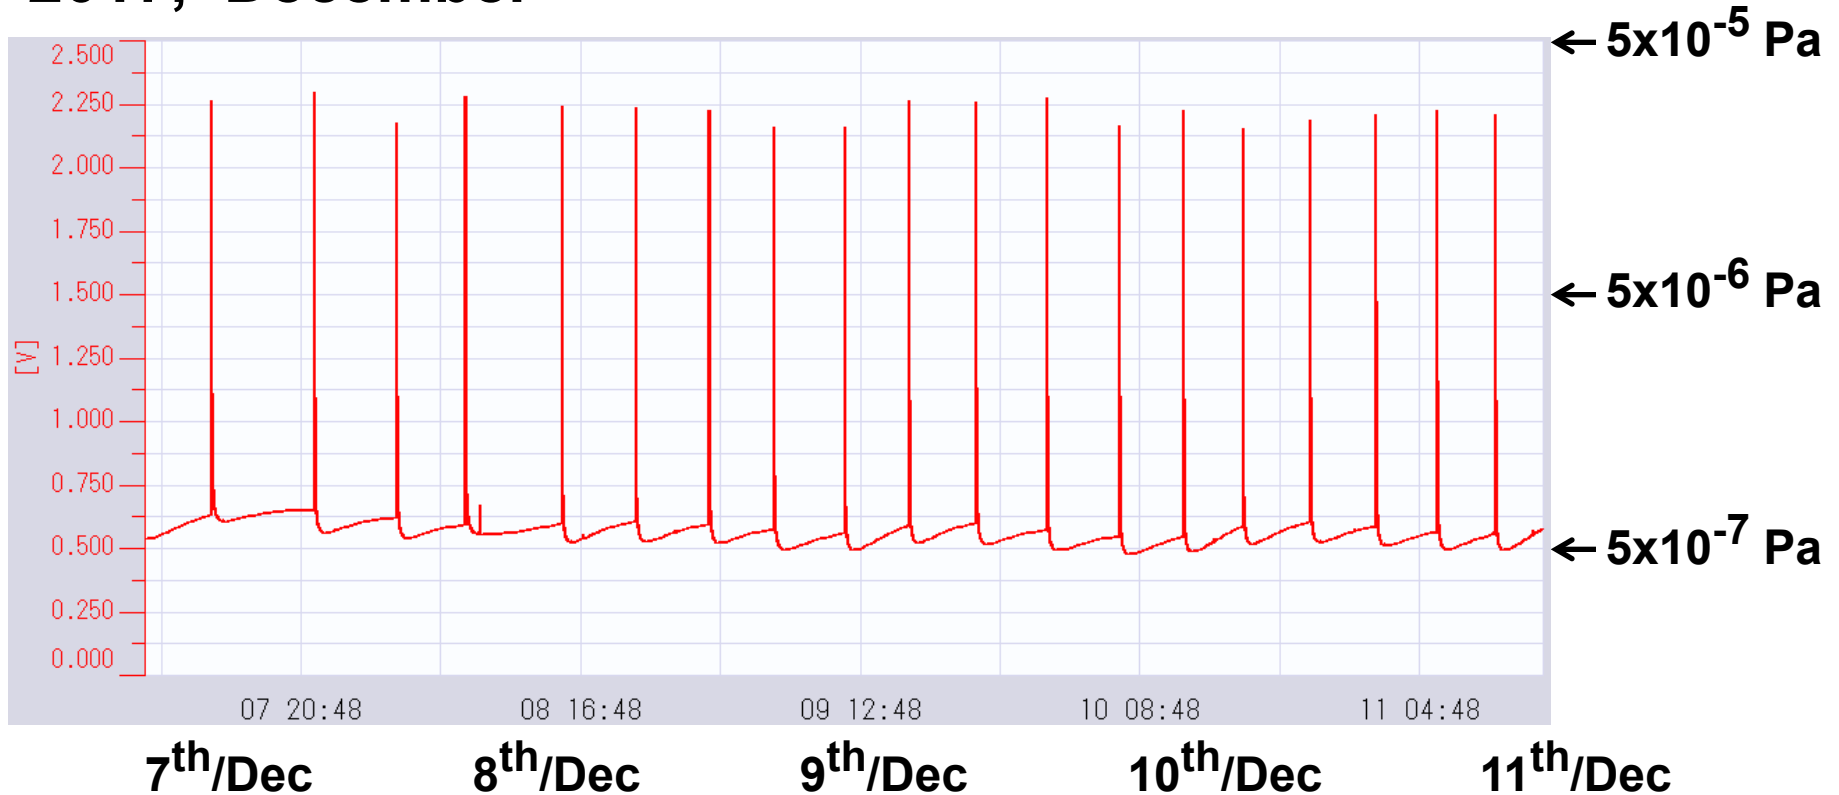
Vacuum at 225 rpm

base
peak of spikes

$\sim 5 \times 10^{-7}$ Pa
 $\sim 2 \times 10^{-5}$ Pa

Vacuum
TDR Requirement
 10^{-6} Pa

We got better results

$$3 \times 10^{-6} \text{ Pa} \rightarrow 5 \times 10^{-7} \text{ Pa}$$

But we still have spikes

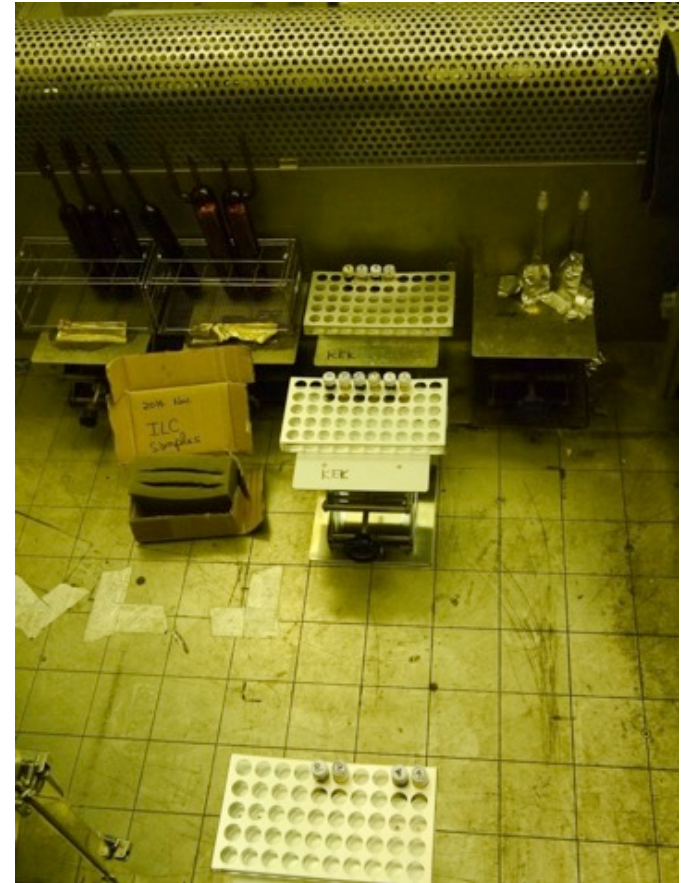
Takasaki Advanced Radiation Research Institute, JAEA

- The seal dosed up to 4.7 MGy
(3 ILC year , 2600 bunch) is examined.
- Rotation : 0-600 rpm.
- No leak was found. GOOD!
- But, viscosity increased.

(1) The ferrofluid dosed 4.7 MGy (3 ILC year, 2600b)

We used the ferrofluid in a small target. Rotation : 0-600rpm.

No leak was found. GOOD!

But, viscosity increased, and we need to know the cause.

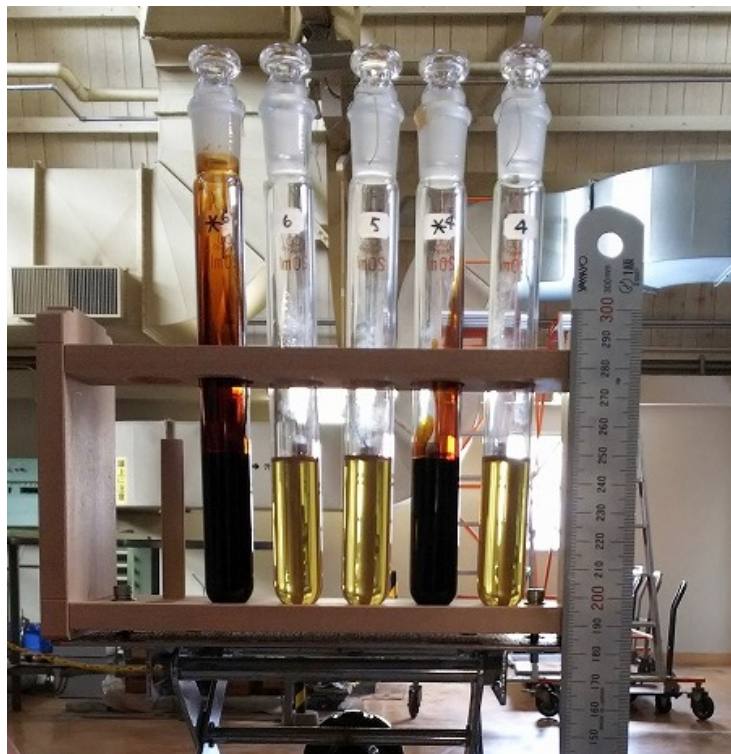
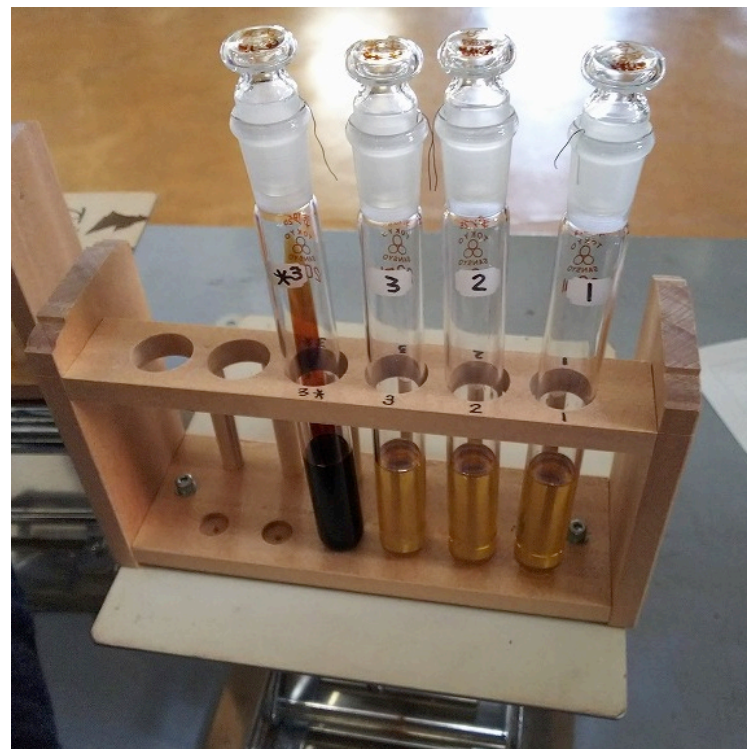
New Radiation Test: Feb 2018 and Summer 2018

**Radiation tests with monocular structure analysis
by GPC and UV-Vis methods are on going.**

GPC: Gel Permeation Chromatography

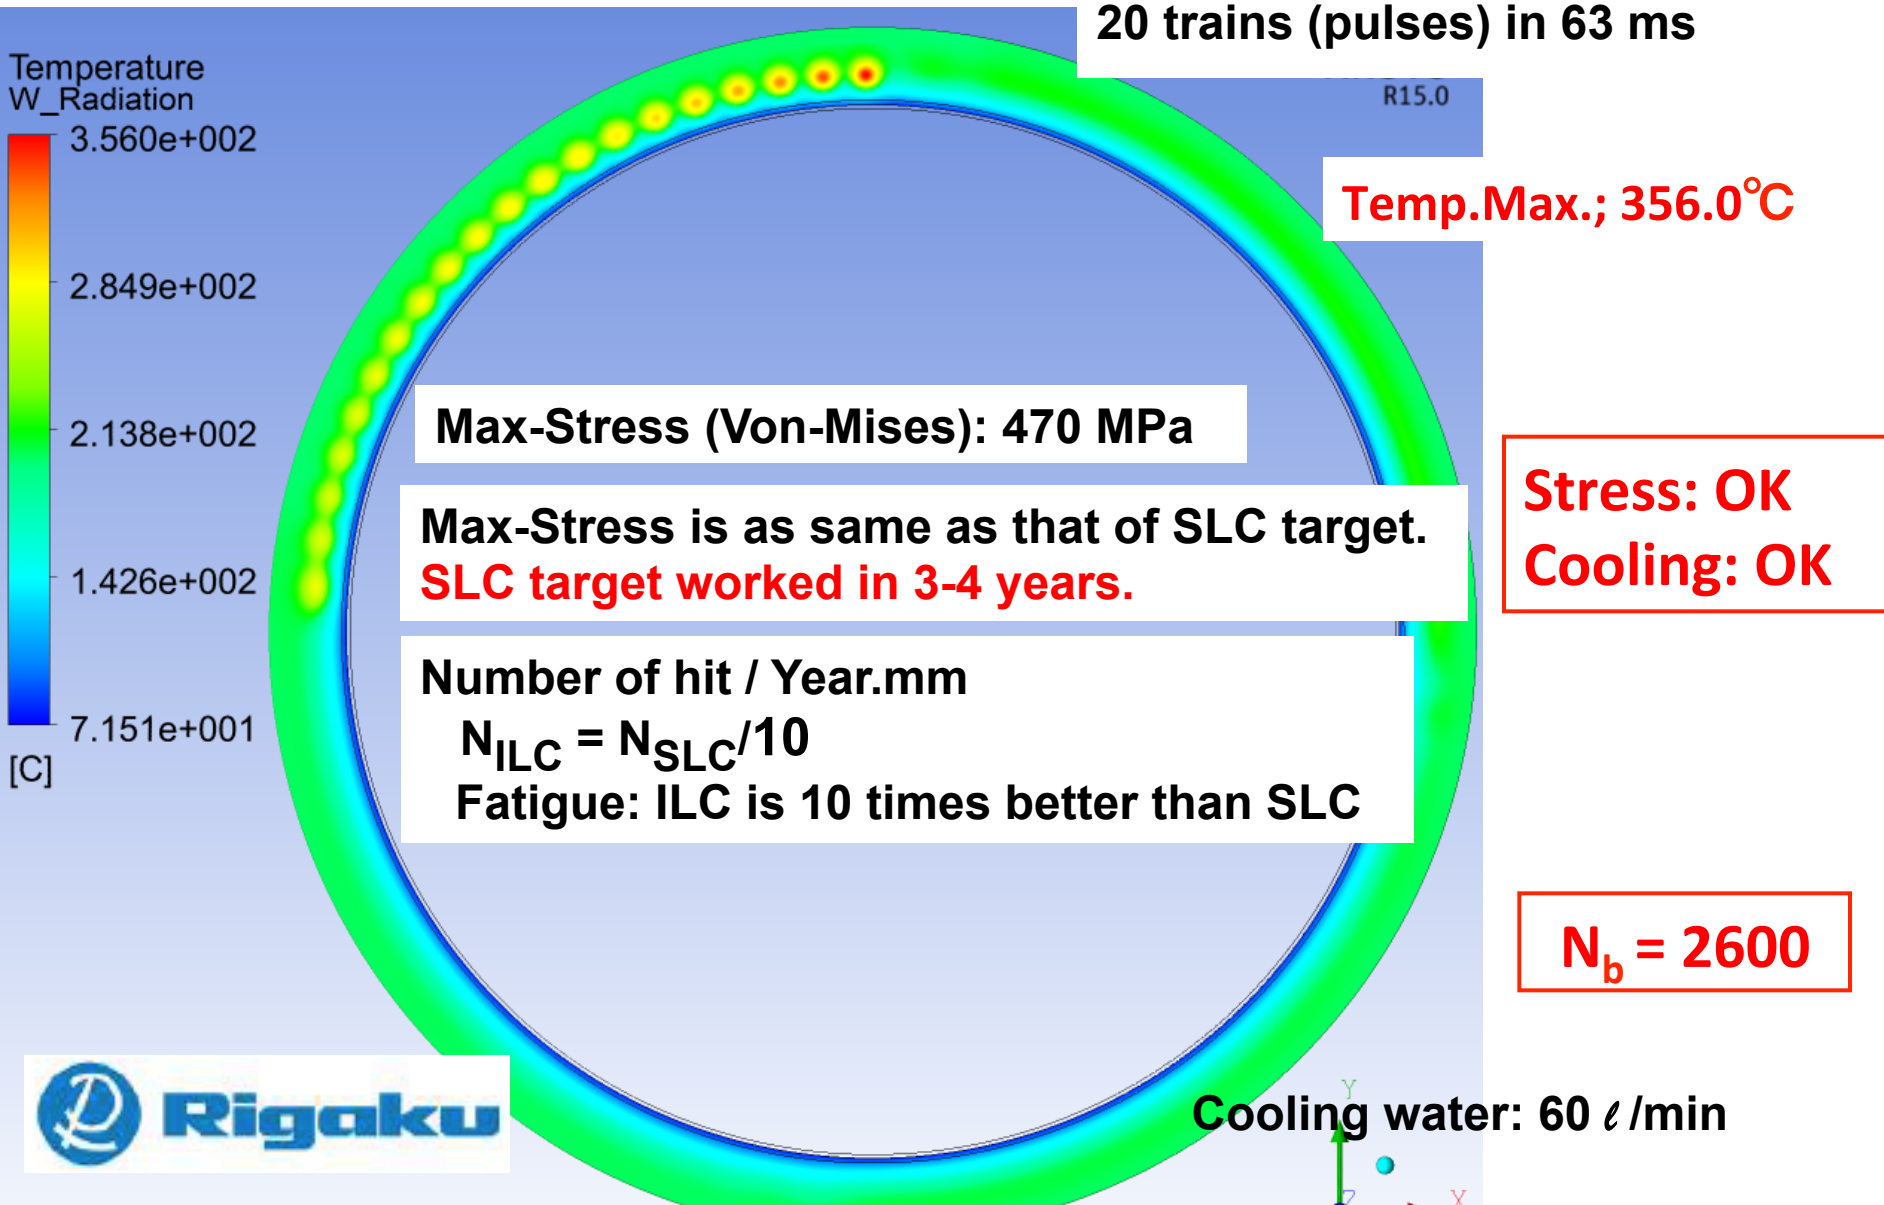
Pulse#02 225rpm

Simulation : target stress and cooling

Pulse beam analysis: step 2

20 trains (pulses) in 63 ms

- Stress of the ILC target is as same as that of the SLC target.
- Compare Number of hit / Year.mm
