ILC E-driven e⁺ source Rotation Target design and R&D

T. Omori, 23-Oct-2018

**LCWS 2018, Oct 22nd - 26th, 2018
University of Texas at Arlington, USA**

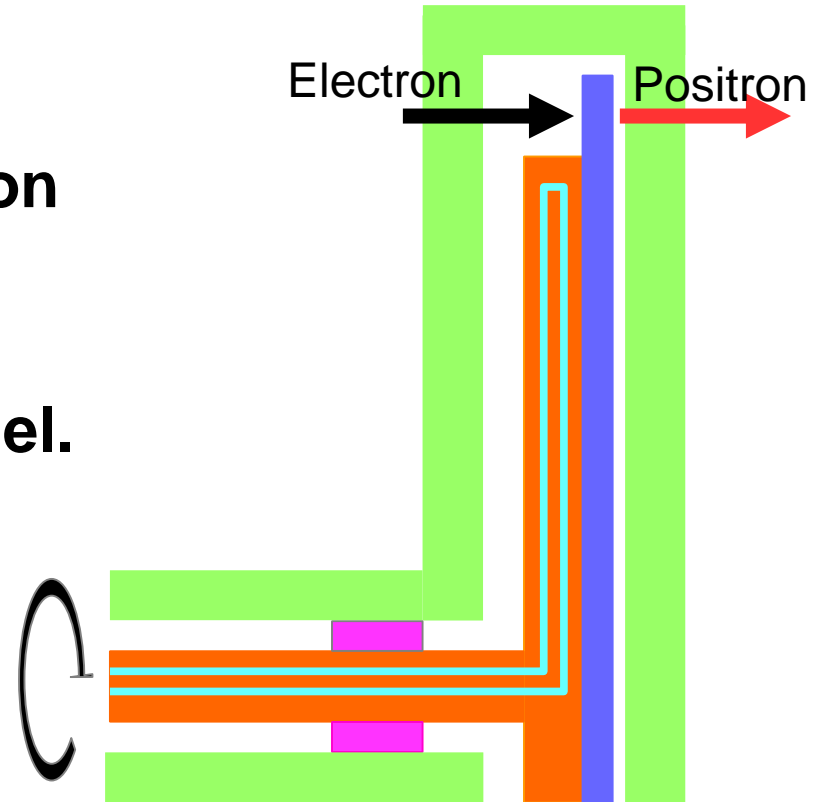
Target

- W-Re 16mm thick.
- 5 m/s tangential speed rotation (225 rpm, 0.5m diameter) in vacuum.
- Water cooling through channel.
- Vacuum seal with ferro-fluid.

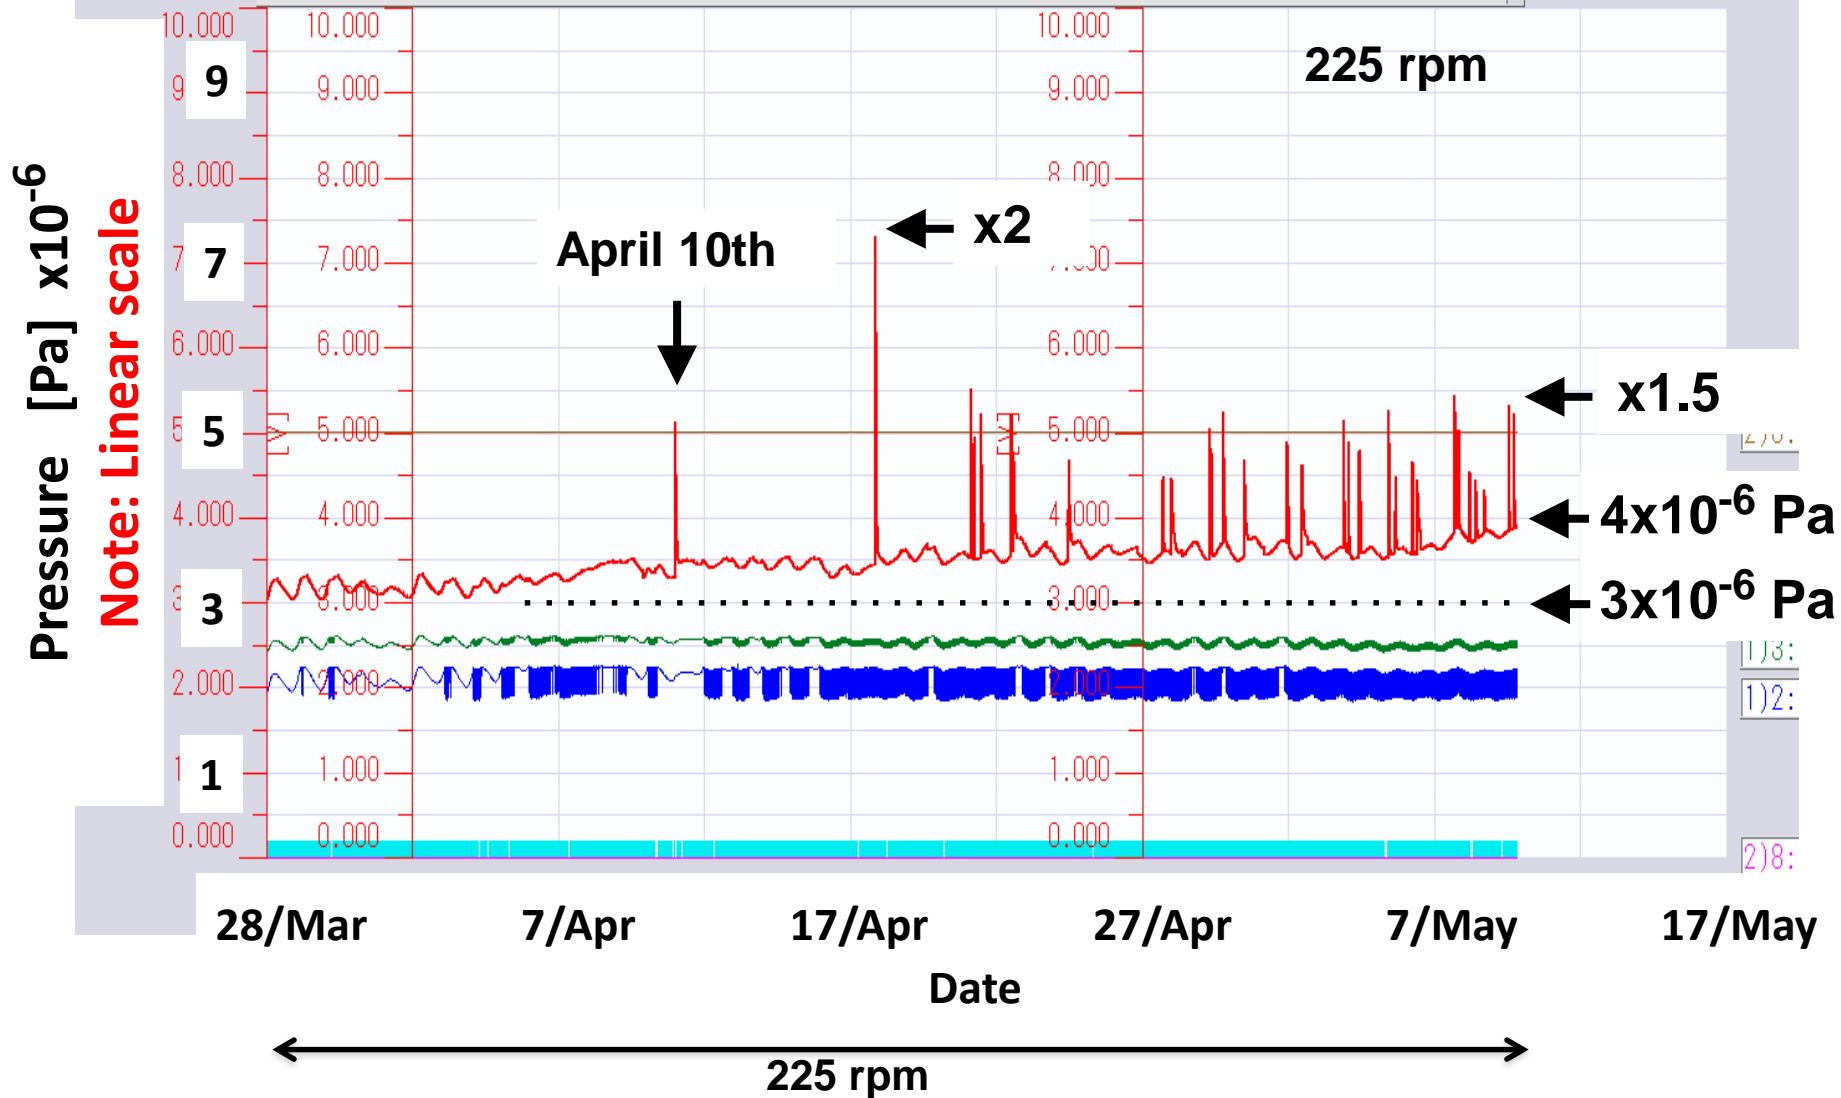
Central Part Prototype Vacuum Test

Small spikes (x1.5 – x 2) were observed

March/28 – May/09, 2017

- Ion pump 100 liter/sec.
- Rotation at 225 rpm (value).
- We started the experiment on February 9th, 2017.
- Vacuum level went good monotonically.
- And reached $\sim 3 \times 10^{-6}$ Pa at the end of March.
- Vacuum level was stable at $\sim 3 \times 10^{-6}$ until April 10th.
- Then, we observed small spikes.
 - Height of a spike $\sim x1.5$.

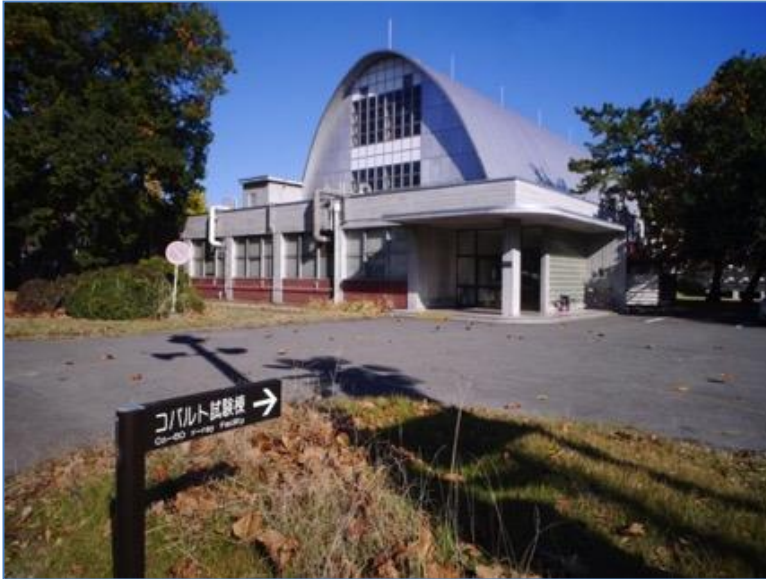
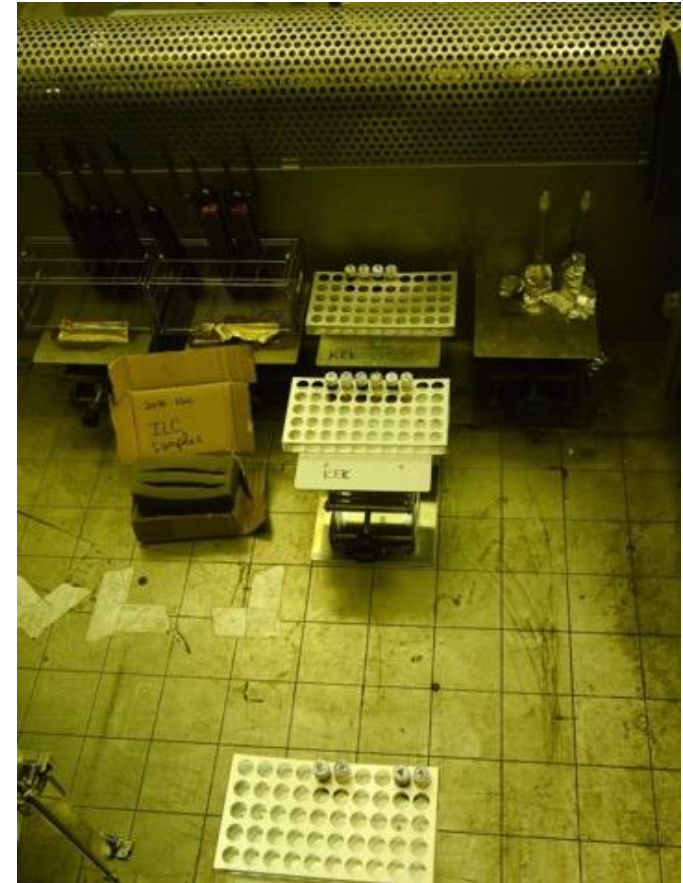
TEST was done: Radiation Tolerance

Takasaki Advanced Radiation Research Institute, JAEA

- The seal dosed up to 4.7 MGy (3 ILC year , 2600 bunch) is examined.
- Rotation : 0-600 rpm.
- **No leak was found. GOOD!**
- **But, viscosity increased.**

No leak was found. GOOD!

But, viscosity increased, and we need to know the cause.

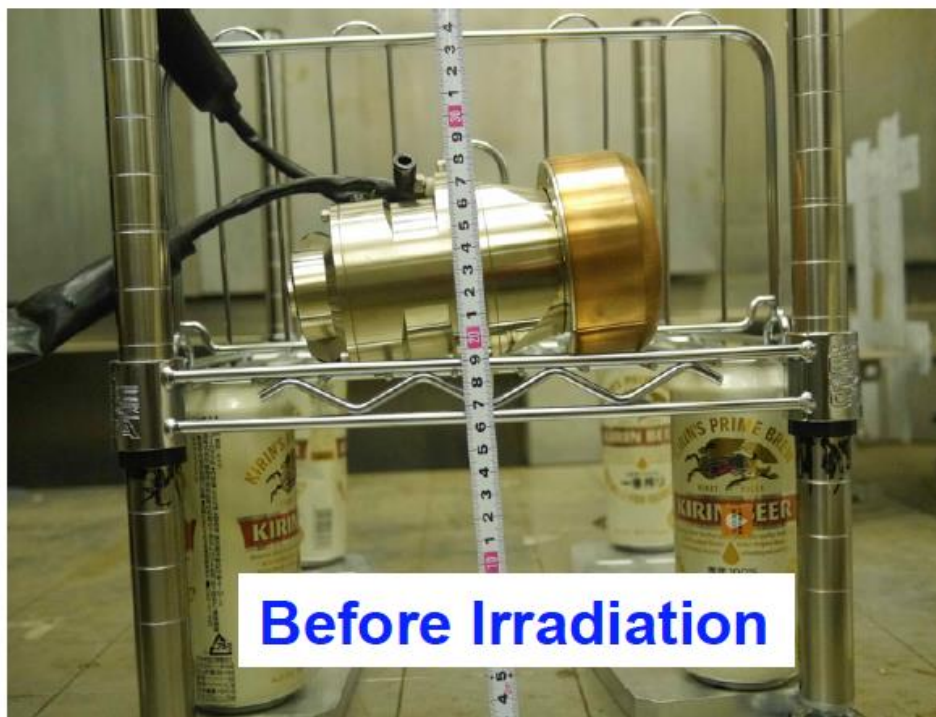
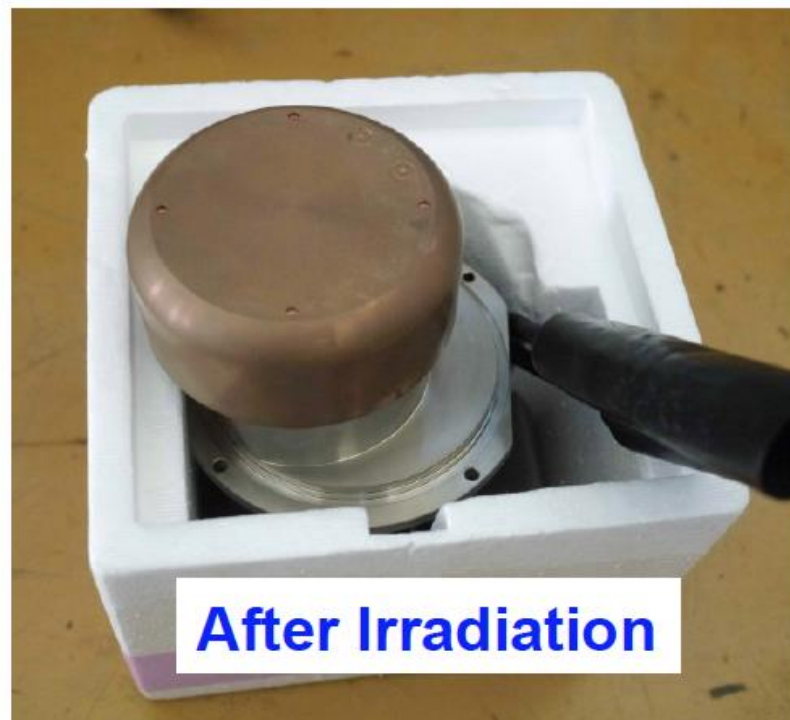
Irradiation to the small (d=10 cm) off-the-shelf rotation target

Radiation test of the **whole system**: motor, bearing, ferrofluid,,,

0.6 M Gy irradiation on the motor.
corresponds 1 ILC year

After irradiation, we made **rotation and vacuum test**.

We found NO problem

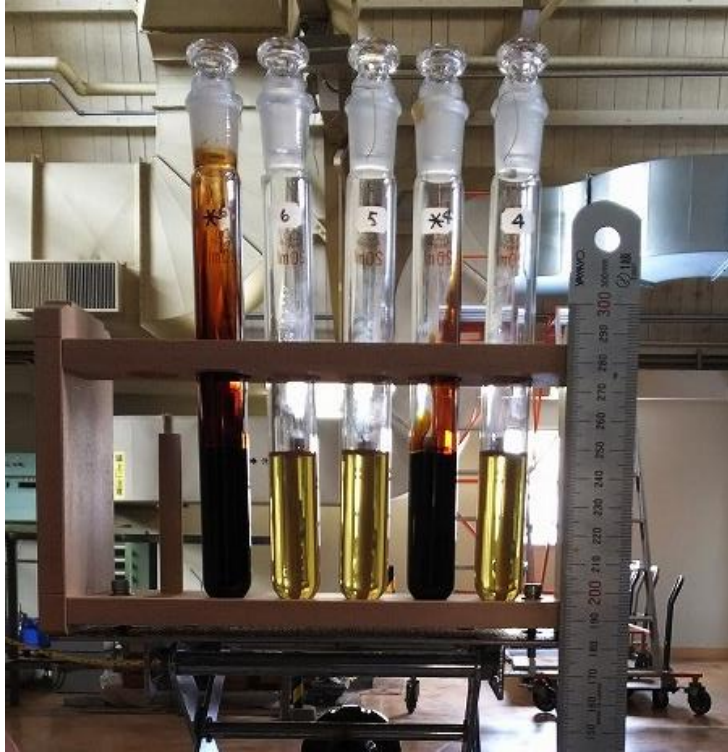
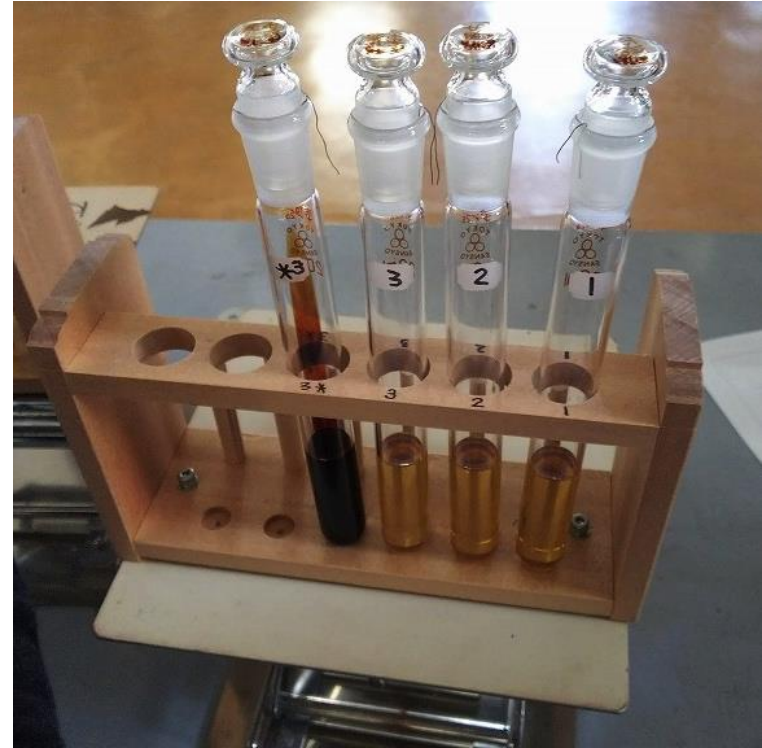
New Radiation Test: Feb 2018 and Summer 2018

**Radiation tests with monocular structure analysis
by GPC and UV-Vis methods are on going.**

GPC: Gel Permeation Chromatography

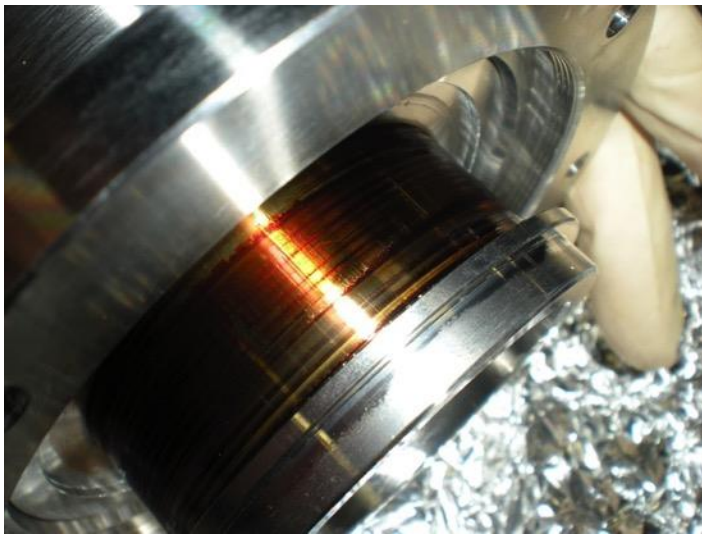
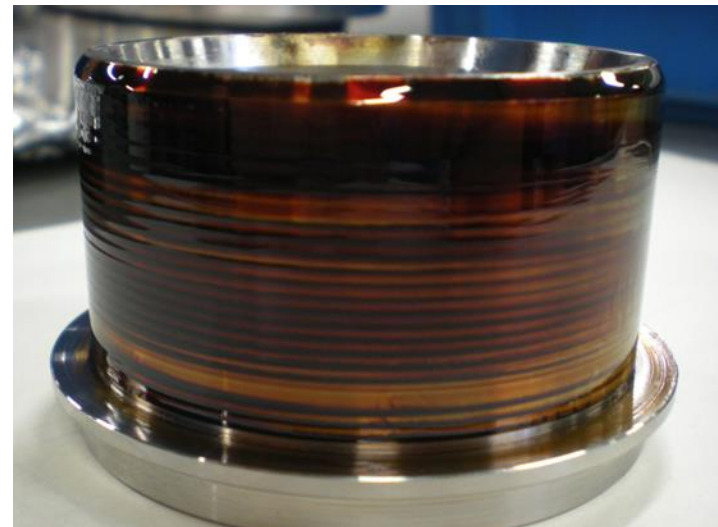
- We opened the chamber of the prototype on 19th July.
And observed inside by eyes.
- No damage of the fluid was observed by eyes.
Even small amount of disappearance of the fluid was observed.

If there is evaporation, we will see powders of dried fluid.

- Before the opening, we expected to see the powders at some stages of the seal (seal has 20 stages in total) near the vacuum.
But we observed healthy fluid even at the inner most stage.

- We opened the chamber on 19th July. No abnormal trace was observed.
- No decrease of the fluid was observed. No black powder (leftover of evaporated solvent) was found.
