Cleanroom Assembly of the IFMIF SRF LINAc

Linear Collider Workshop 2024

IFMIF/EVEDA Project

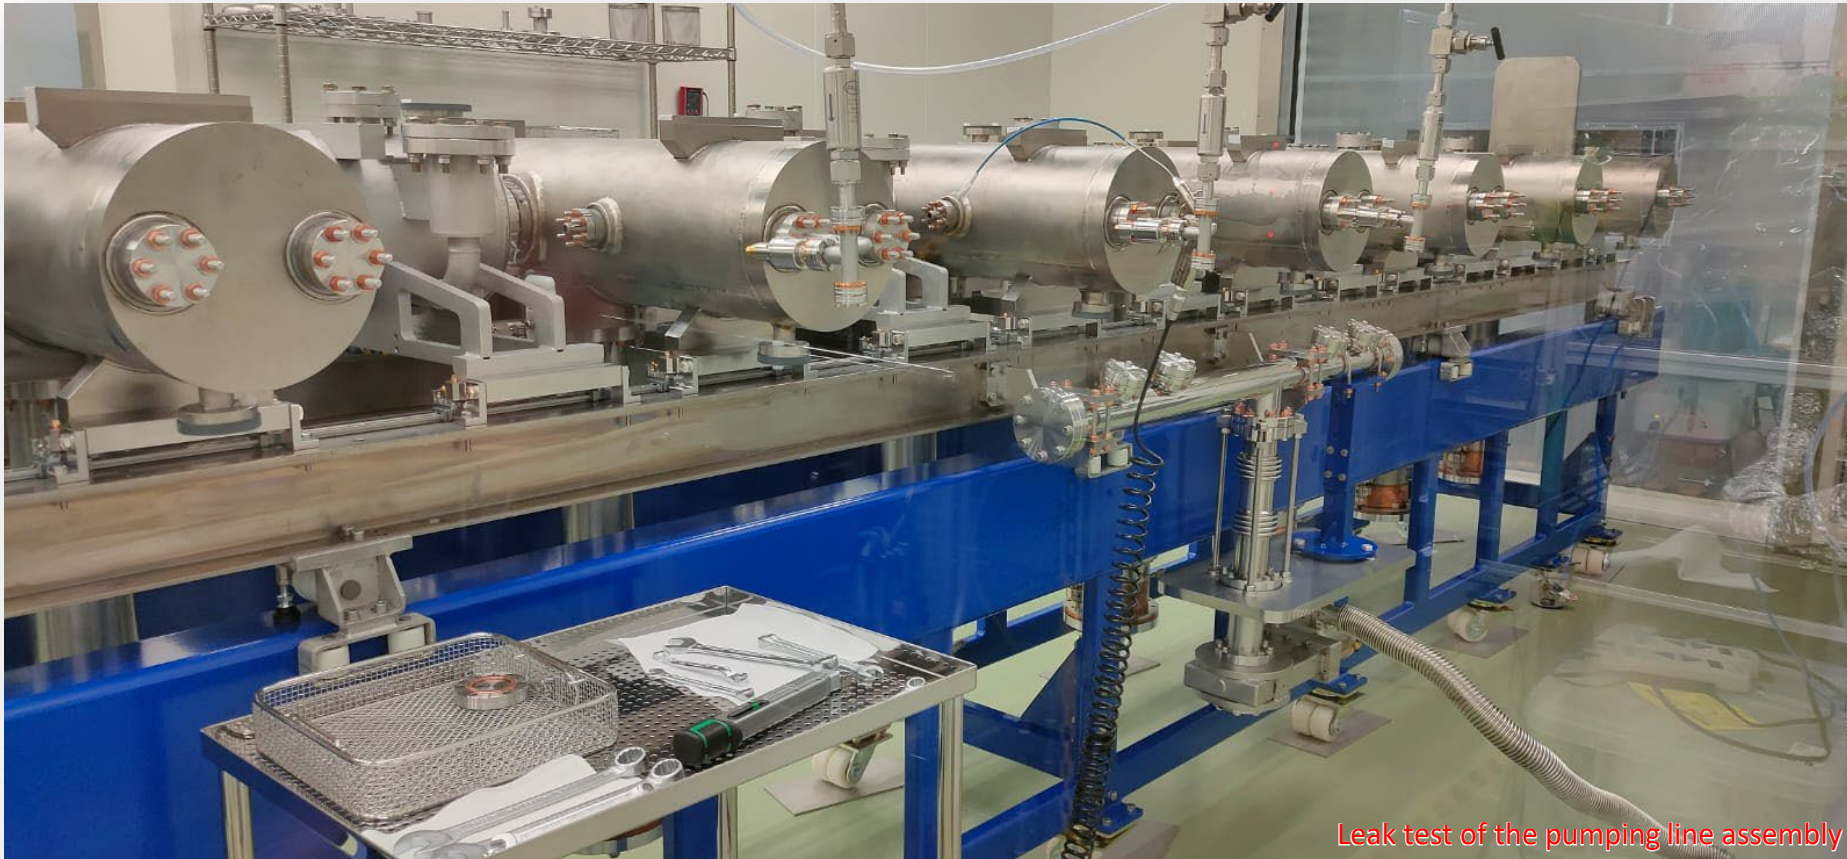
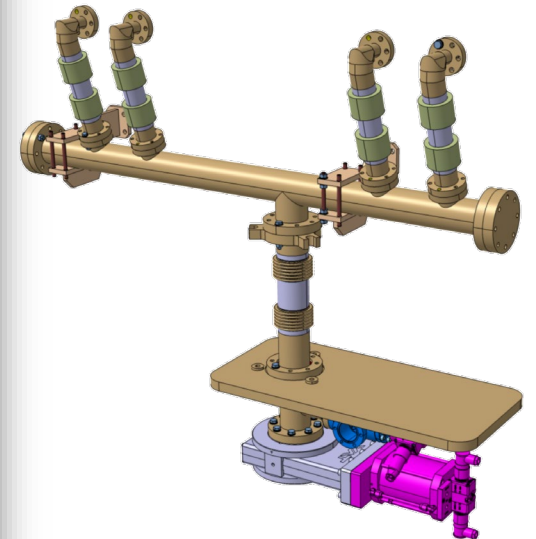
- 3rd Step: pumping line assembly
 - Pre-assembly and leak test of the pumping line prior to the connection to the beam line.
 - Leak test 5 **leaking** – cleanroom assembly paused.

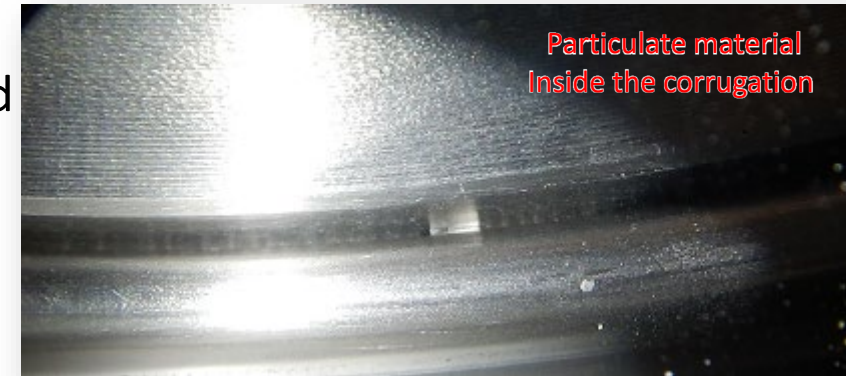
- **2019, March** : quality issue on the solenoid discovered during their HPR preparation in cleanroom at CEA.
 - Rust spots, weld quality issues inside the beam tube, particulate material trapped in the bellows, external surface finished.
 - Remedial actions: light grinding/polishing of the welds, pickling and passivation.
 - Black spots appeared on the newly passivated welds.
 - The process was repeated locally on the weld before a final passivation.

- **2019 September: completion of the remedial action.**

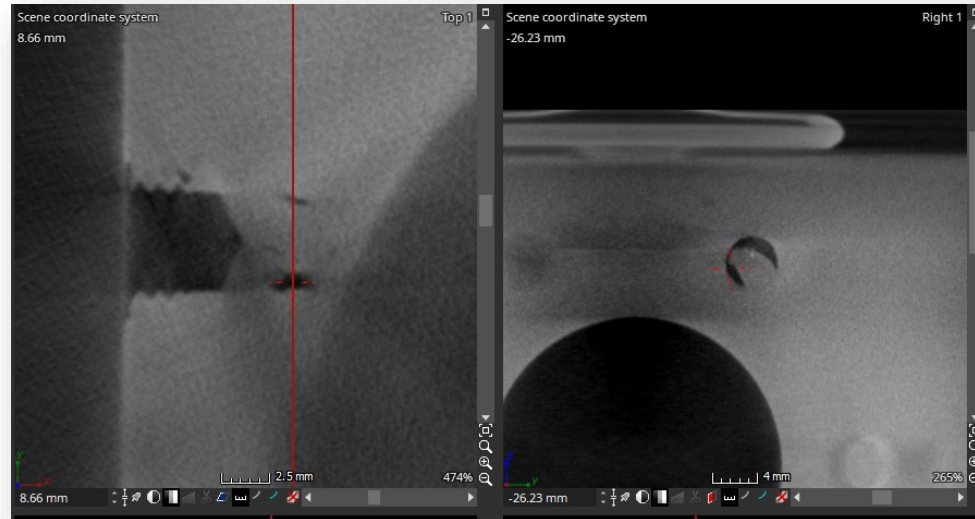
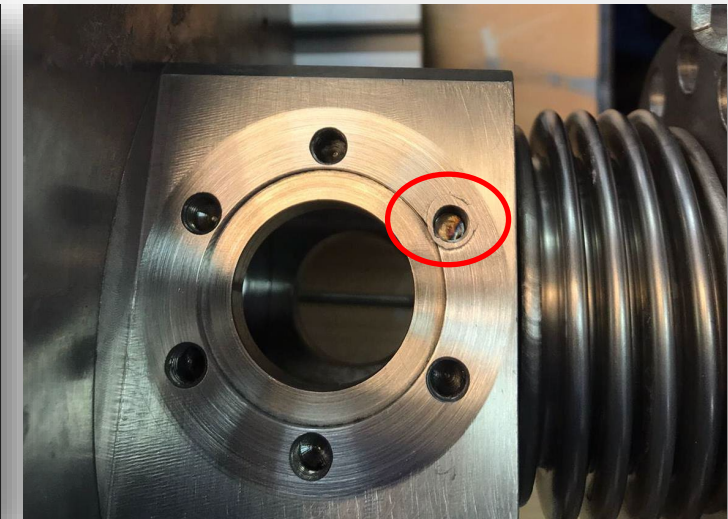
- **2019, March:** strong helium background during the 3 first cavity/coupler assemblies.
 - Suspected:
 - 1- permeation in the O-ring gaskets of the slow pumping system (SPS next to the cleanroom exhaust).
 - 2- issue with the Helicoflex gasket sealing surface.
 - Solution 1: A new slow pumping system with all metal gaskets.
 - Solution 2: mock-up of the C/C interface and test with Helicoflex gasket.
 - Aluminium Hexagonal gasket were used during the vertical test -> possible damage of the sealing surface?
 - All the assembly tests done were perfectly leak tight with thermal shock in liquid nitrogen.
- **Assembly resumed in August 2022:**
 - Still strong helium background $\sim 1\text{E-}9$ mbar.l/s.
 - The valve isolating the calibrated leak was leaking.
 - Calibrated leak was removed.
 - All remaining assembling went smooth, 2 gaskets needed a second try.

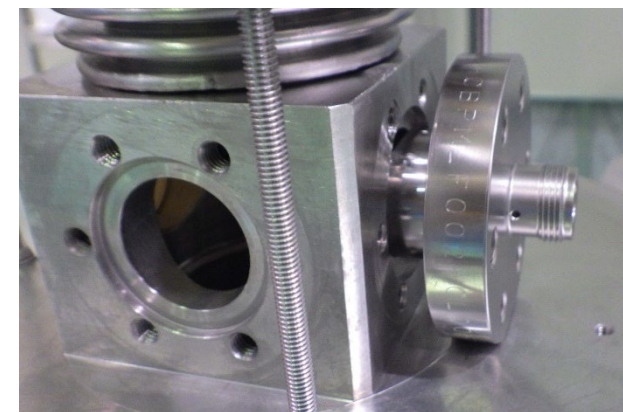
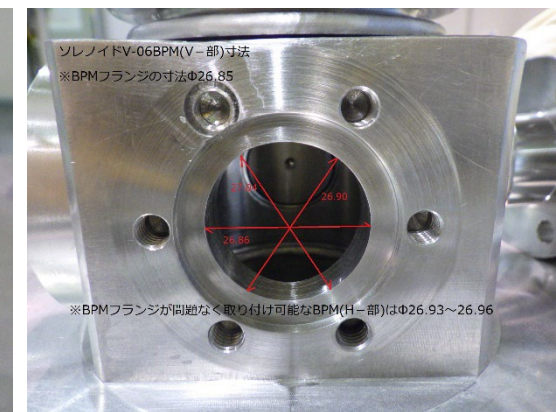
- The screw found in V06 is used to keep the coil in place during the assembly and can be removed.
- A CT scan of all the solenoids was decided.
- The BPM port on V06 was deformed. Same face that had one of its thread repaired. To be solved at QST during the cleanroom assembly.

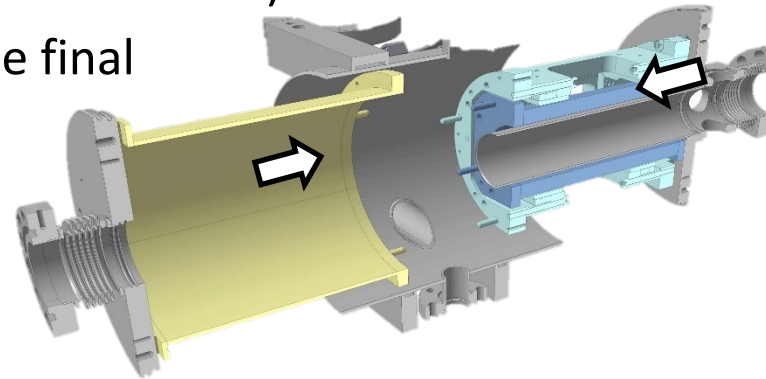
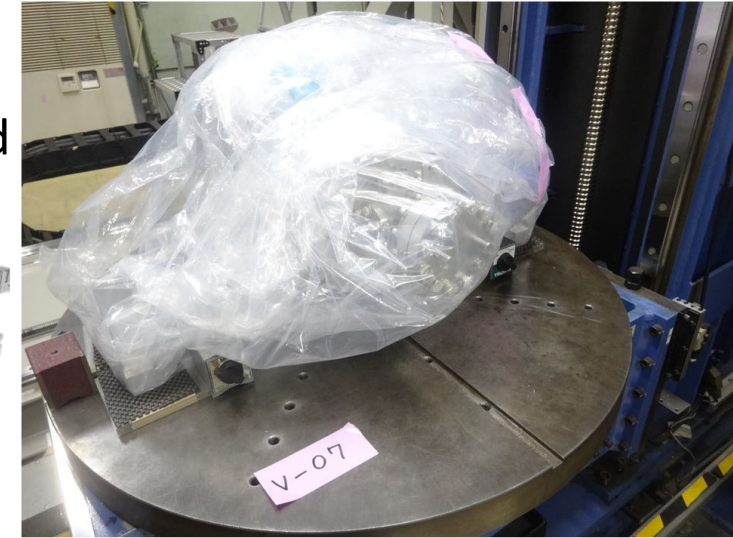
- **2022, July: CT scan of the solenoid at Hitachi**

- New issues were detected by analysing the centring pins and screws used for the assembly of the coils (solenoids & steerers).
- Some pins were pushed out during the final assembly.

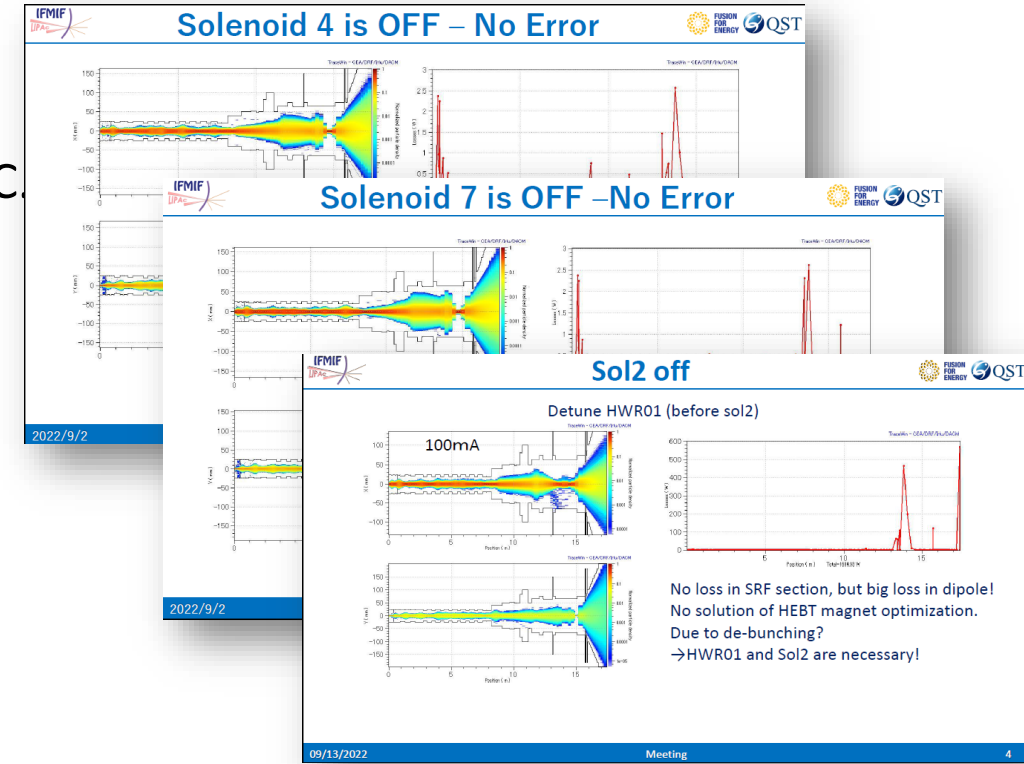
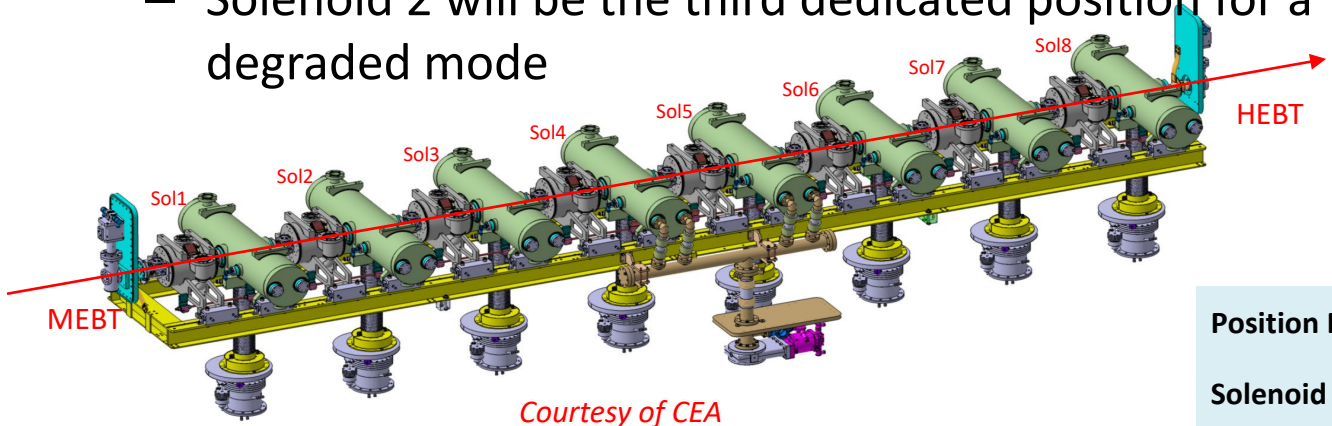
Positioning with respect to the beam

- The solenoids were sorted by degree of severity.
- Beam simulations were done to determine the best arrangement on the beam line in case of a failure of one or more solenoid.
- Solenoids 1 and 8 are critical for the operation of the LINAC.
- Solenoids 4 and 7 can be turn off (Sol4 for a better beam physics)
- Solenoid 2 will be the third dedicated position for a degraded mode

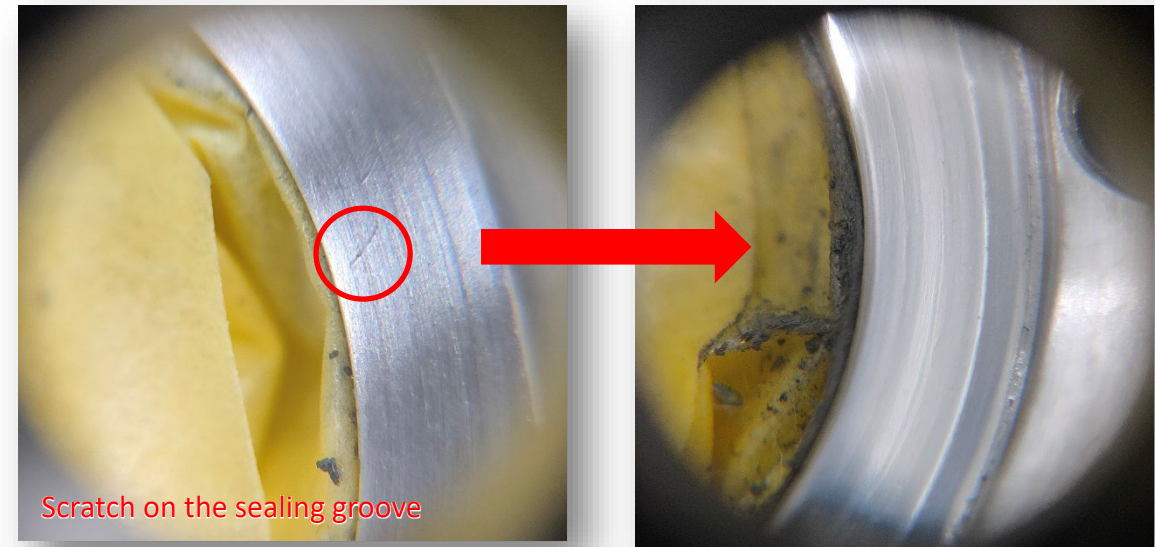
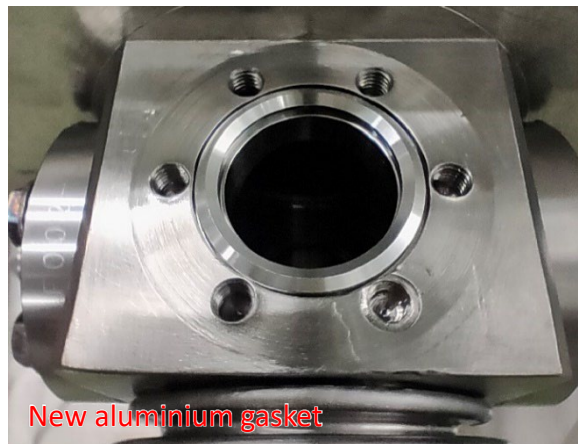
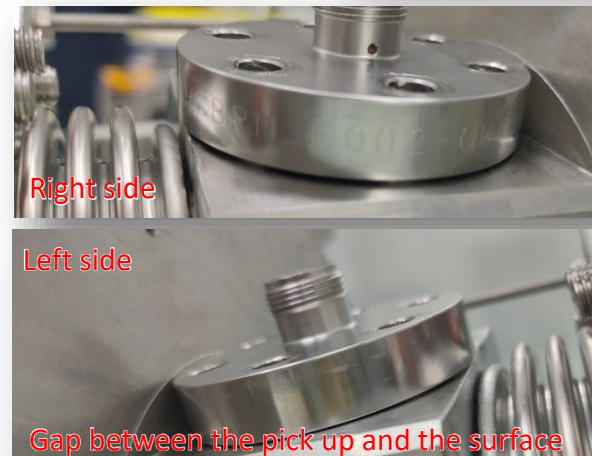
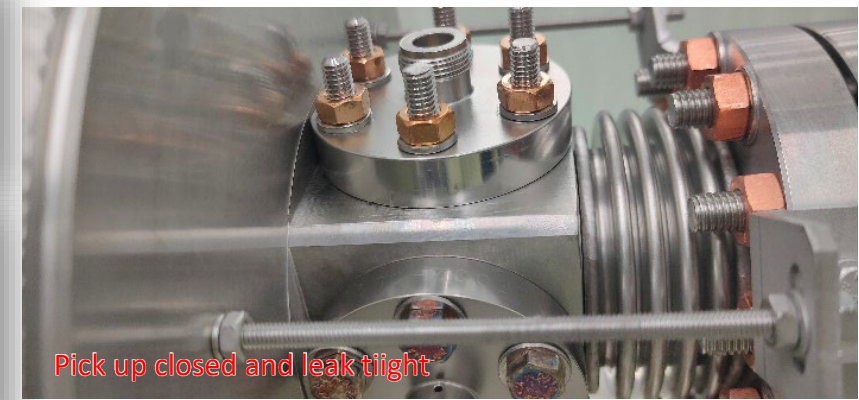
- **October 2022:** BPM pick-up issue on V06
 - The pick-up head was machined to removed $0.2\ \mu\text{m}$ on the diameter.
 - The pick-up finally fitted but was tilted and leaking.
 - The face of the BPM was deformed probably as a consequence of the repair.
 - The sealing groove was still within tolerance, but a scratch was found.

- After different attempts of preserving the HPR, a more invasive rework of the sealing surface was done. An aluminium gasket was also chosen in place of the Helicoflex to preserve the flatness of the pick-up.
- A new HPR was needed at MHI.
- During the incoming inspection at MHI, a new leak appeared on the bellows on the non-BPM side

- **September 2023:** V06 was shipped to MIRAPRO (bellows manufacturer) for a tentative of repair.
 - It was not possible to fix the leak after 6 attempts.
 - Decision was taken to change the bellows.
- **Early December 2023:** bellows was replaced and V06 was sent back to MHI for the HPR.
- **Late March 2024:** V06 was HPR and ready to come back to Rokkasho.

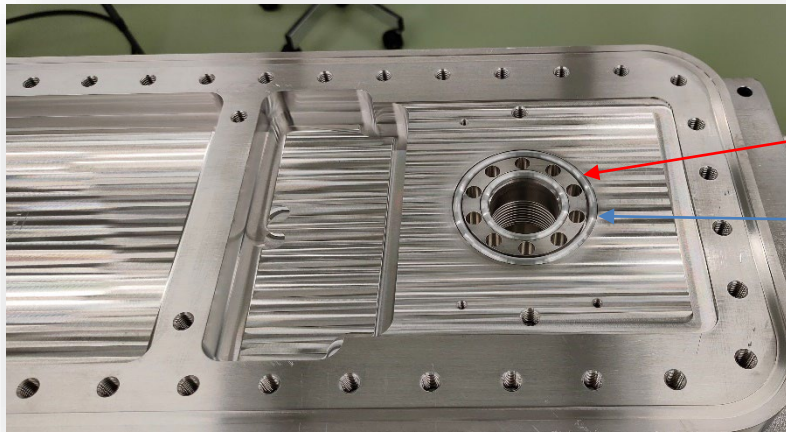
Isolation Vac. Gasket
Beam Vac. Gasket

- **October 2022:** the 2 cold warm transitions of the beam lines had NC on their sealing surfaces (Helicoflex gaskets)
 - Cold Warm Transition: allows transport of the beam to/from the SRF Linac.
 - Transition from 300 K to 4 K and from Atmospheric pressure to Vacuum.

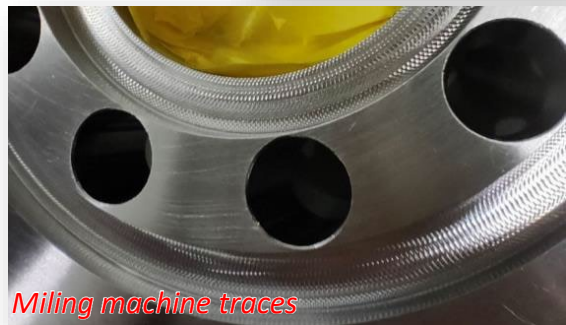
Miling machine traces

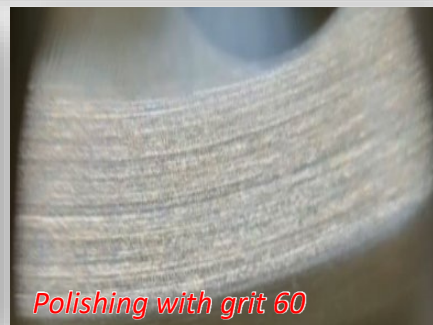
Polishing with grit 60

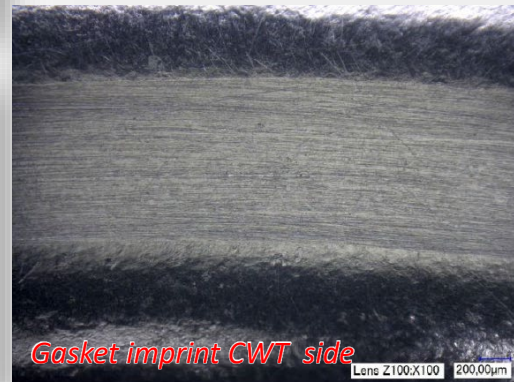
Gasket imprint CWT side

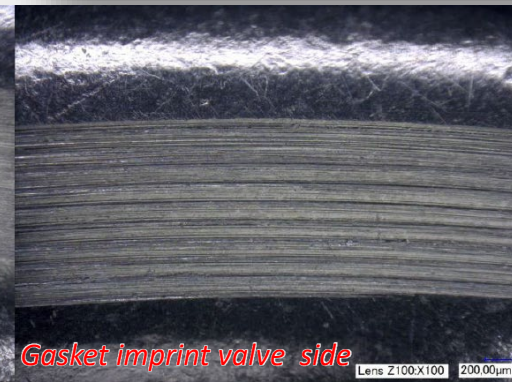
Gasket imprint valve side

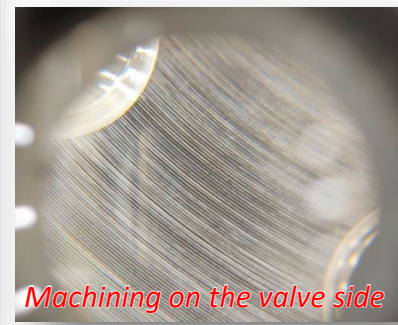
Machining on the valve side

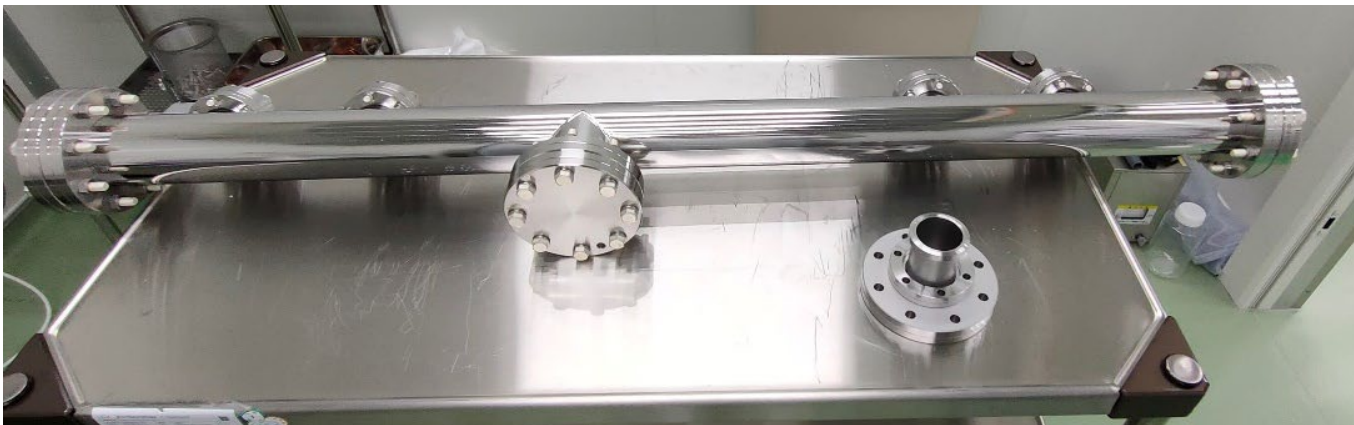
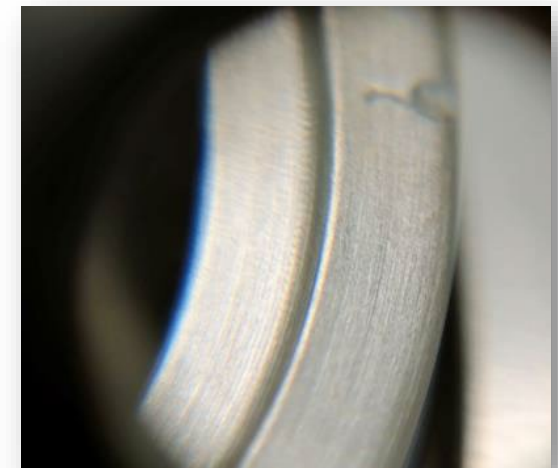
- **October 2022:** multiple leaks on the pumping manifold
 - 4 of 7 CF flanges had dulled knives. Improper protection during passivation was suspected.

- A new manifold was manufactured (easier than repairing) - **October 2023**
