Magnetic center with respect to the mechanical center

Problems with magnet & alignment plate

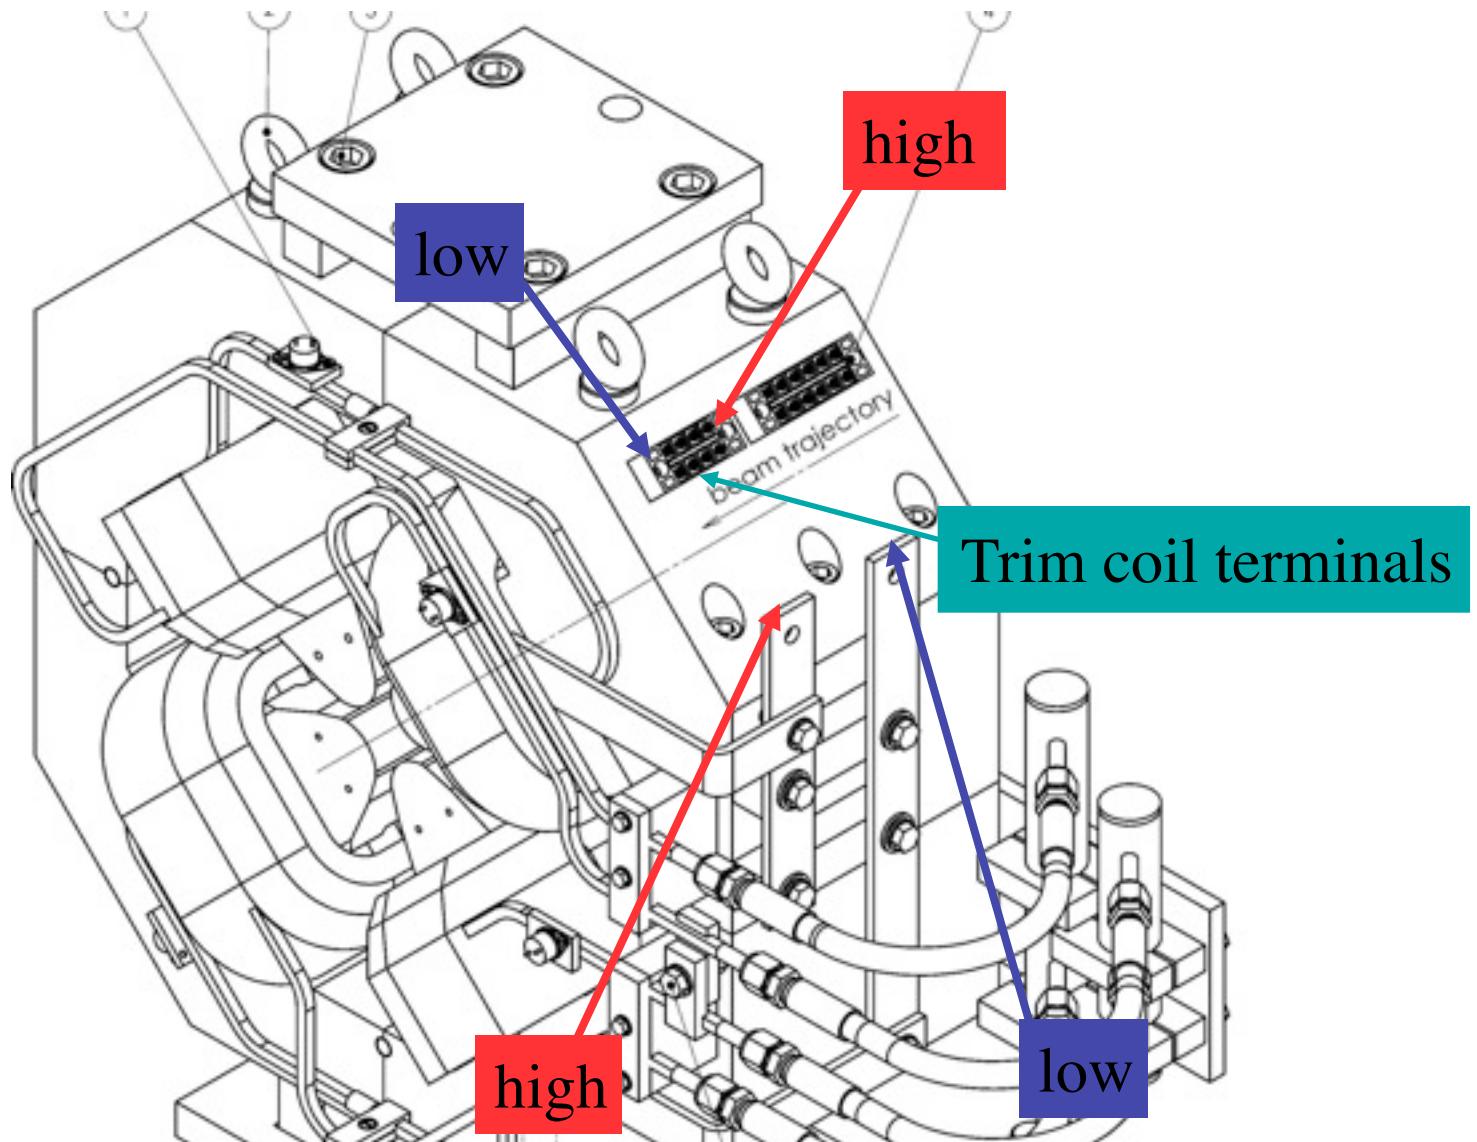
Trim coil data (with QEA03 magnet)

This configuration gives the same polarity as the field generated by the main coils.
