# Optical Inspection Update and Material Studies at JLab

Jefferson Lab ILC08, November 16-20, 2008, UIC

## A13 Bulk EP + 600CX10hr Full Inspection Equator EBW typical

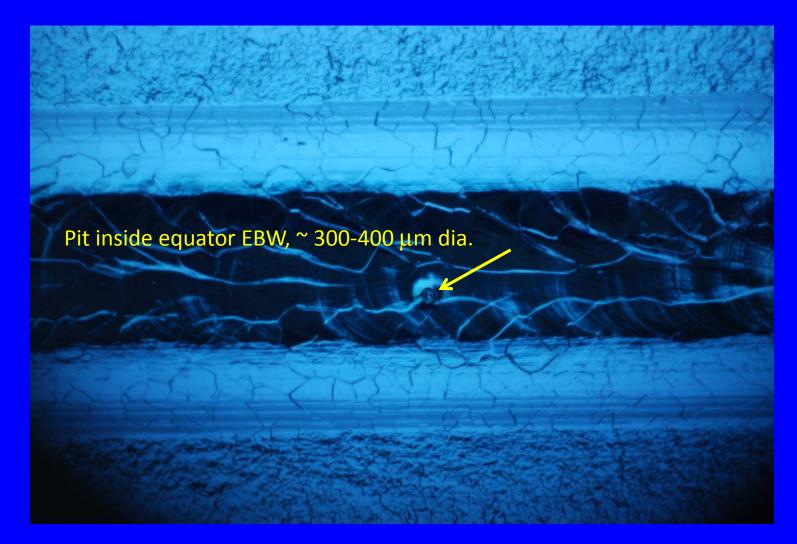
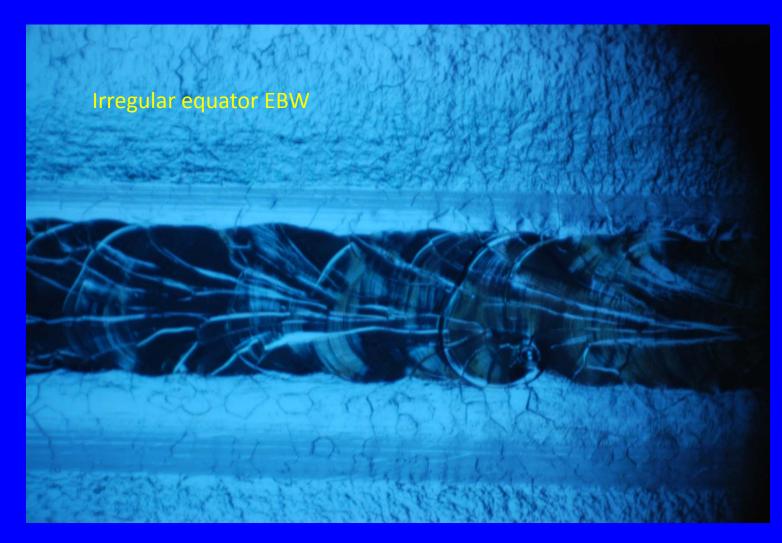
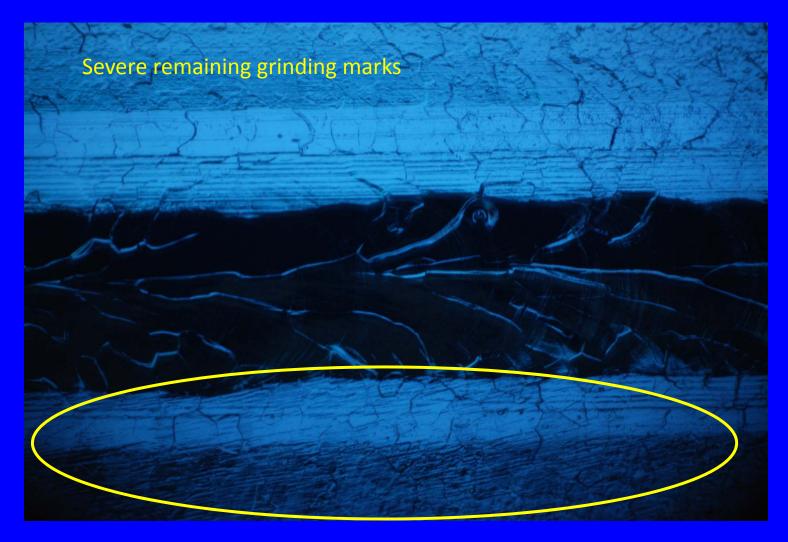
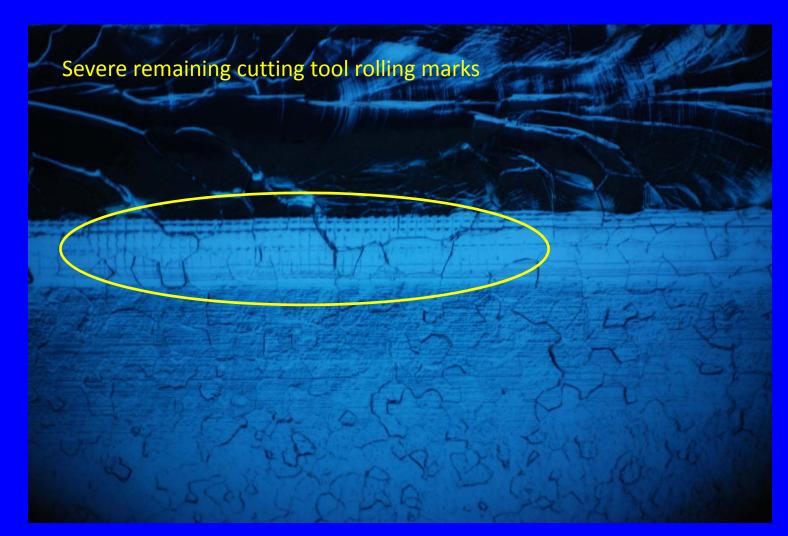
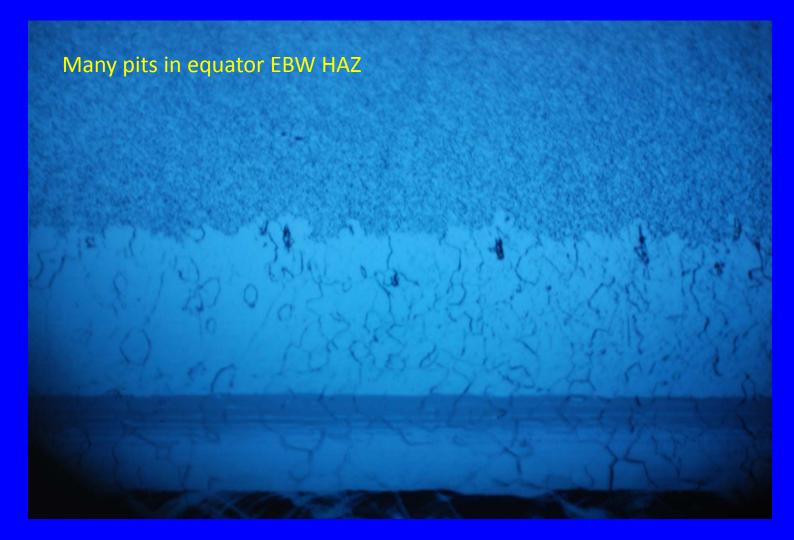
- 5-cell original CEBAF cavity. Built about 20 years ago.
- BCP etched only.
- Recently re-etched and tested.
- Quench limited at 10 MV/m.
- Goal of inspection: establish reference defects naturally existing in real cavities.

Linear defects (most likely slip lines and slip bands associated with plastic deformation)

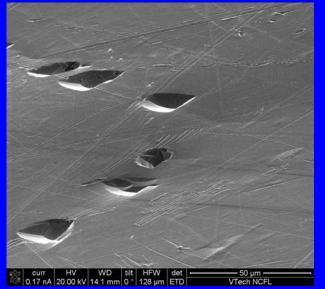
A recent JLab result by Xin Zhao et al dislocation etching pit large-grain BCP presented at MSU material workshop

EBSD+IPF+IC figure shows all the etching pits are in a single crystal grain
