First report from FONT4 at ATF Week of the 21st of April 2008

Sampling errors from March 2008

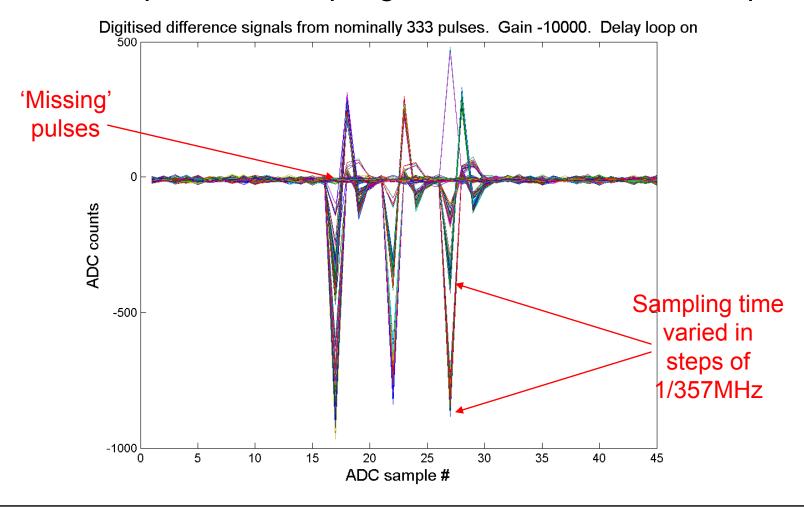
Two independent sampling issues from March 08 trip

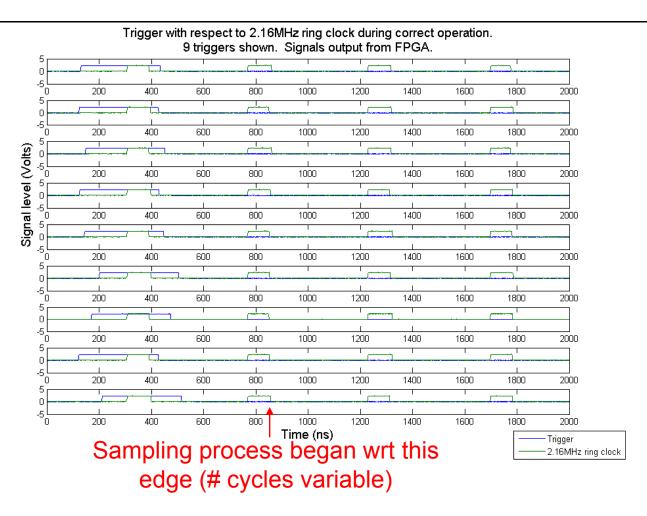
Digital board triggering

Trigger selects correct ring clock cycle

Trigger jitter causes missing pulses

Pre-beam trigger jitter wrt 2.16MHz ring clock ±60ns

c.f ring clock period of 463ns

- Trigger close to ring clock edge
 - → Wrong ring clock cycle sometimes selected
- Solution: implement trigger delay in firmware (to do)

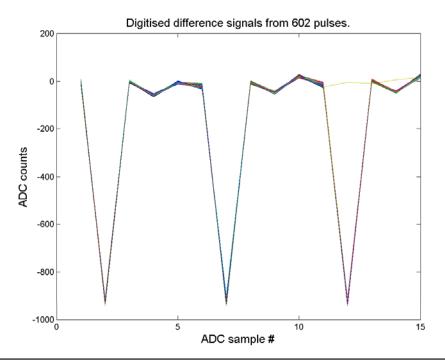
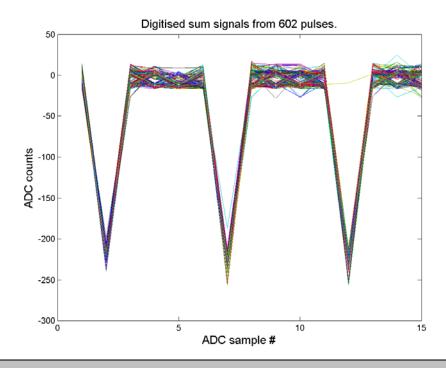
Further sampling analysis

March data (left), modified firmware #1 (right)

New results much more sensible!

- Carefully timed pre-beam trigger
- Modified FPGA firmware (modification #1)
 - Sampling now begins wrt 2.16MHz rising edge
- Sampling issues resolved

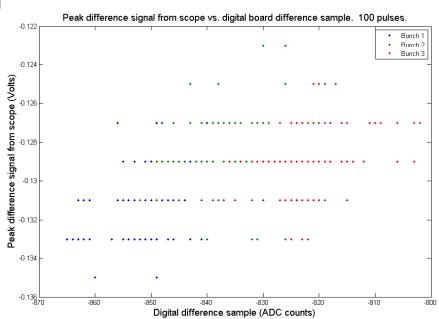
Further sampling analysis

- Split BPM processor output
 - Sampled with scope
 - Sampled with digital board

- Looks reasonable
 - More detailed analysis with integration and/or gaussian fitting
