Optical Inspection at JLab

Rong-Li Geng, Curtis Crawford

Jefferson Lab

ILC Cavity Group Meeting, September 16, 2008

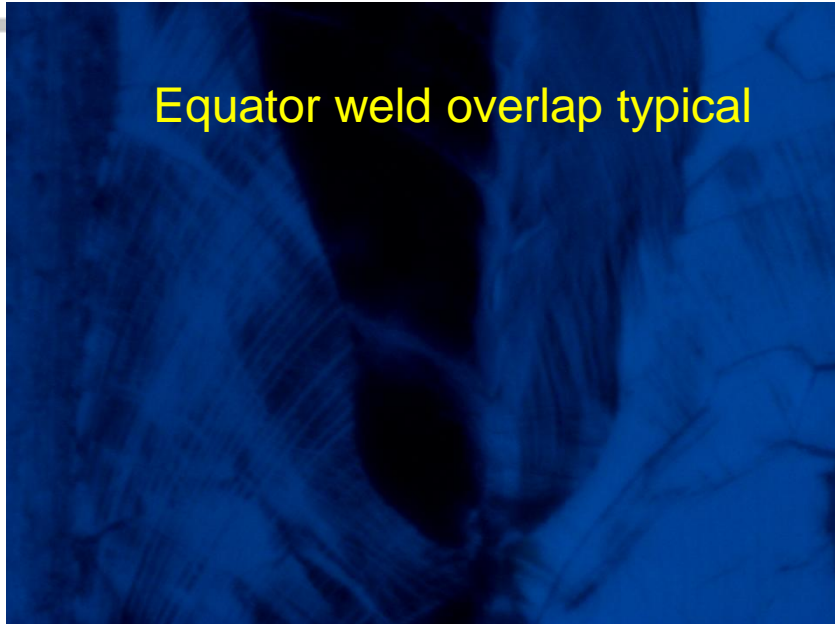
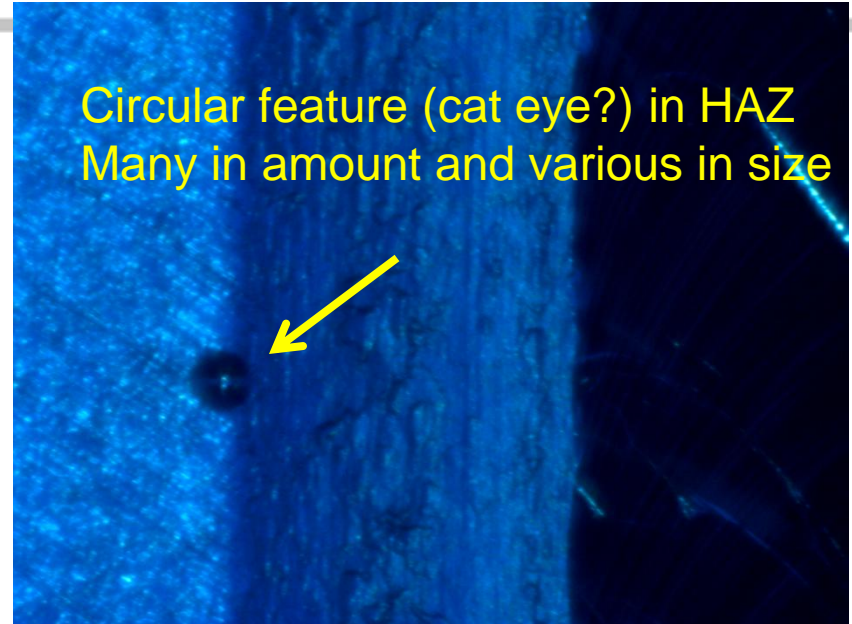
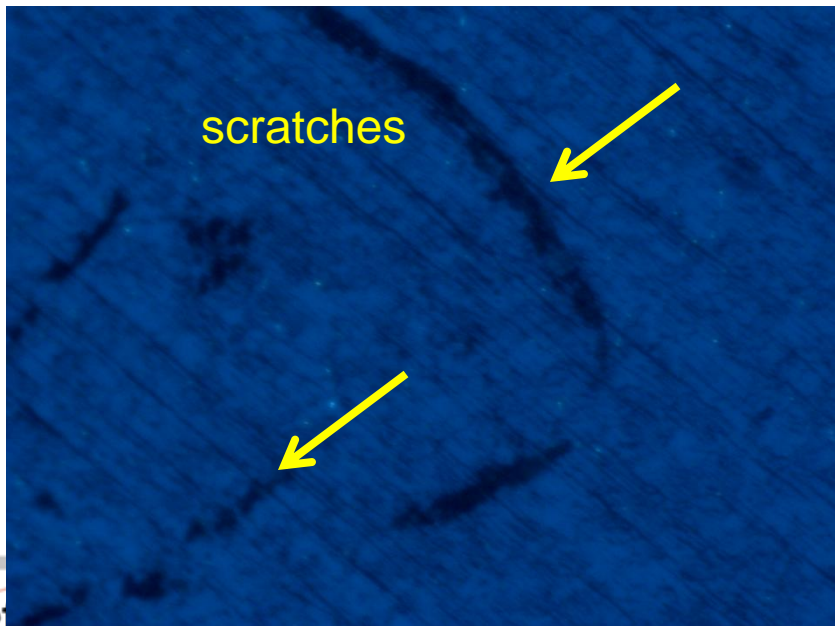
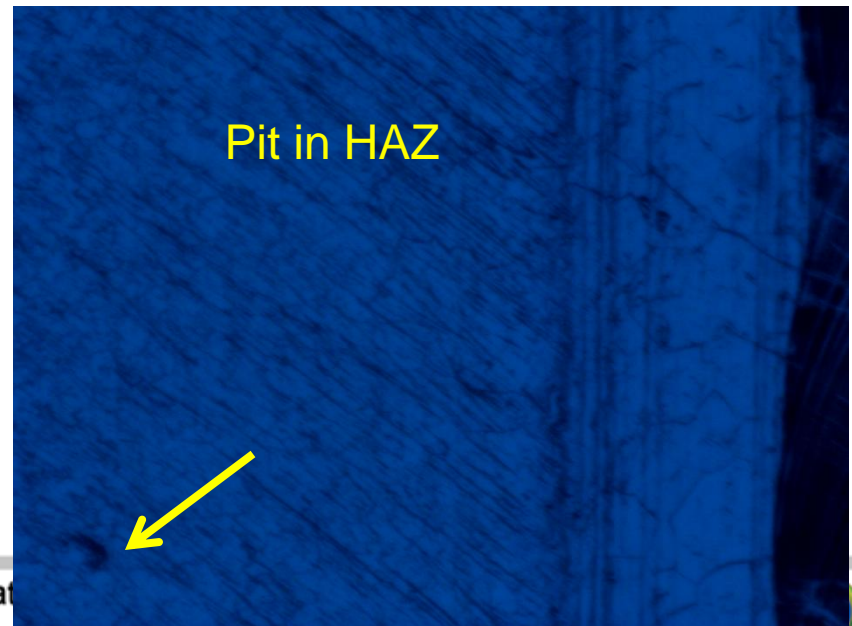
J1 9-cell cavity as-built RF surface

Damage caused by grinding

Damage caused by contact at iris

Remaining weld imperfection
After iris grinding

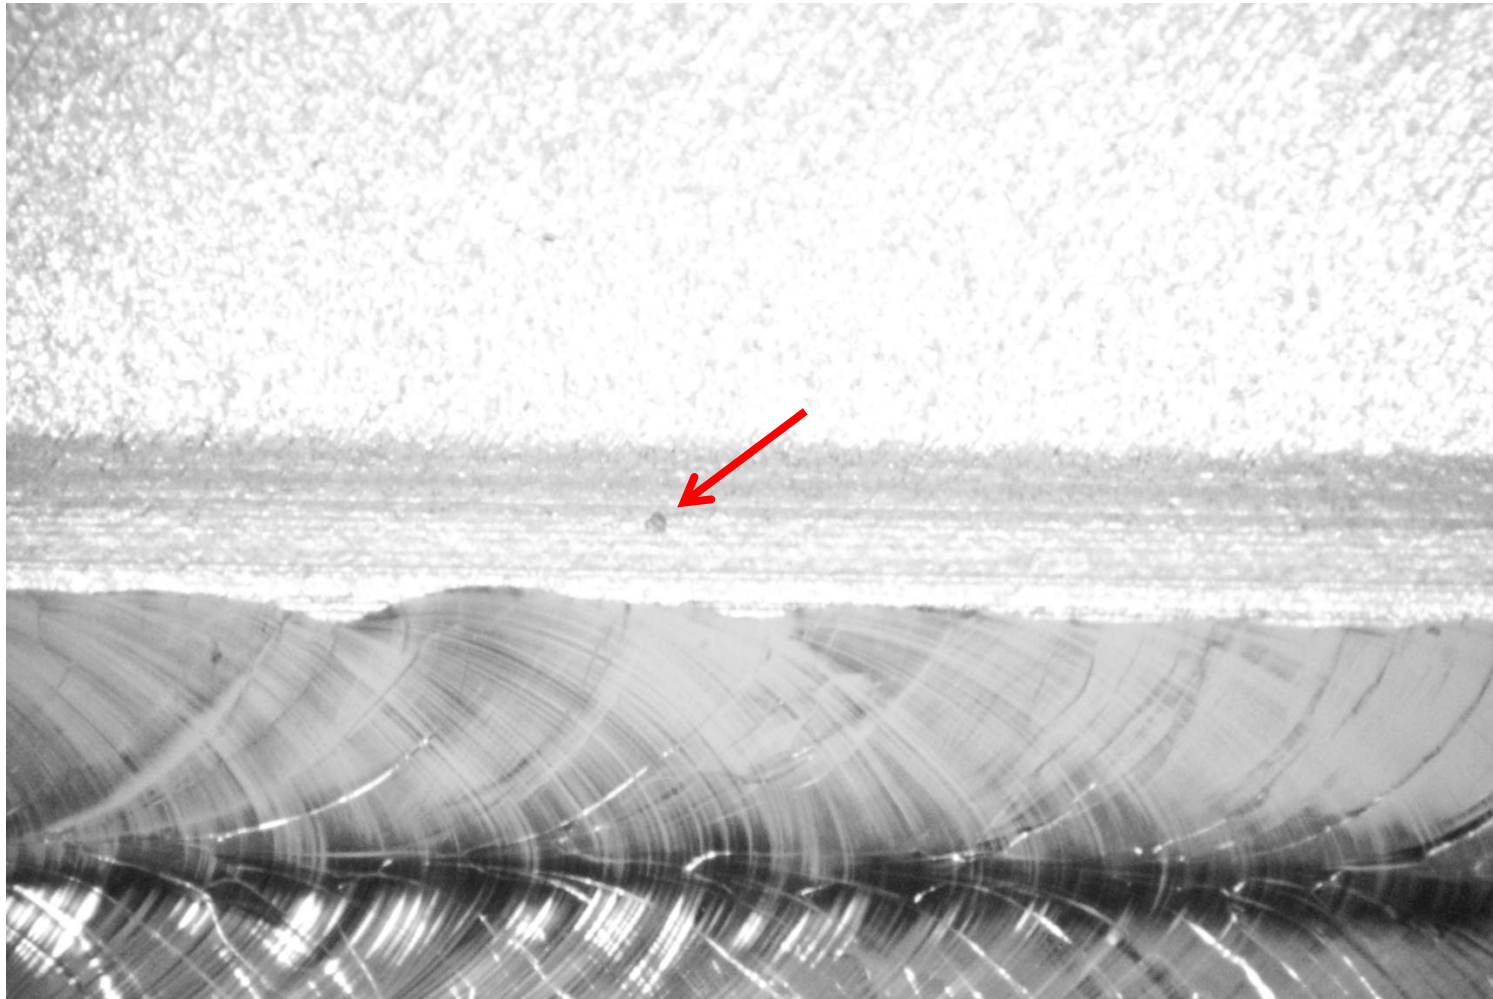
J2 9-cell cavity as-built RF surface

- J1, J2, PKU 9-cell (HC1, HG006, LG1)
- These defect are all close to the EBW
 - HAZ of equator EBW: A15, AES1, AES3, RE 9-cell, J1, PKU 9-cell, HG006, LG1
