# **Results of Second Alignment and Longterm Variation of Tilt of Magnets**

**R. Sugahara**

**KEK**

**October 22, 2008**

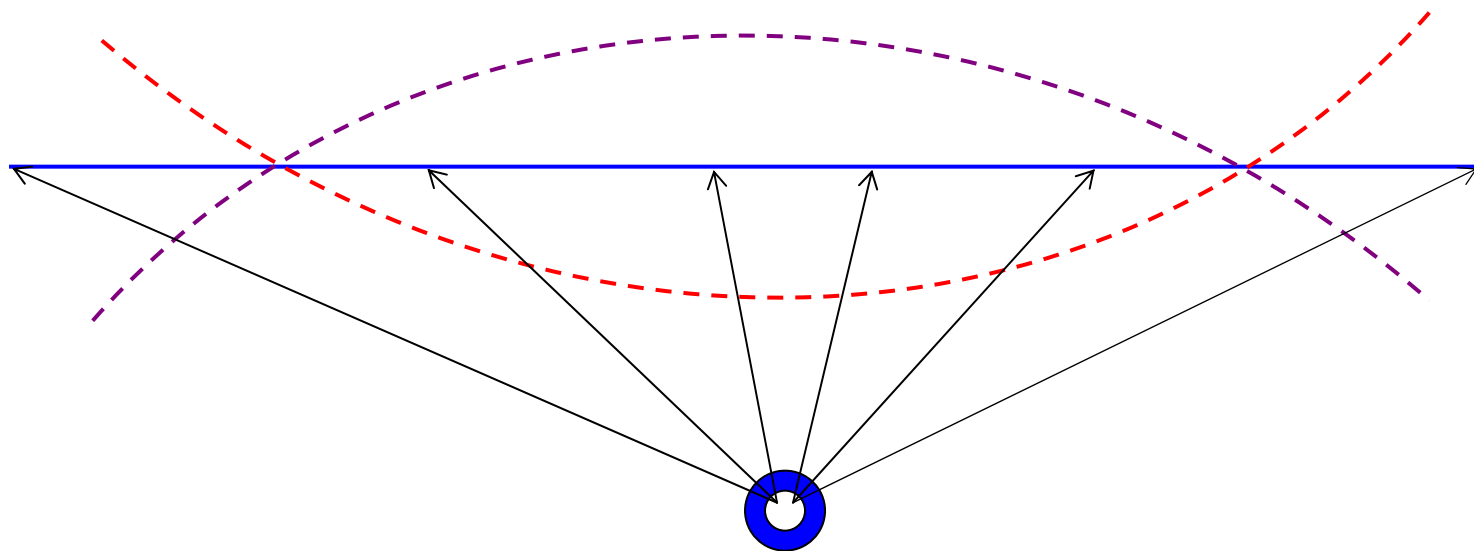
Laser tracker

About the variation of the smoothing curve, I am suspicious of the tracker's systematic error in angle measurement, because the tracker is not good in straight line measurement.

--> We will do the tracker calibration before the next ATF2 beamline survey, and let's see .....
