Result of Optical Inspection at STF

(MHI-05 and MHI-06)

Ken Watanabe (KEK) TILC09 in Tsukuba 19-April-09

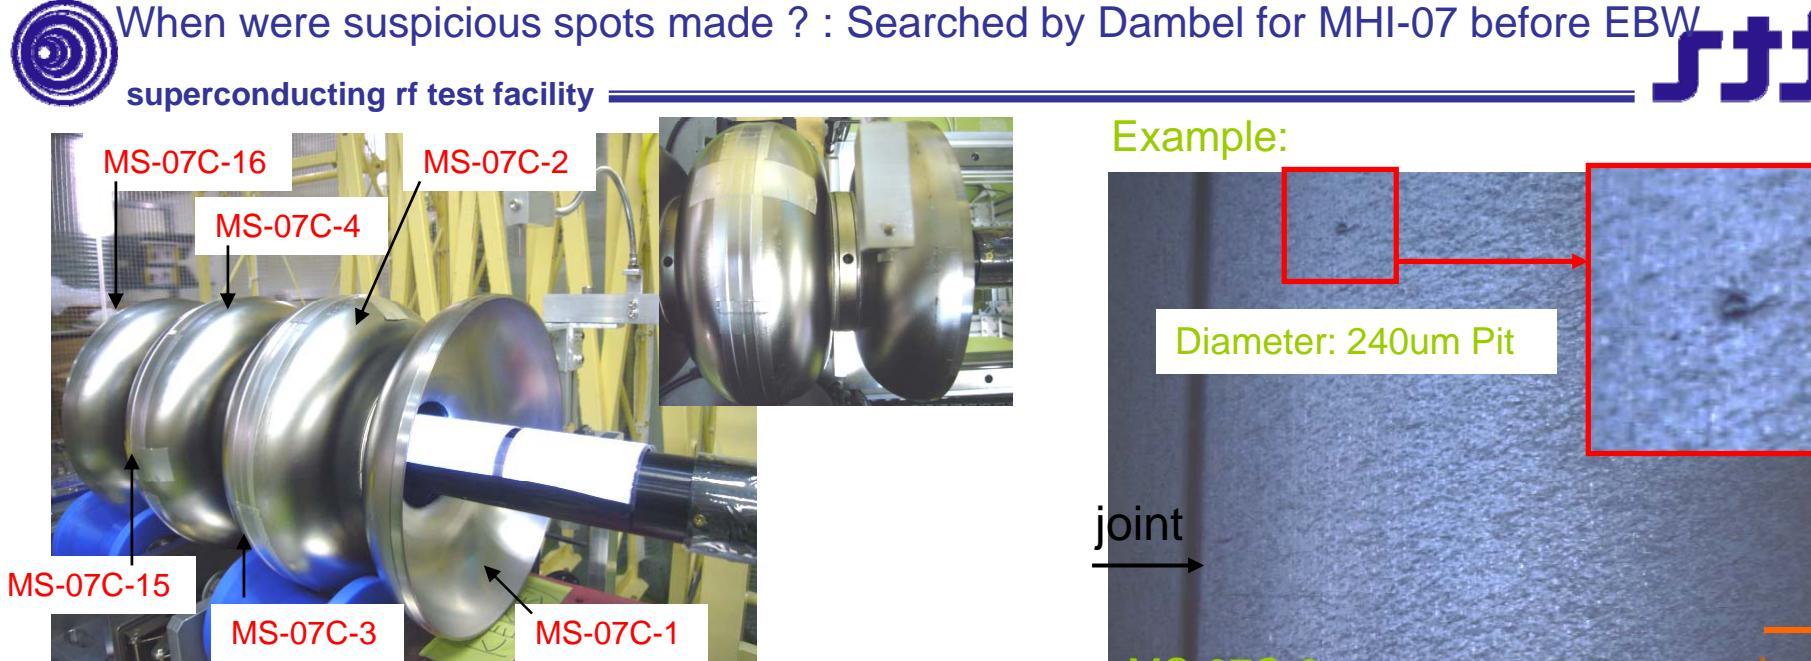
To search that "When were suspicious spots made ?",

We tried to be inspection by using a three dambels for the MHI-07. Result :

*The spots were observed on the surface at point of the dambels.

(The spots does not occur in the Surface treatment.)

*The location of the spots are between 15mm from a joint point.

However, a heating of similar spots are not detected at V.T. for MHI-05 and MHI-06

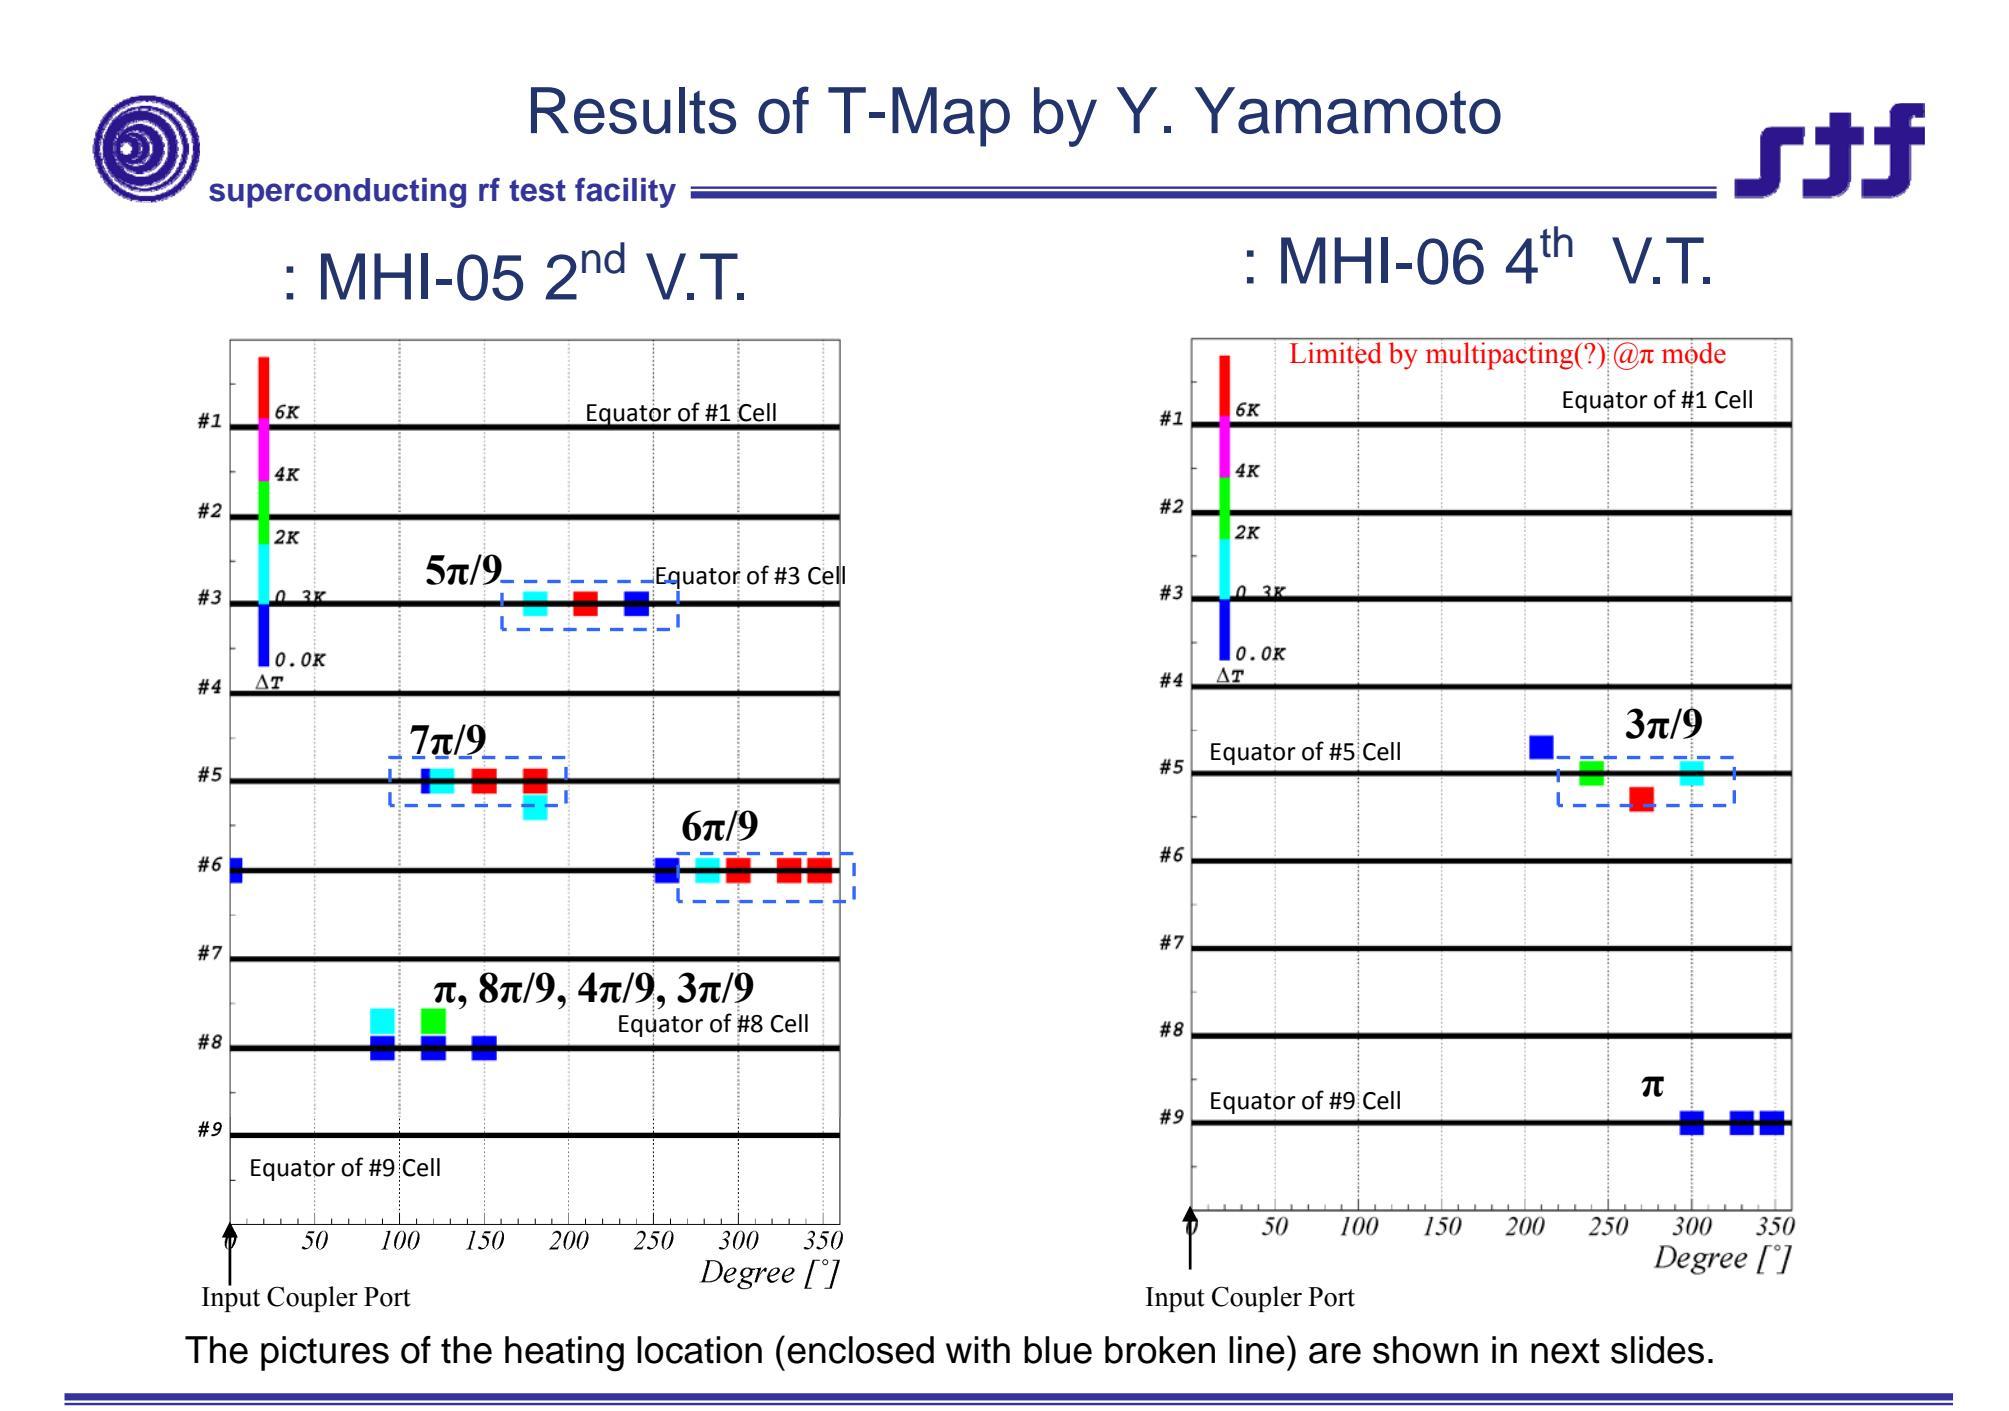
MHI-05 cavity

* The observed heating location at high field were near unstable area of the EBW seam at equator.

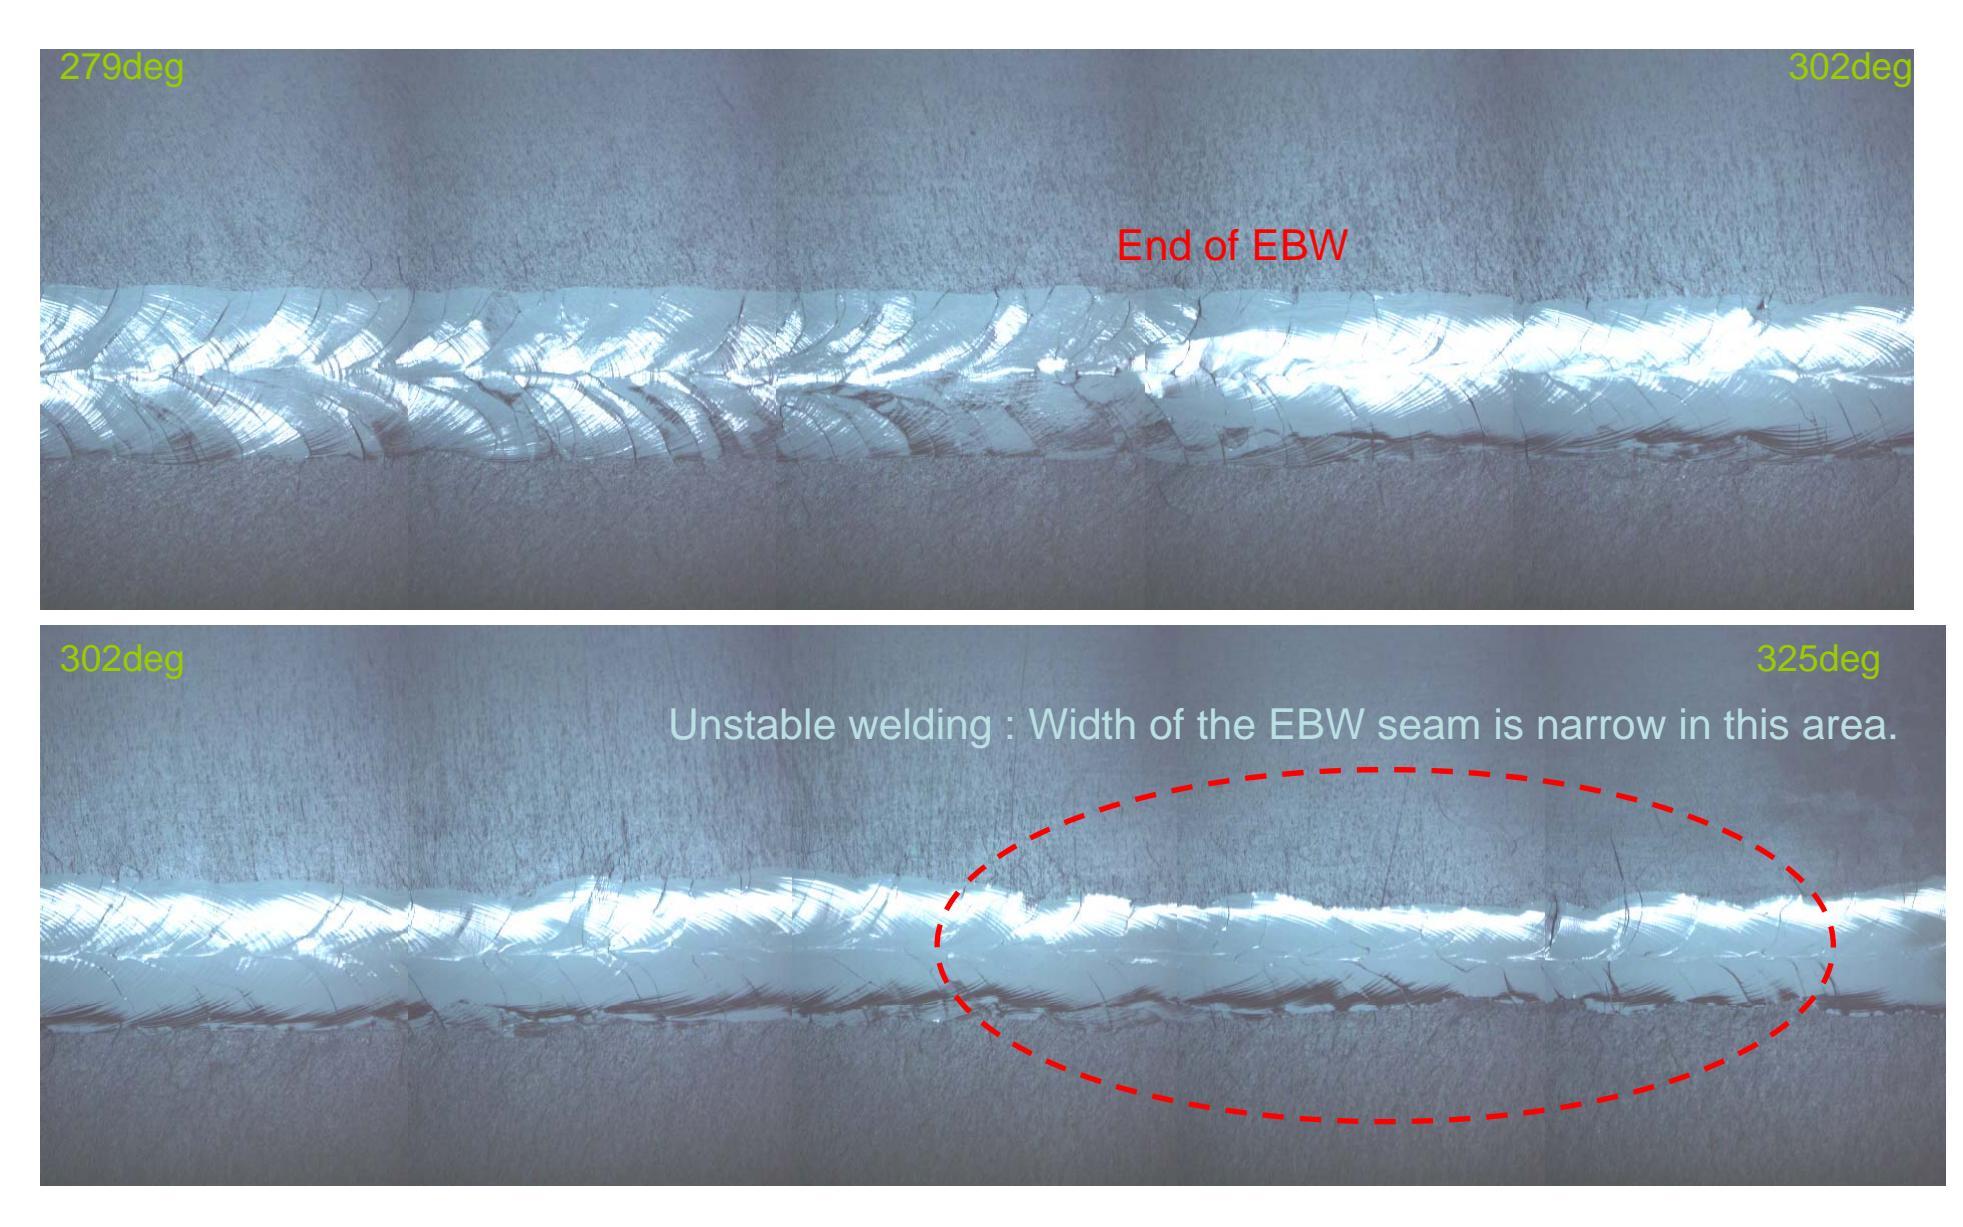
Heating area #6 cell equator :270° ~ 360° : Sensor 300° ∠T=10 K, 330° ∠T=10 K, 350° ∠T=8 K

#6 equator, 279 ~ 325 degree. Condition : As received.
