Optical Inspection at DESY

S. Aderhold (DESY)
TILC09

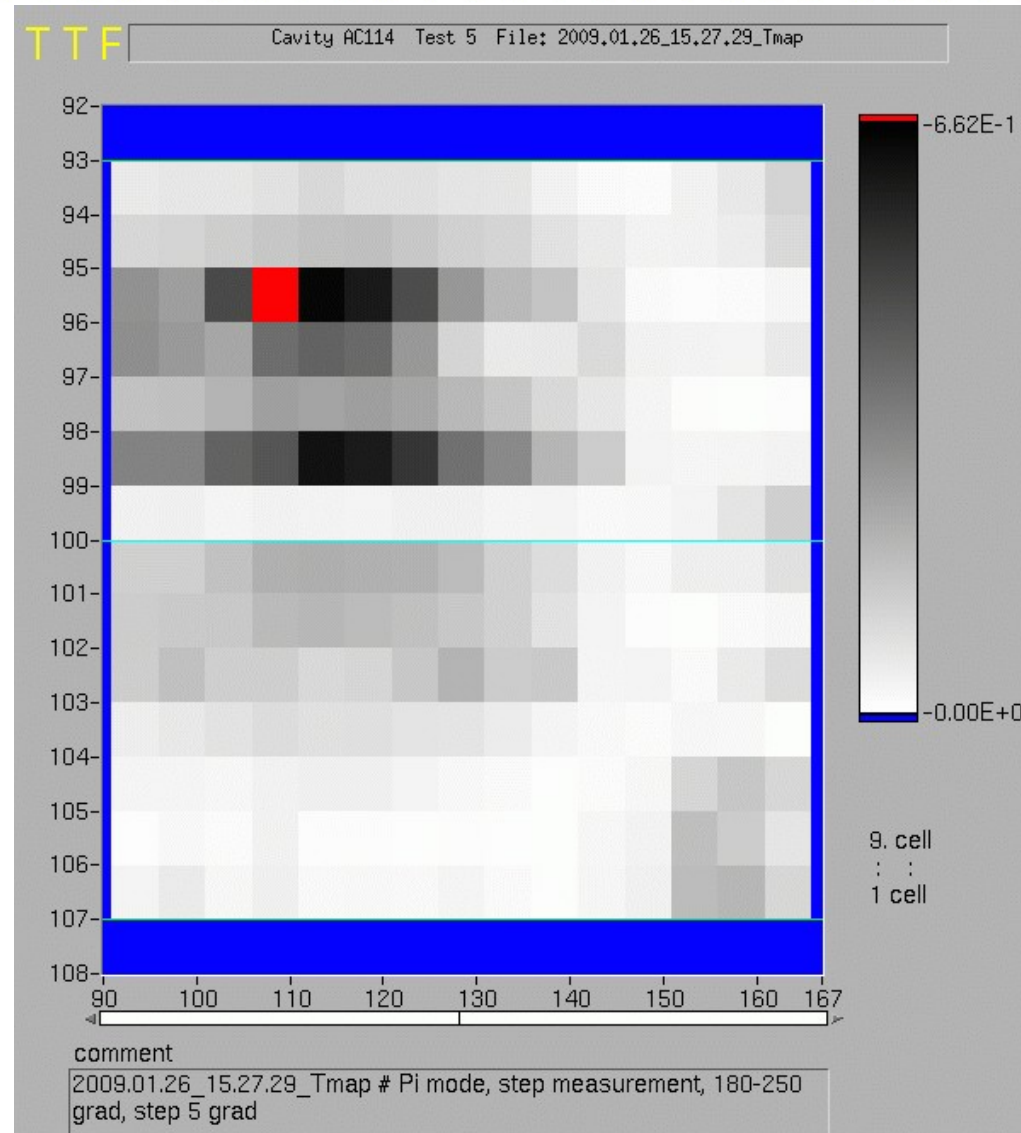
Cell 2, resistor 98 (next to equator)

- Cell 2
- Limited at 15 MV/m
- Hotspot in π -mode and $1/9$ - π -mode
- Lower spot: hotspot in $4/9$ -, $3/9$ - and $2/9$ - π -mode

hotspot in modes: $4\pi/9$, $3\pi/9$ and $2\pi/9$

leftover from grinding

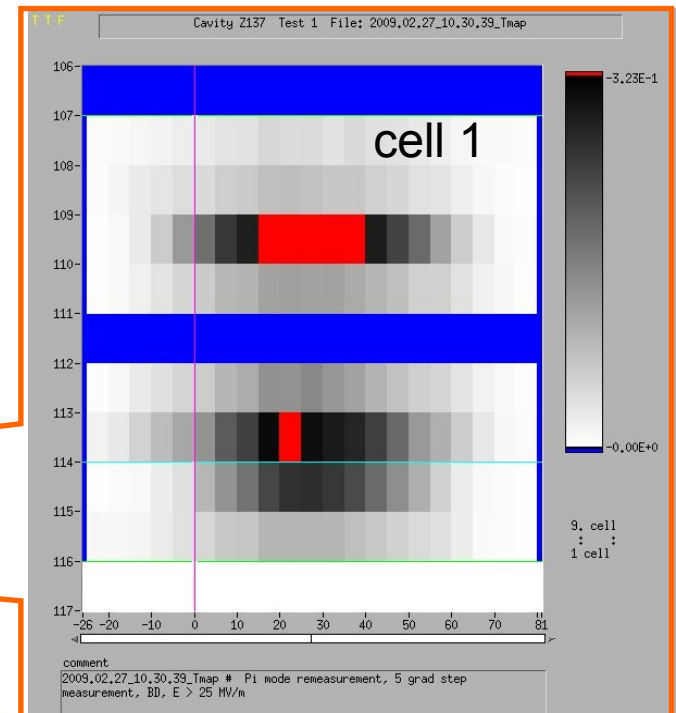
T-map of Z137

- Equator #1 shows large steps and rough grains after main EP
- All other equators normal

π -mode, BD at 25.2 MV/m
