## Status of GEM panel

# Under-grad. students had measured X-talk on PCB and gain check of module 1/2

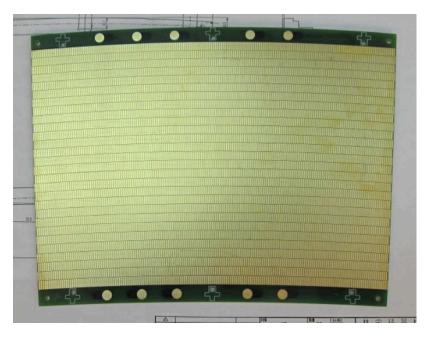
#### PCB x-talk

Target channel is connected

to pre-post-amp -> Oscilo

Scan X-talk moving input channel

around the target channel

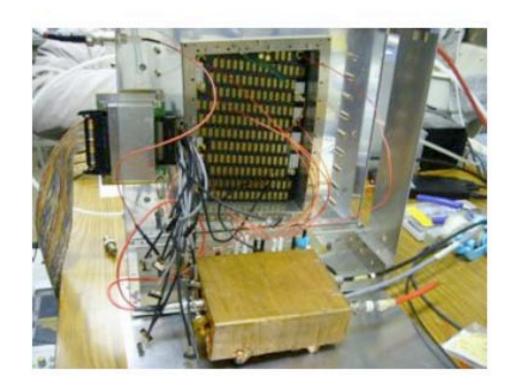
Fe55 PH(main peak) is monitored through (belle) pre/post amp by oscilloscope.

so accuracy is very poor!!

16ch+16ch are all connected together

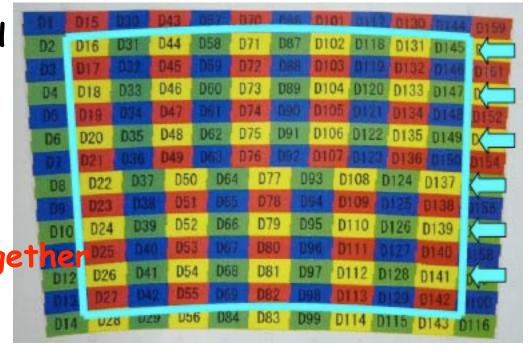
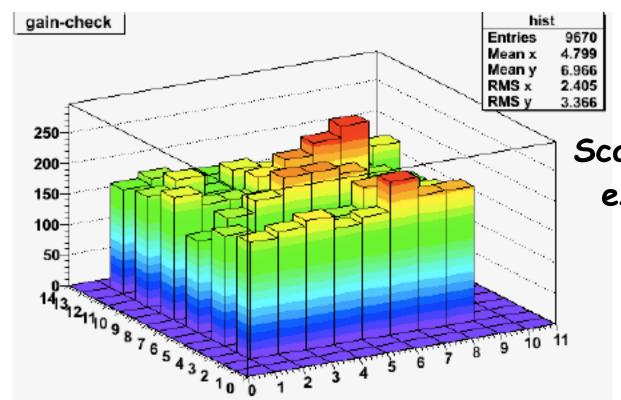
Scan every other connector except outer edge

Fe55 PH(main peak) is monitored through Ortec pre/post + PMCA
