Replica-method and local grinding repair

K. Watanabe (KEK)

LCWS 2010 in Beijing.

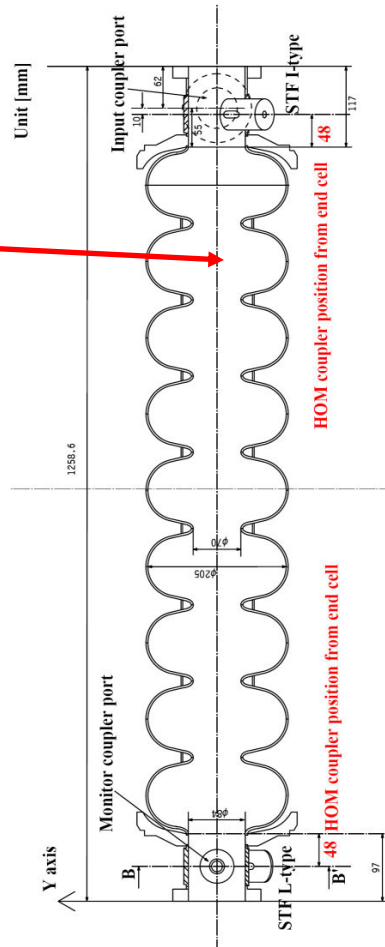
2-cell equator, $t=172$ deg. Pit

The cavity was quench at 16 MV/m on the 2-cell equator. The defect was made after EP-2 process.

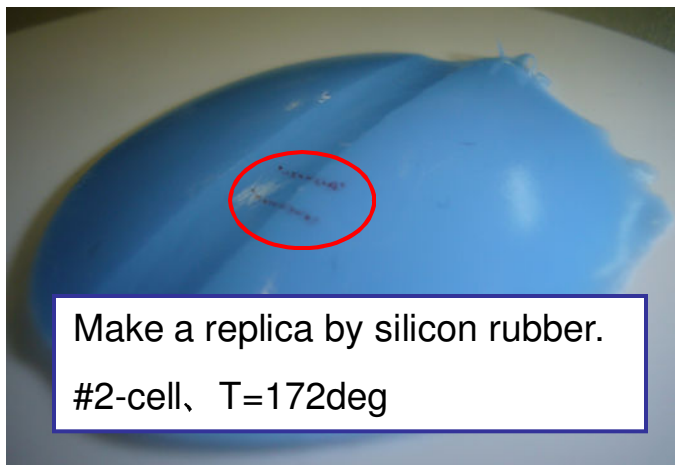
Result of shape analysis by Laser microscope. : Pit type deep defect, depth = 115 μm .

Copy to stycast.

Shape analysis by
Laser microscope.

Test of the grinding for
the target.

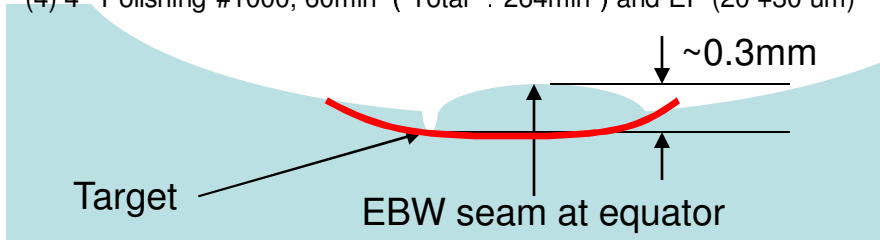
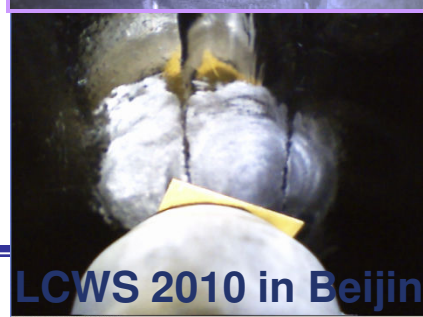
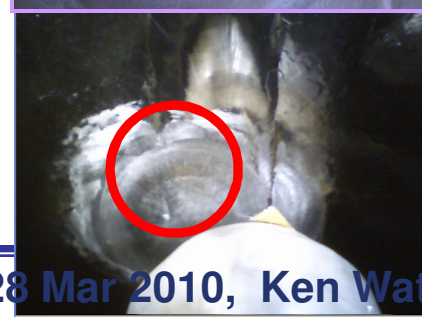
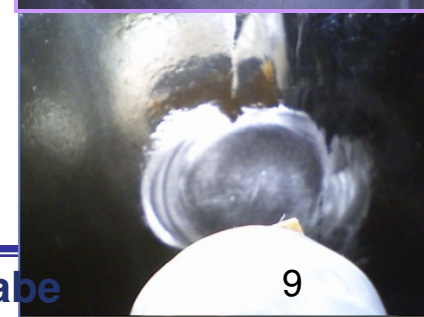
4. MHI-08 : Grinding of the defect : 2-cell equator $t = 172^\circ$

In this case, the defect type was pit at the boundary between EBW seam and HAZ.

History of the Grinding, (0) before Grinding.

- (1) 1st Grinding #400, 58 min
- (2) 2nd Grinding #400, 76min (Total 134min)
- (3) 3rd Grinding #400, 70min (Total 204min)
- (4) 4th Polishing #1000, 60min (Total : 264min) and EP (20 +30 μ m)

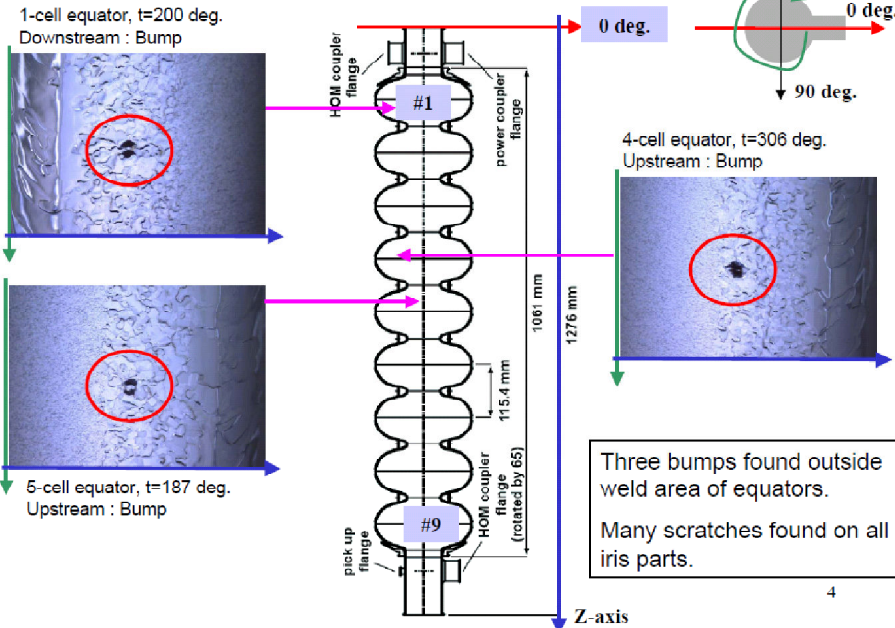
Map of the Suspicious spot in equator area: AES-03

Equator: three places (1-cell $t=200$, 4-cell $t=306$, 5-cell $t=187$)

Iris: 20 places (see the map of the iris part.)

The Quench location was “4-cell equator, near $t=306$ degree” at 20 MV/m measured by FNAL and JLAB.

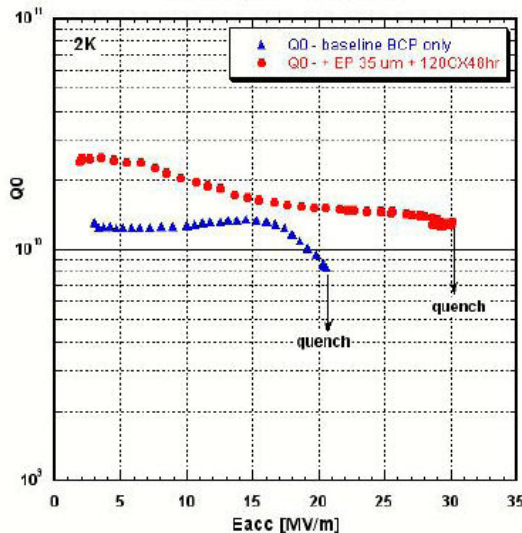
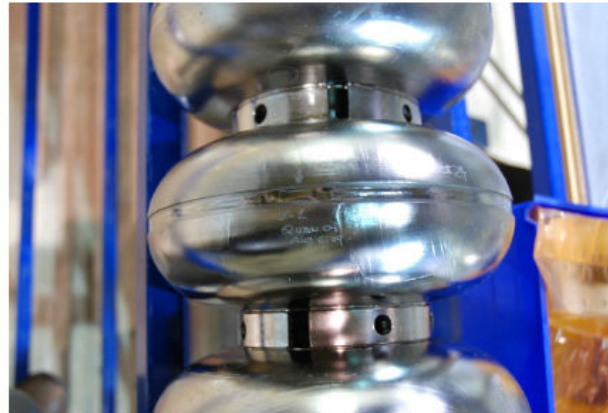
JLab Large-Grain 9-cell LG1

30 MV/m quench limited cavity, one defect in one cell. Other cells 33-35 MV/m

Limiting defect is weld repair – geometric flaw!

After the baseline test with quench limit at ~ 20 MV/m, the cavity was light EP treated - and the quench limit was raised to 30 MV/m. T-mapping found the quench location at the equator EBW of the cell#5. This cavity was then sent to KEK for local grinding.

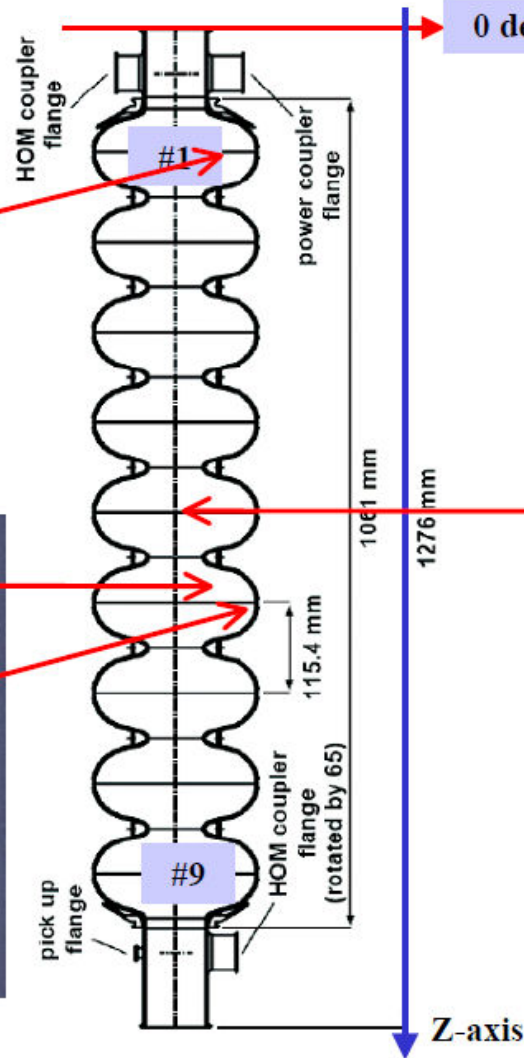
Hot spot at 30 MV/m

The welding seam was flaw in hot spot and other locations. Take a replica at 5-cell using by special tool. The Local Grinding made at 5-cell defect.

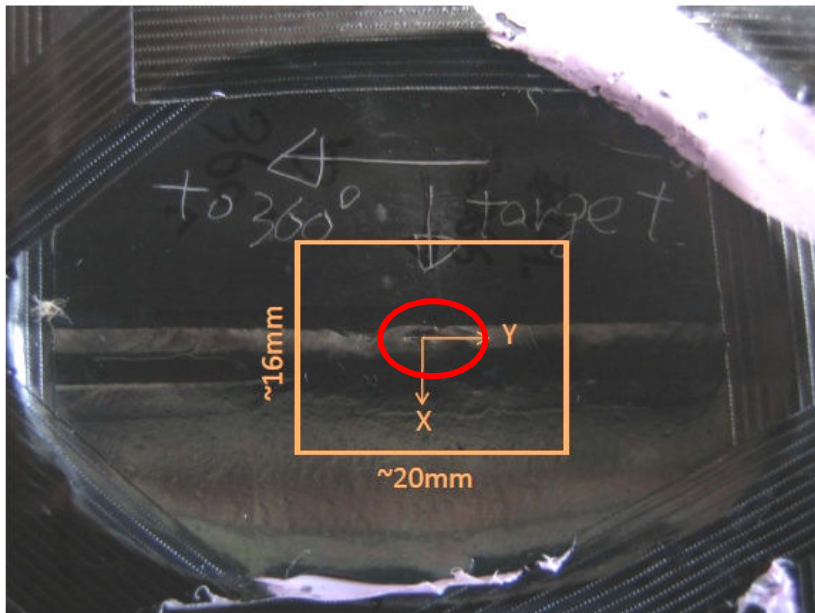
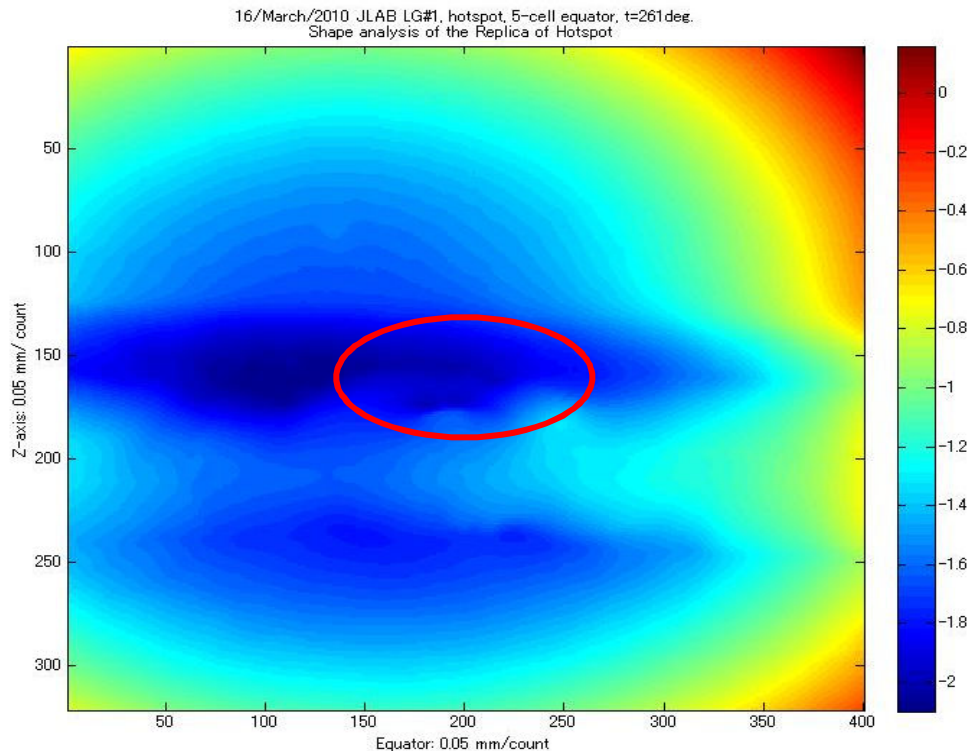
6. JLAB LG-01 : Shape analysis of the replica at 5-cell

Measured by FORMTRACER CS-5000 (Mitutoyo)
