Summary report of the fundamental power couplers meeting at SLAC

Tug Arkan, Andrei Lunin, Ken Premo

May 10, 2010

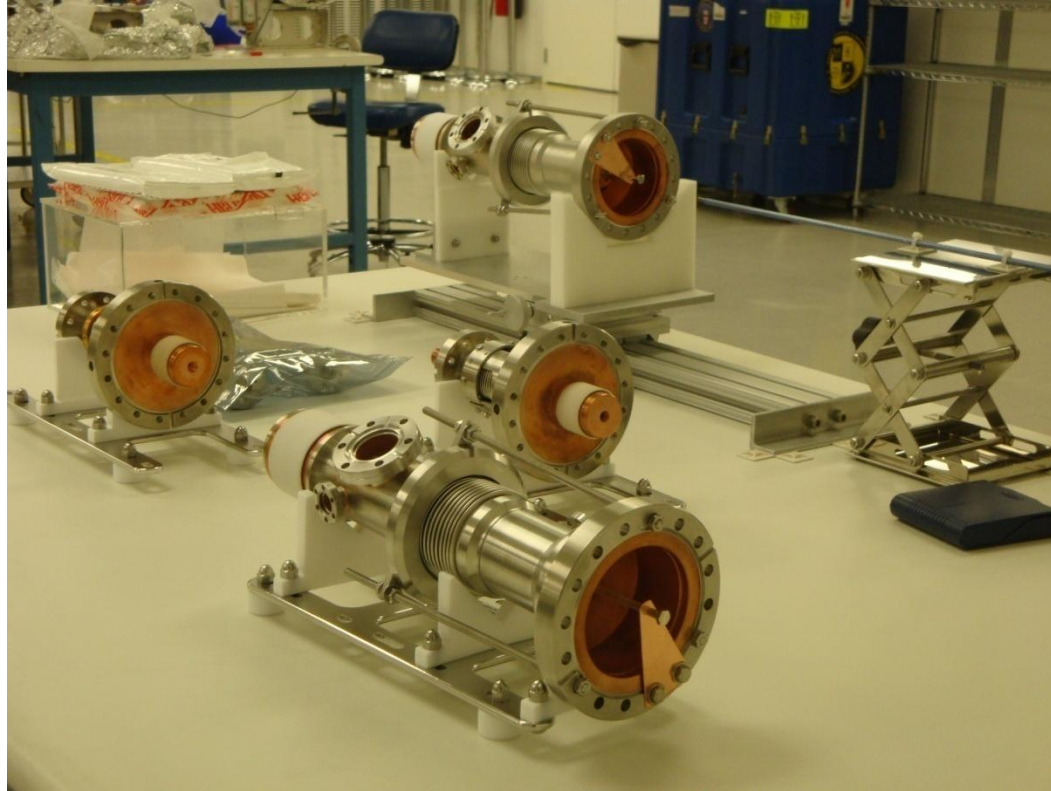
Incoming QA: Class 100,000 cleanroom

Visual Inspection of the clocking of the flanges

Boroscope Inspection of the internals of the cold and warm ends

No mechanical measurements are done at SLAC

CPI does not provided any mechanical measurement data

- SLAC will conduct a more detailed incoming QA including the mechanical measurements of some critical features.
- Cold end twisted bellows issue was understood and mostly eliminated by SLAC technicians. (A more permanent tooling rather than a counterforce wrench needs to be developed for repeatable results)
- A visit to CPI is planned by the end of May 2010

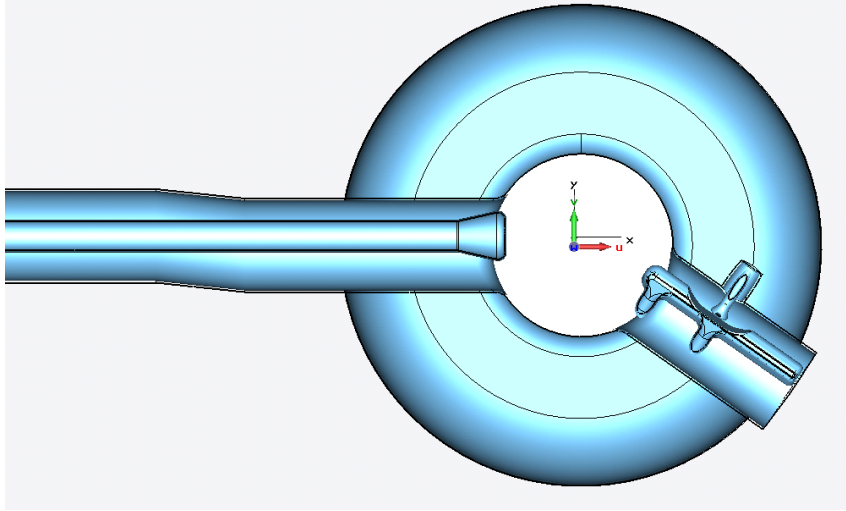
Vertical antenna shift

1. Both antenna tilt and shift demonstrates the same behavior .
2. The most sensitive manufacturing parameter is a horizontal antenna tilt. Both vertical and horizontal antenna tilts regarding to the 70K flange should be within ± 1 deg ($\sim \pm 5$ mm antenna tip shift)*.
3. The mutual cavity and coupler cold part flanges displacements allow up to ± 5 mm* non-concentricity (could be limited by other factors like a higher electric field).
