# NR001 & NR002

- **Summary of QC findings**
- Visual inspection
- Optical inspection
- RF measurements
- CMM measurements

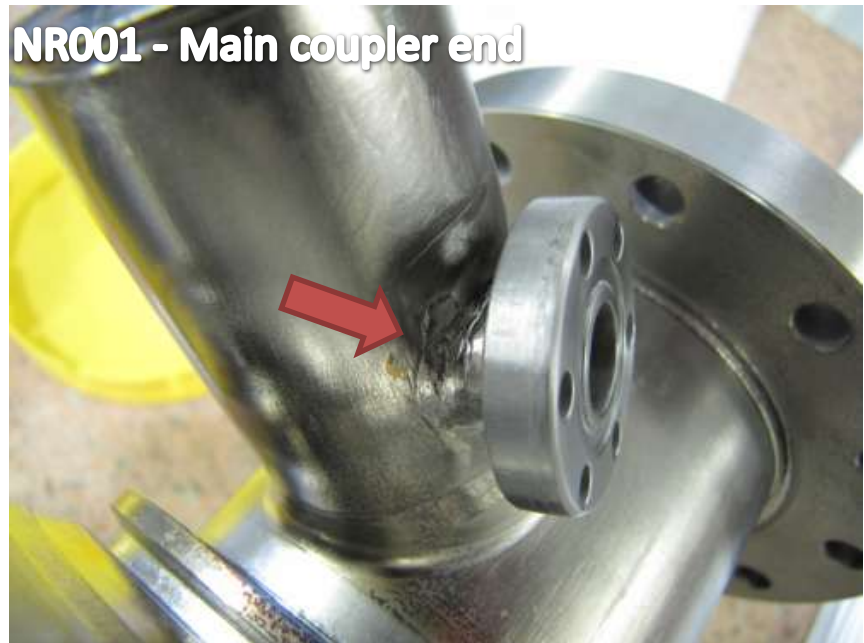
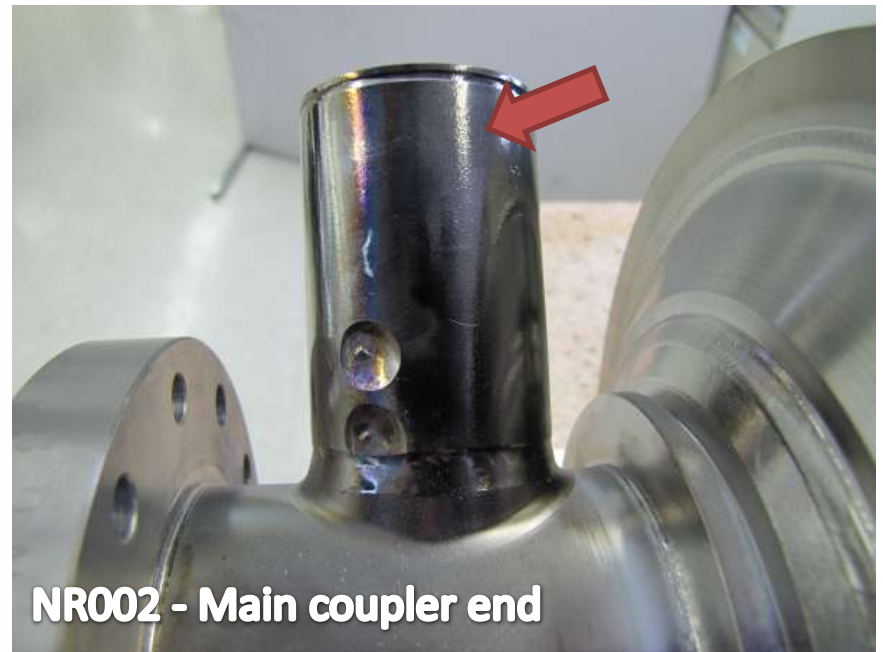
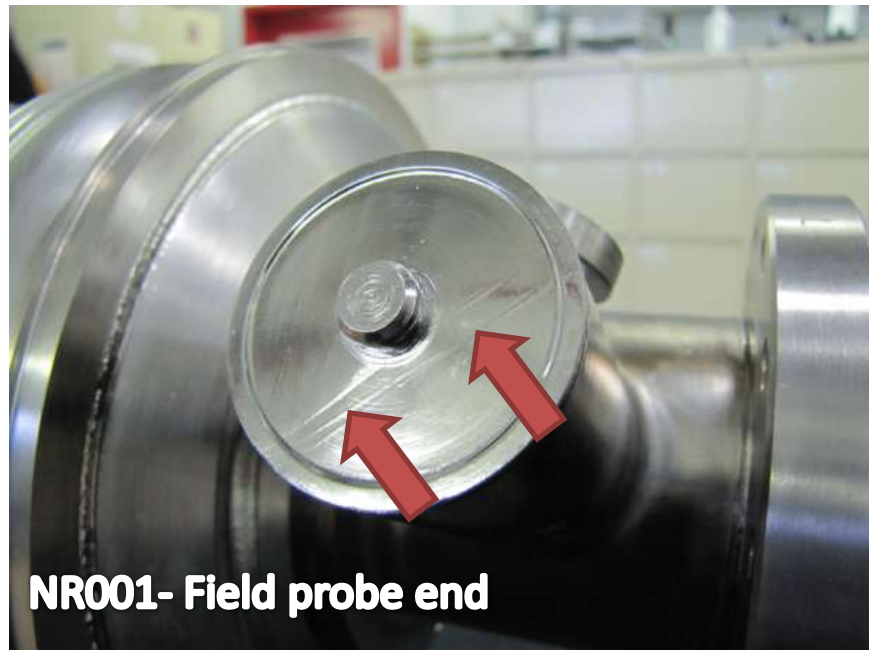
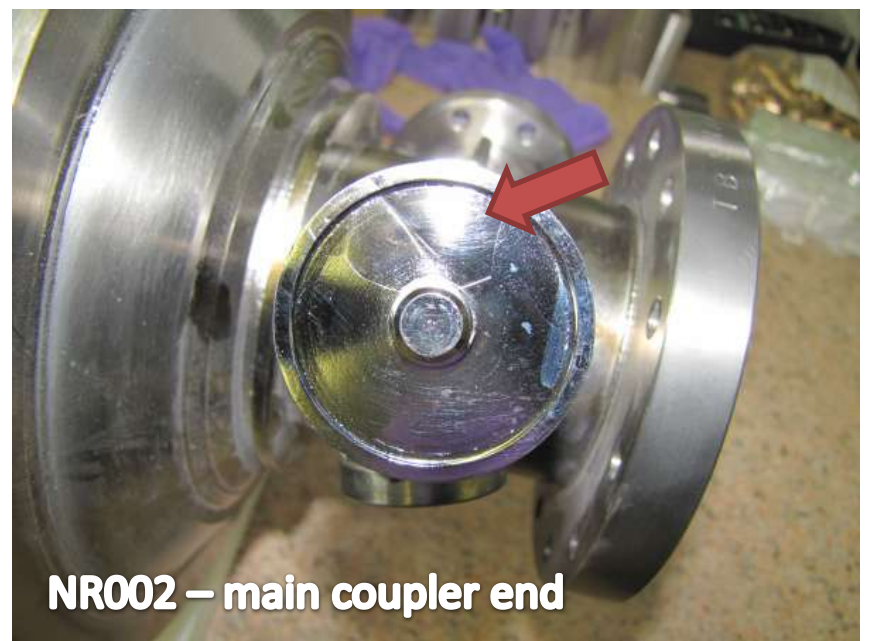
NR001: scratches and buffed area on half cell. Fixturing? – not necessarily bad per se but a sign that fixtures/handling is not appropriate.

- All handling and fixturing operations should be analyzed and improved to avoid any damage to the parts.
- The forming of the half-cells should be analyzed to identify the nature of the atypical horizontal streaks seen near the equator welds

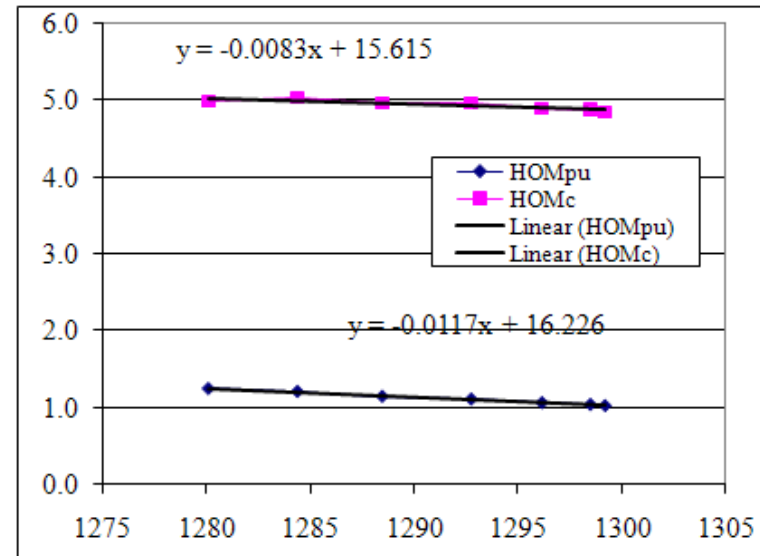
Cavity TB9NR001. S21 through cavity.

HOM1 notch frequency ~500 MHz lower than design.

- HOM notch frequencies shall be measured and adjusted prior to welding the end groups. The position of the formteil should be monitored and measured after welding.

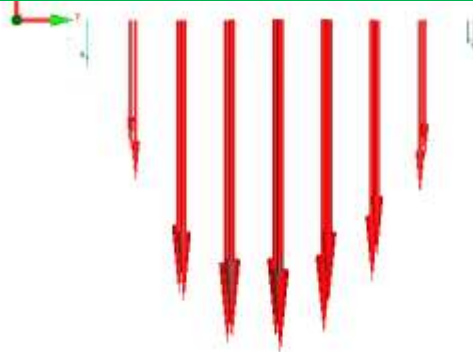
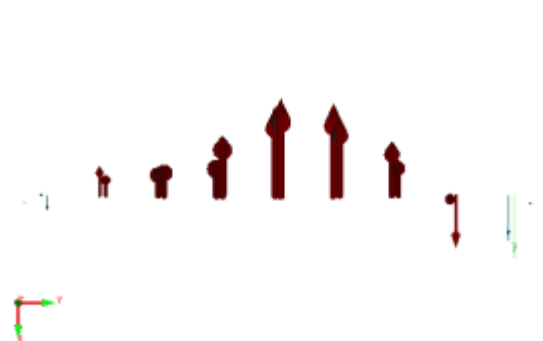
typical  
(RI026)

- NR001 is 3.373 mm longer than nominal
- NR002 is 2.710 mm longer than nominal
- Perpendicularity of end flanges from cavity axis is off by  $\sim 0.2$  degrees
- Equator diameters of both cavities are 0.4-0.6 mm larger than normal
- Equators are 0.2-0.5 mm out of round more than normal
- Positions of equators relative to cavity axis are atypical (see next slide)
