# Problems with AC151

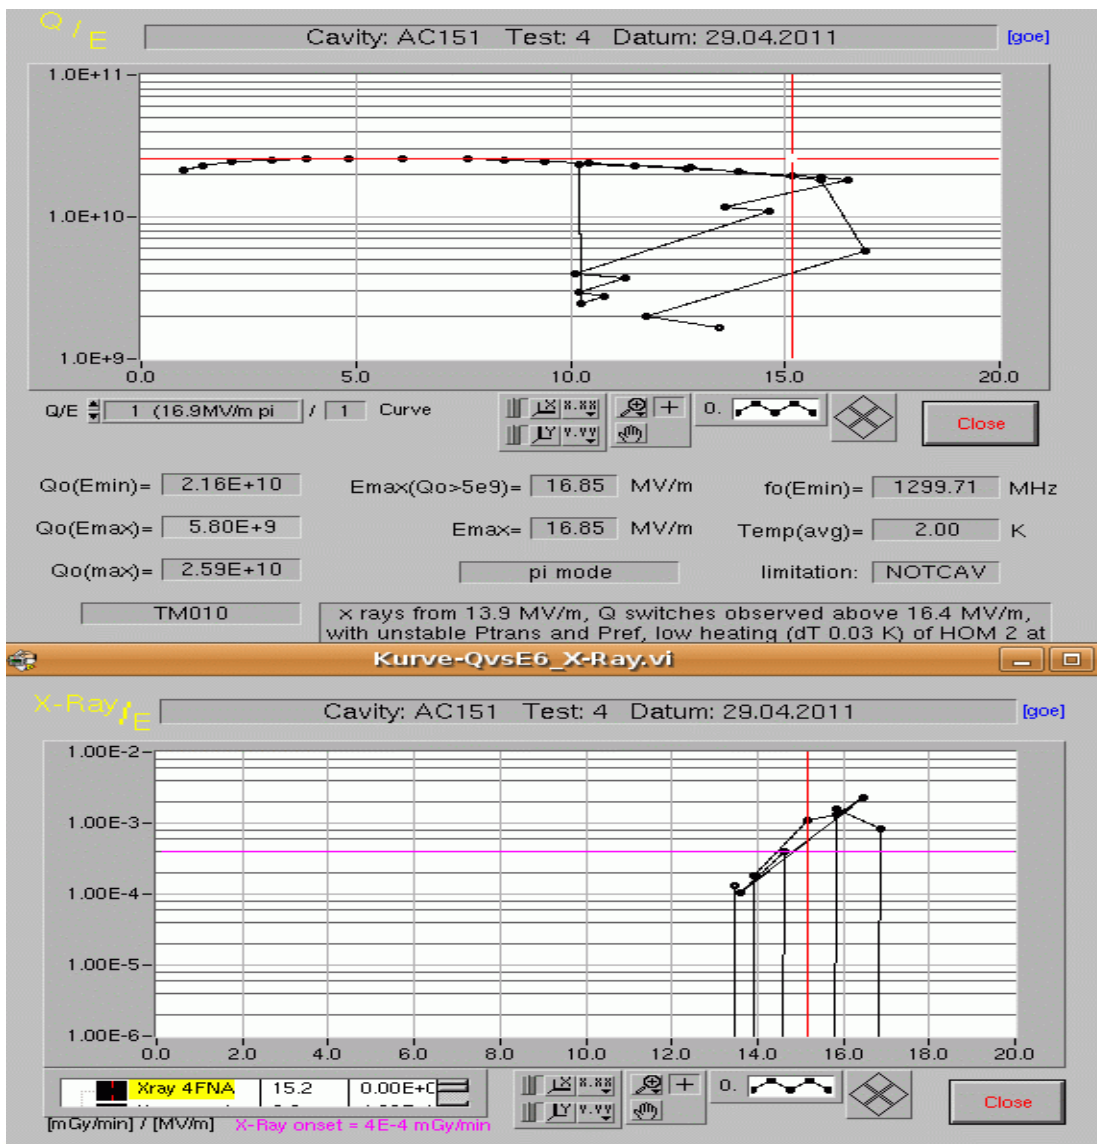
# Problems with AC151

- after 128  $\mu\text{m}$  BCP
- **BD at 28.7 MV/m with strong FE**

- after additional HPR
- **BD at 26.7 MV/m with very low x-rays**

- after 48  $\mu\text{m}$  EP
- **Limited with Q-switches at 19.9 MV/m**

- **Added T-sensors**
- **Limited with Q-switches at 16.7 MV/m**
