LP HV / Part II

Destroying and Fixing the
Cathode Side HV Connections

WP Meeting 163, 22.11.'12
R. Diener / FLC-TPC

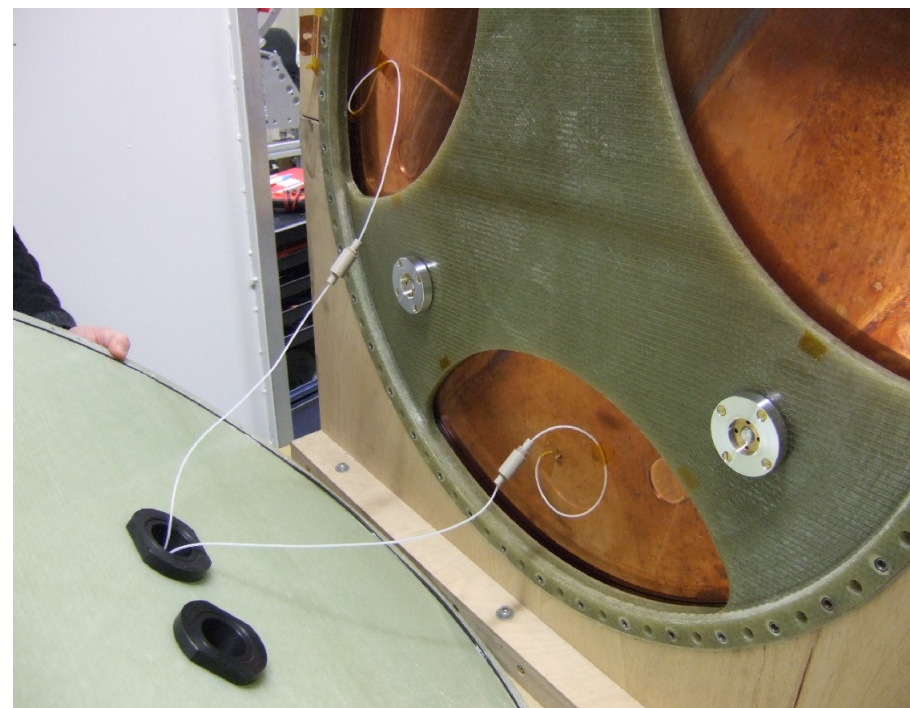
- Beginning of 2012:
 - Additional insulation on the cables at the cathode side to make field cage stand more than 16-17KV (discharge light seen in tests before)
- Before and during DESY GEM module test beam:
 - Many repairs and fixes beginning of September 2012 for the HV connections on the anode side
 - See talk from WP Meeting 158:
<https://ilcagenda.linearcollider.org/conferenceDisplay.py?confId=5822>
- 23. Sept. 2012:
 - During DESY test beam Large Prototype HV tripped again, this time at the cathode side
 - Test beam continued with lower drift voltage (15.5kV before, 10kV after)
