Status report from Lund

8.1.2015

Test set-up for testing SALTRO16-chips on Carrier Boards

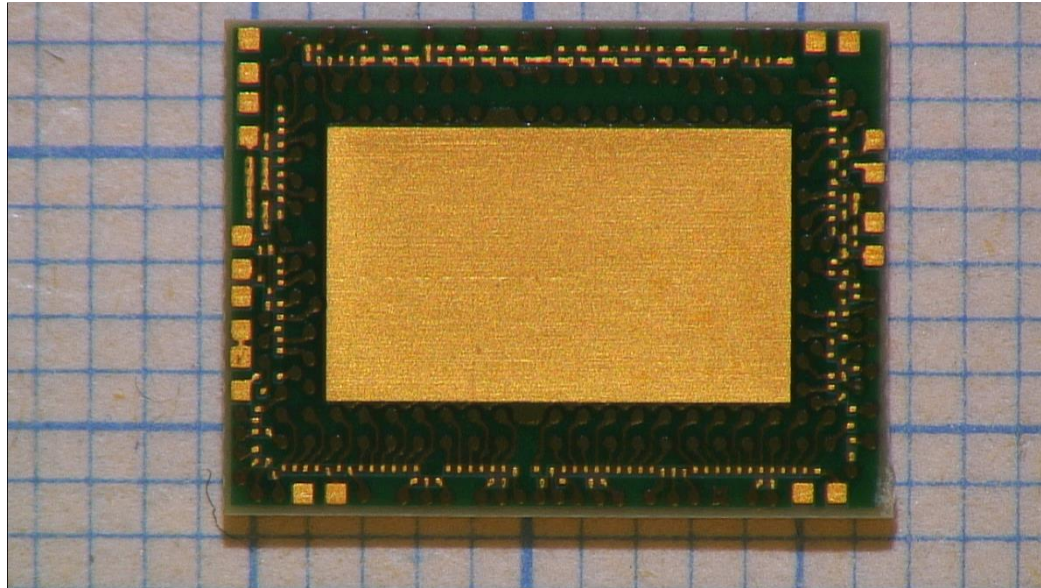
The 7th of January we received 3 naked carrier board which will be carefully investigated

- Make a list of what the various pads should be connected to and check that this is the case
- Check again carefully the design of the carrier board
