Status of the carrier board

17.3.2016

Leif Jönsson
Lund University

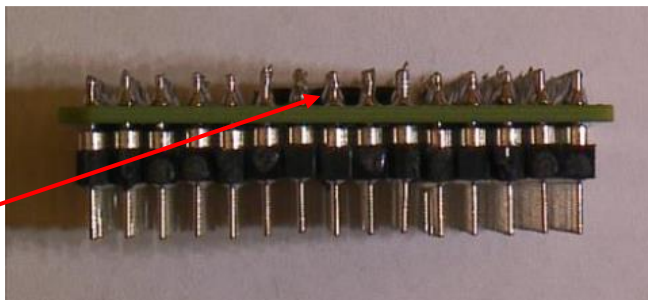
Carrier board; bottom view with tin balls in BGA pattern

The first test of the carrier board mounted on the adaptor board showed that one data line didn't have a connection. This was the only error found. The first test with readout was otherwise promising.
