# Investigations of the long-term stability of a GEM-TPC

Oleksiy Fedorchuk  
FLC TPC group  
2016, Hamburg

# Goal of the Study

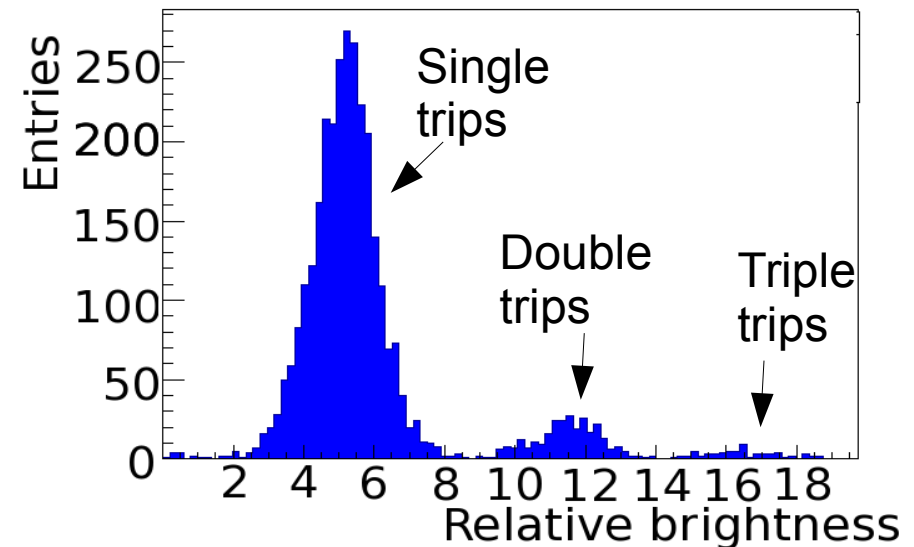
## Discharges light intensity

- **observe multiple discharges: They happen in different sectors (within one time frame of 33ms)**

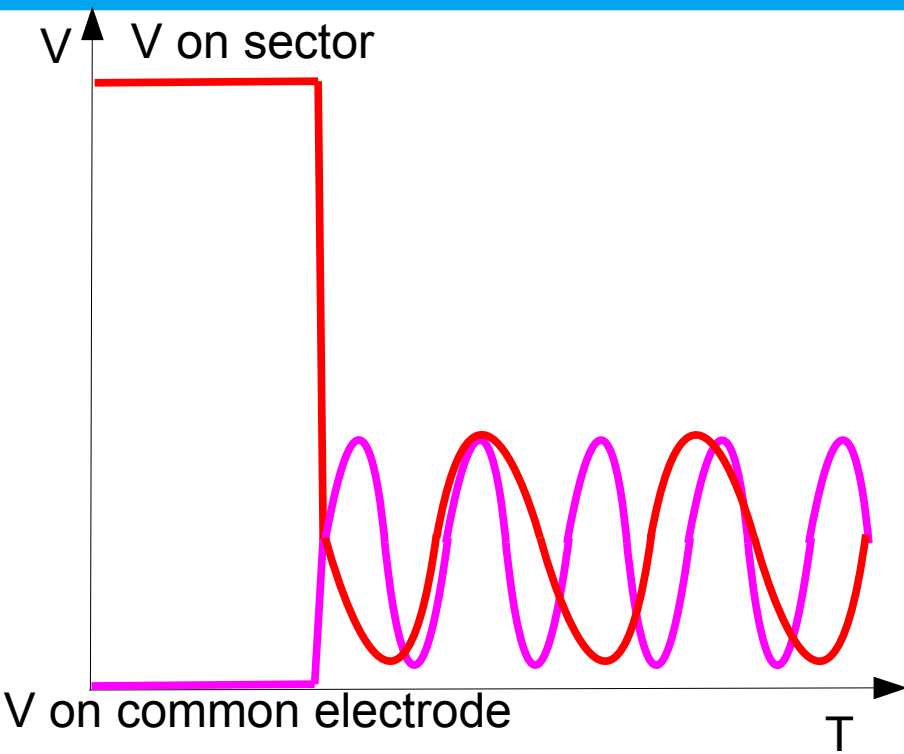
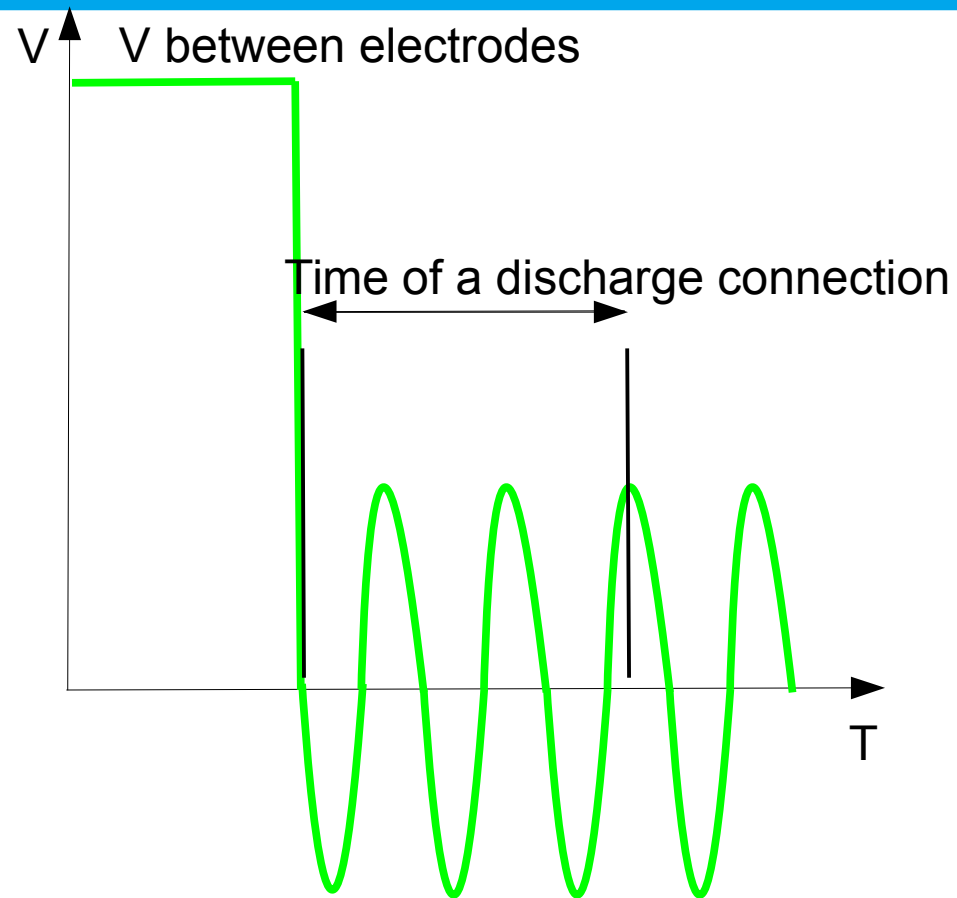
# Idea of oscillation destruction influence

- If time of a discharge connection is higher than oscillation period ( $\sim 10\text{ns}$ ) then we have a current oscillations in discharge channel during a discharge.

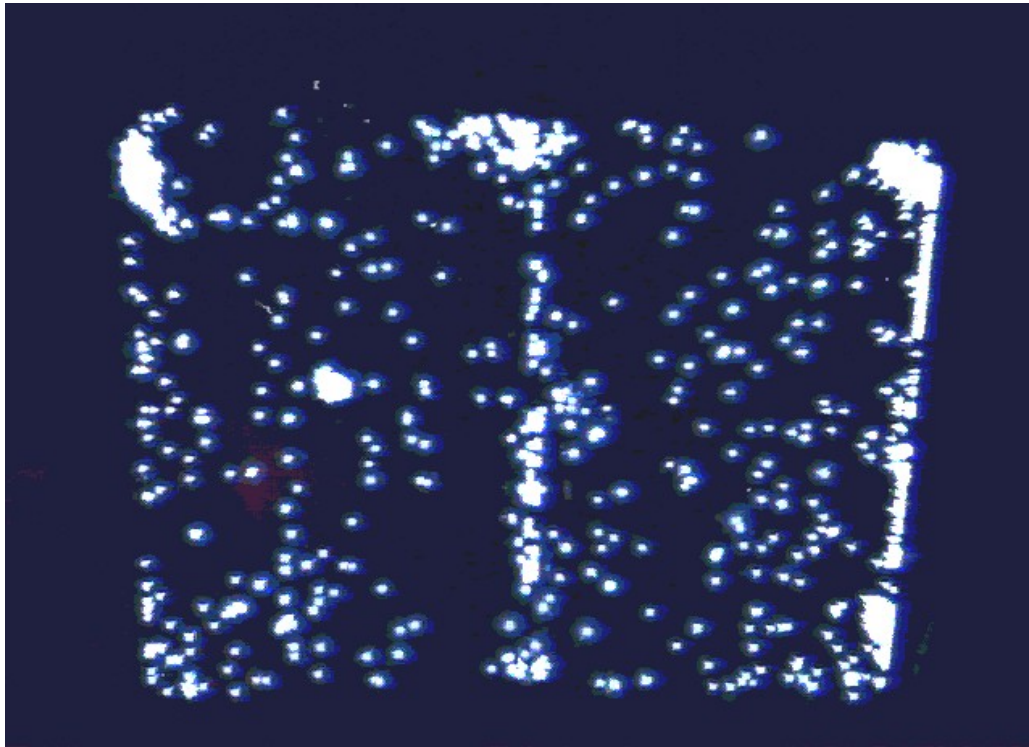
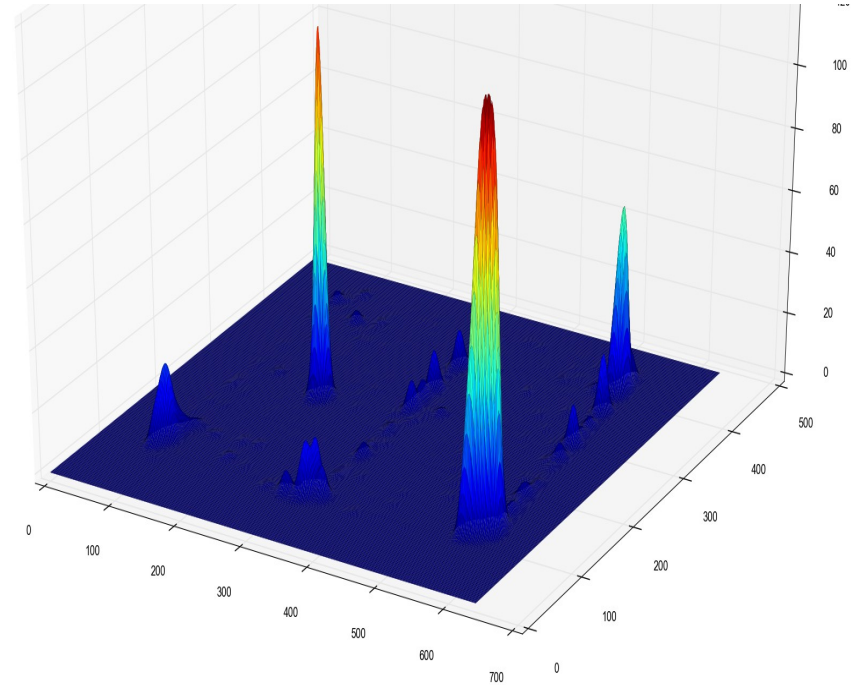
# Results for 4 sector GEM

- have done a long term study with a full sector and with additional protective circuit
- have observed  $>10,000$  discharges
- still no damage
- test continues to run

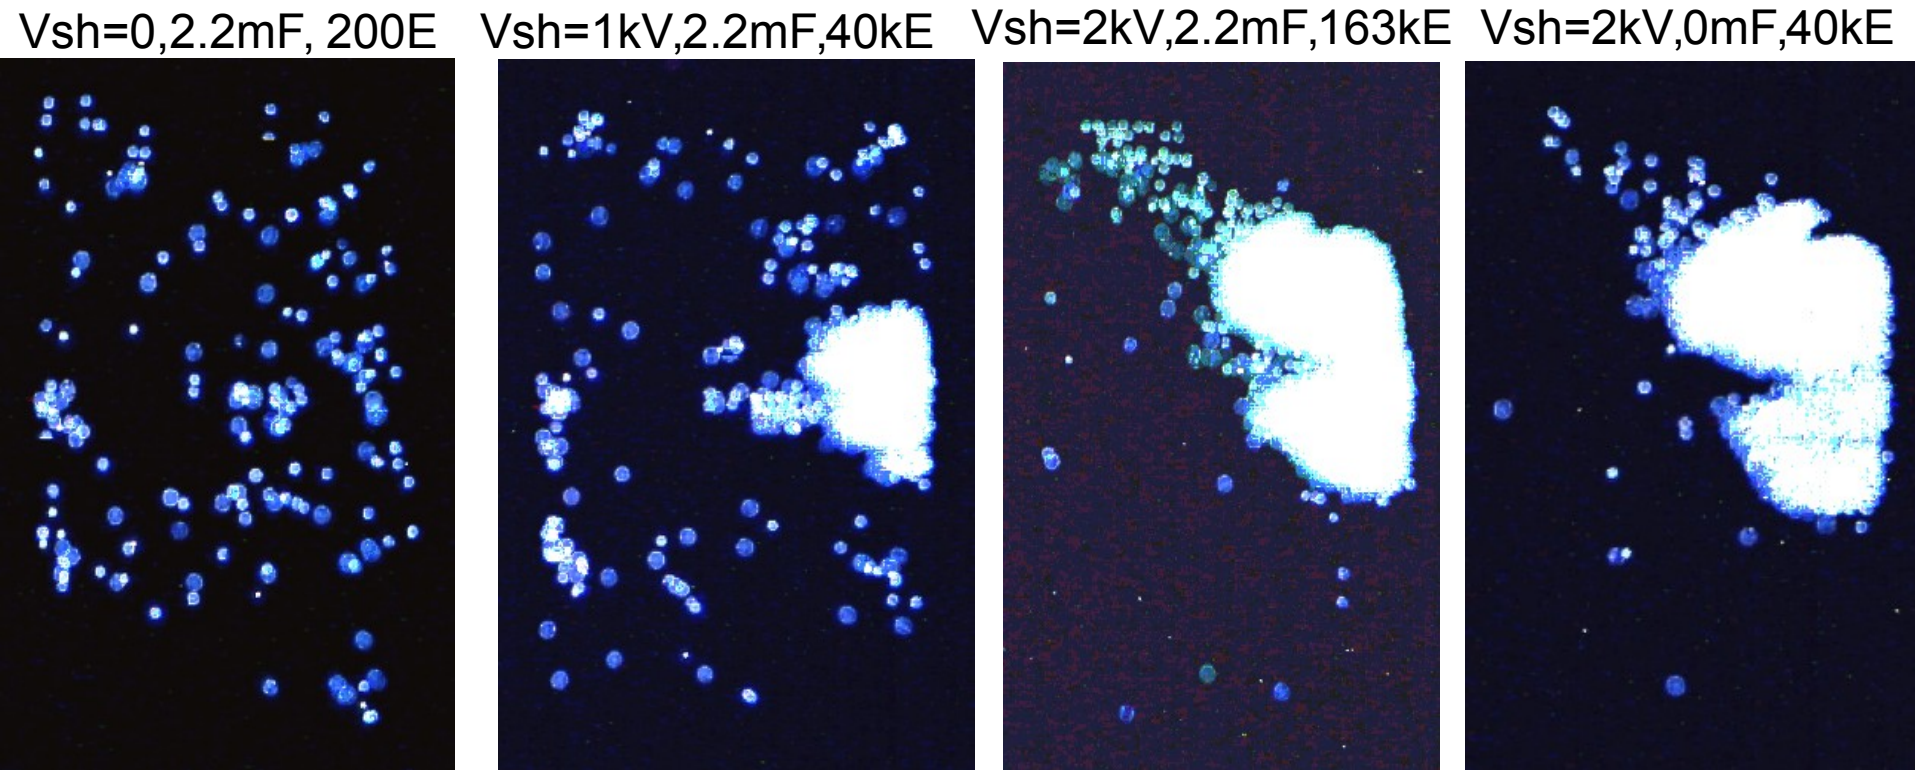
# Results ([http://desy.de/~fedorch/Trip\\_animation/](http://desy.de/~fedorch/Trip_animation/))

## ➤ Why did the sector not burn without protection?

- Is just a luck? Very robust sector
- Influence of the burned area?

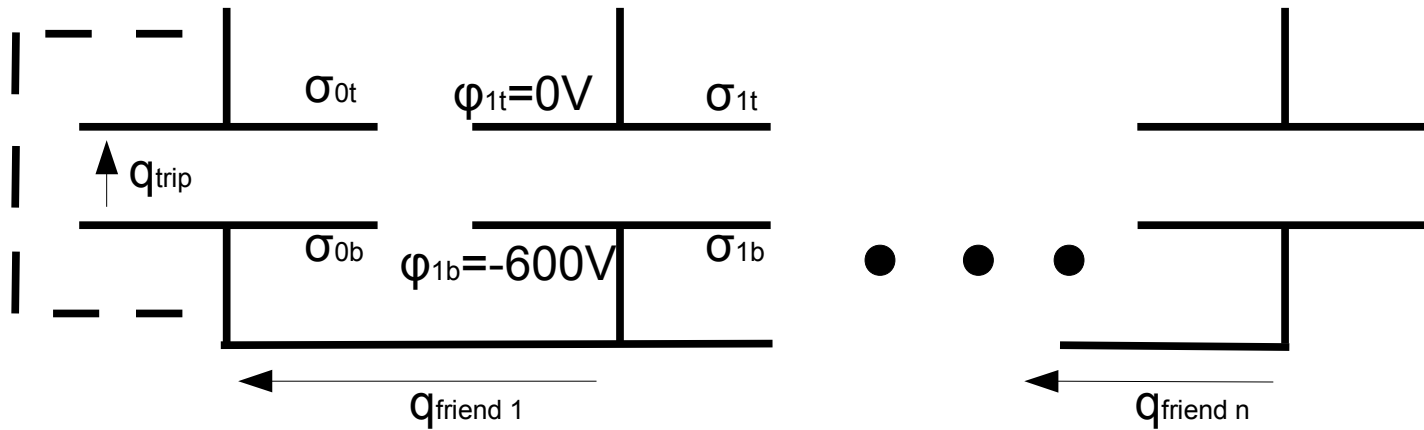
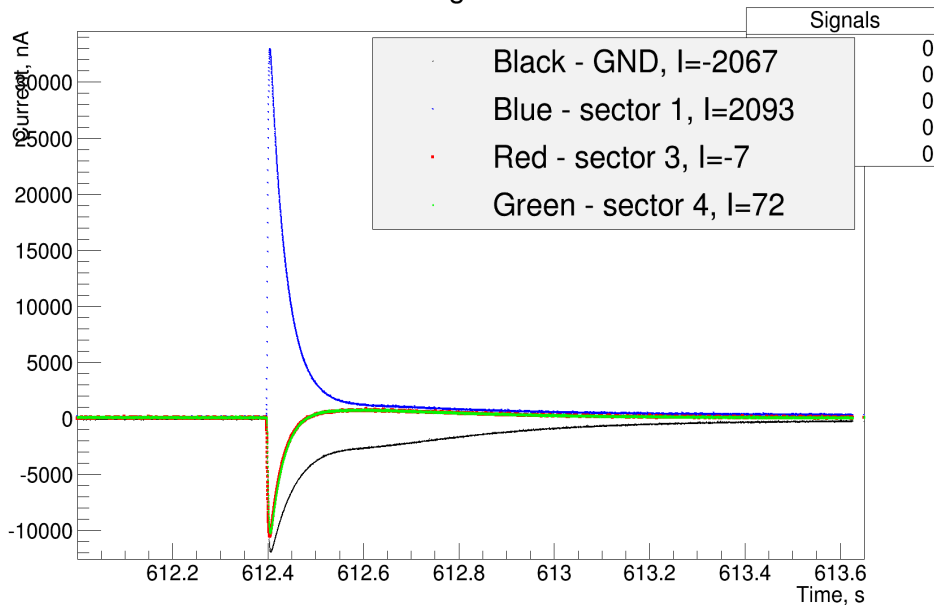
# Usual trips

- Electrode spectators shows total zero current
- Splash and tripped electrode has opposite sign and equal value of charge exchanging
