# Sensor delamination

On behalf of the SiW ECAL Groups in CALICE:

CALICE Meeting – October 2022

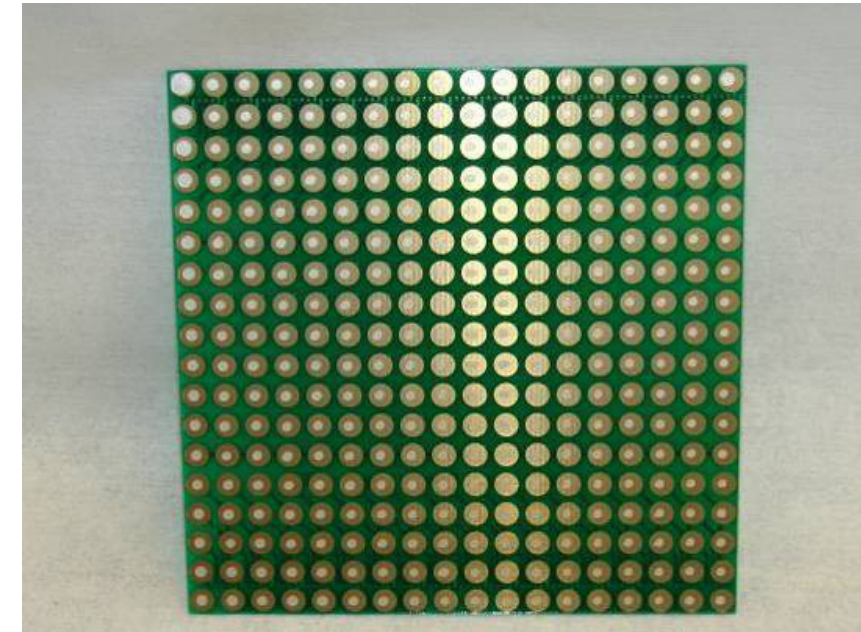
- **PCB bending during cabling ?**
  - Heat may cause deformation of PCB that in the long run pull on the glue dots
  - => Carry out some fake cabling with existing material in next weeks

- ... and measure the PCB dimensions after each step
- **Surface issues ?**
  - Production PCB were also used (before) intensively on test benches
    - => degradation of (gold) coating on PCB

- Reaction between glue dots and PCB and sensor surface
    - Will inquire with glue producers
    - Will try to produce fake (unprocessed) sensors with Al coating similar to “real” sensors

- With these sensors we can produce fake ASUs for mechanical tests
- **Quality of glue ?**
  - Glue is two component material. Has the correct mixture been observed?
