S0 Status

Ongoing Activities

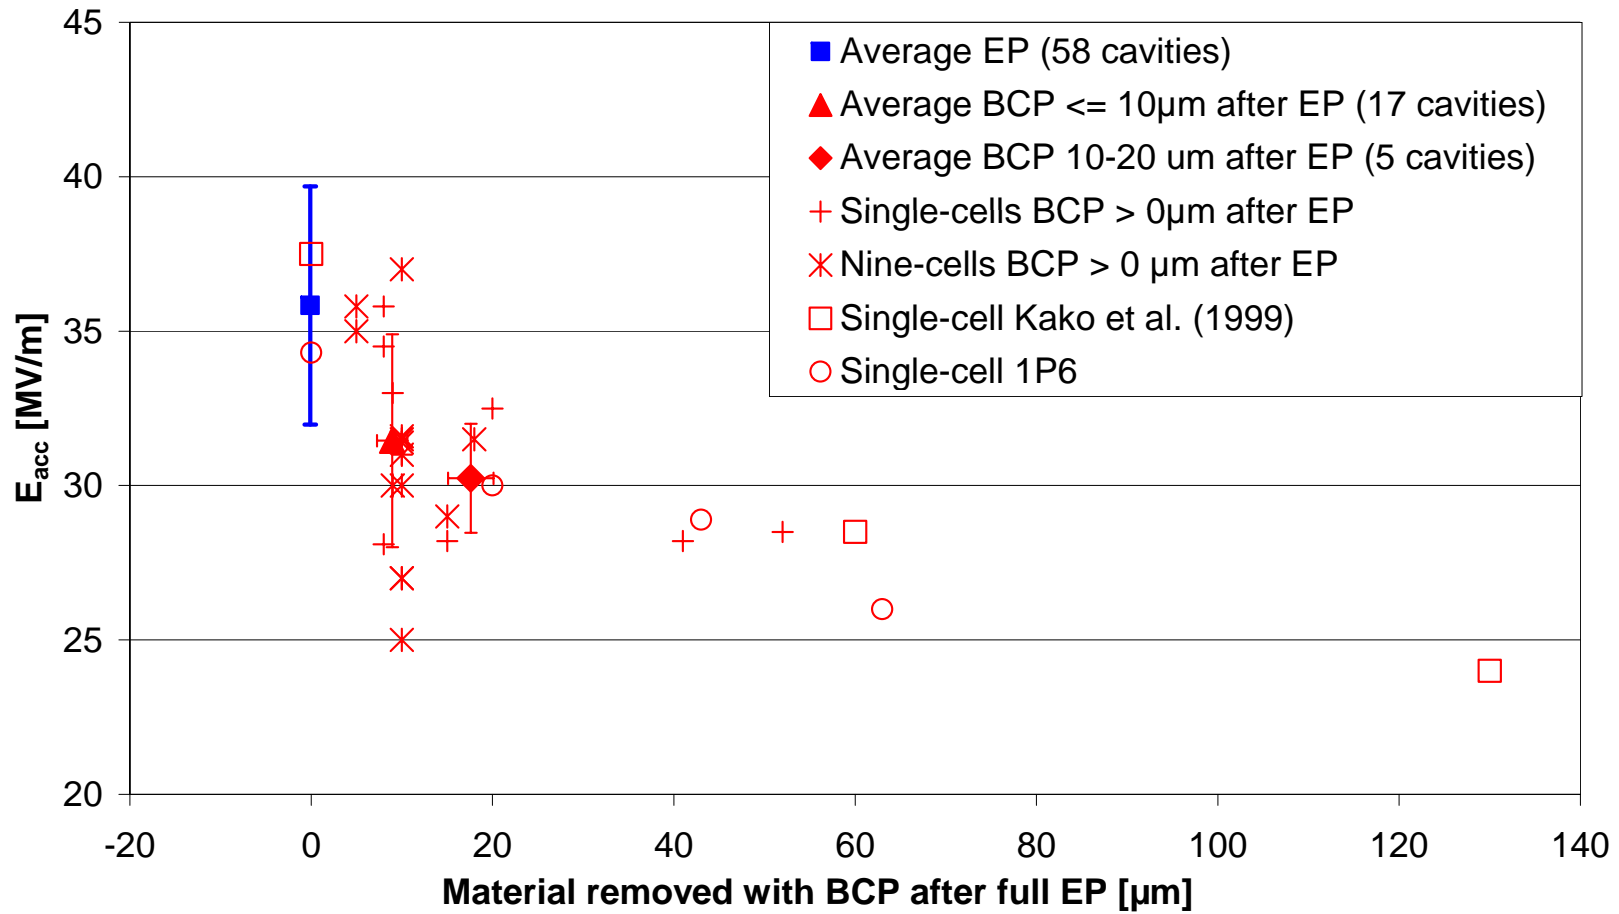
Etching after EP

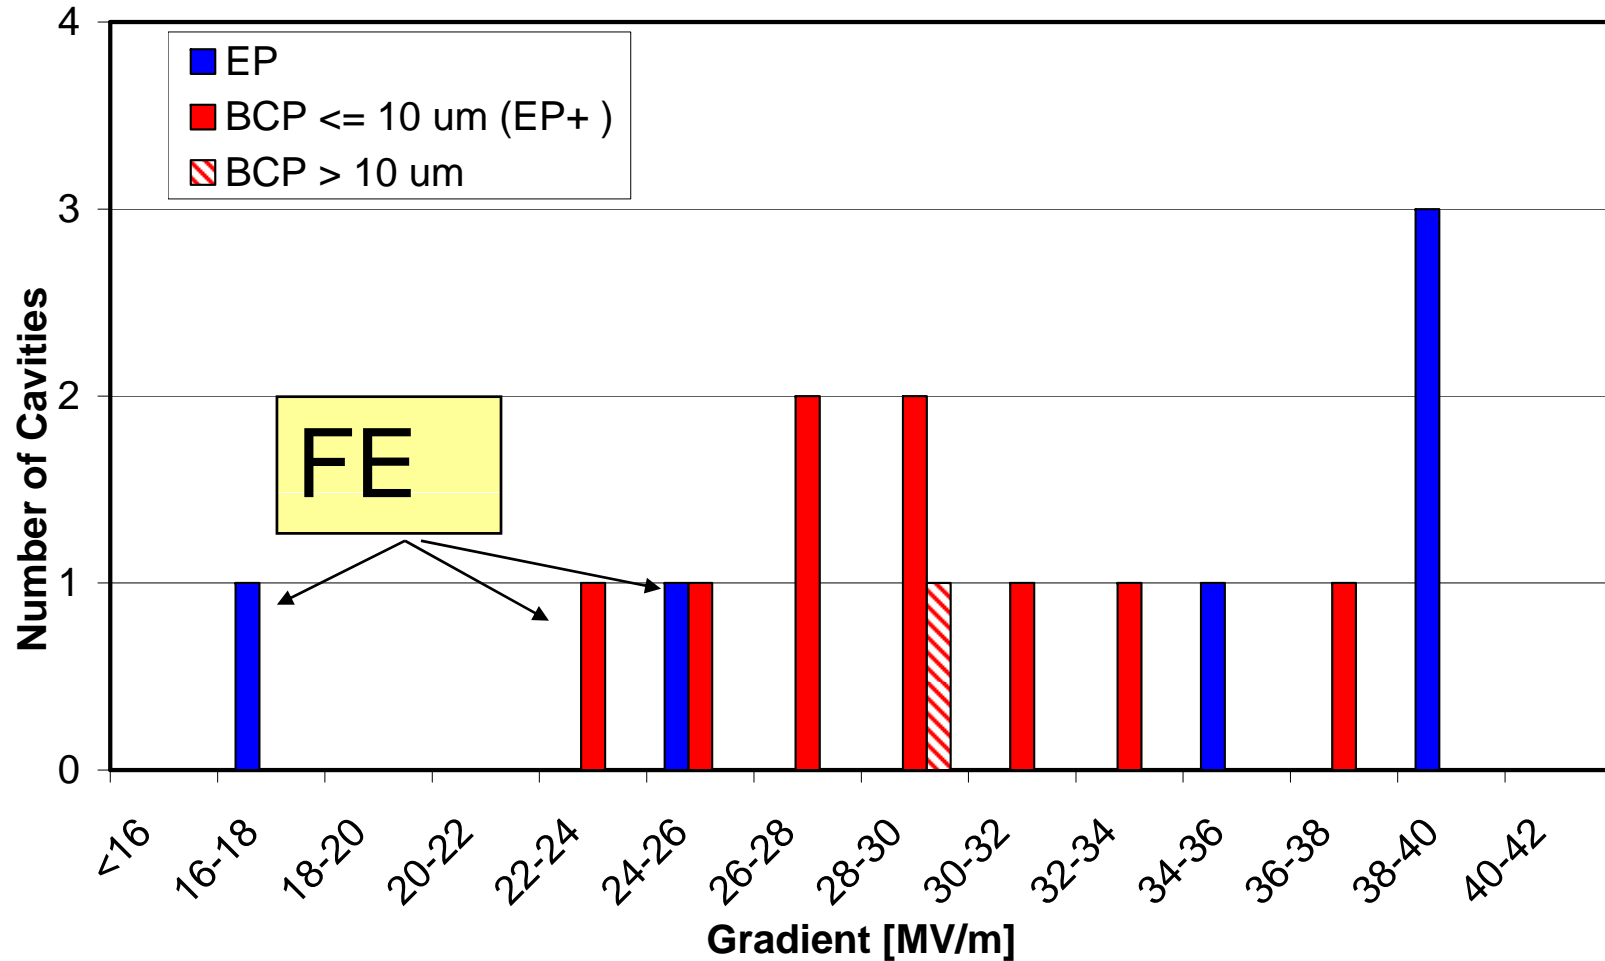
Comparison of Etch and EP as final treatment

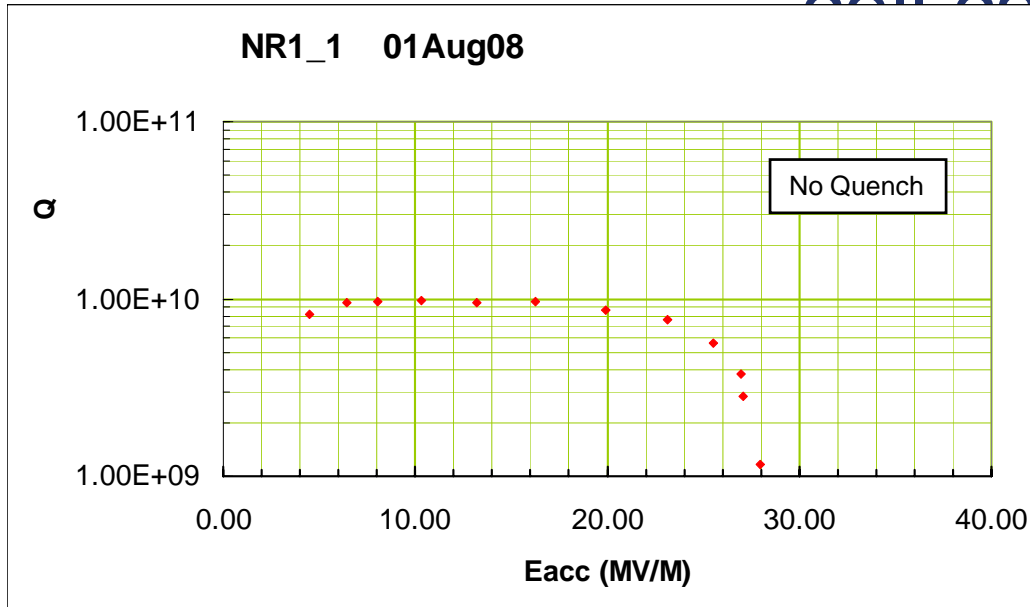
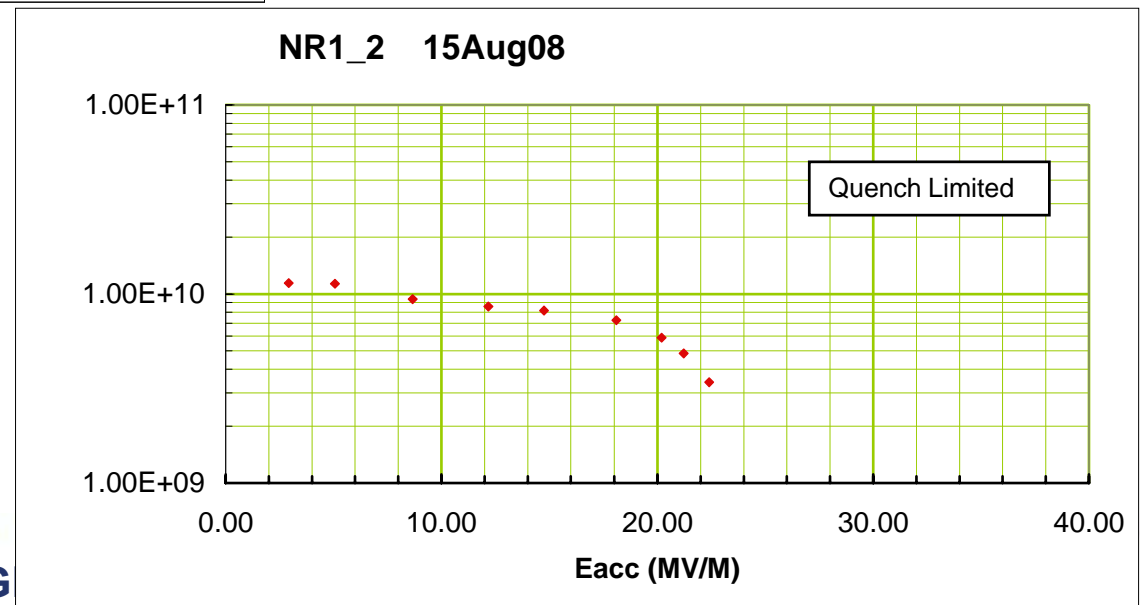
qualification of Niowave/Roark single-cell cavities

- Second-sound technique used to determine quench location near equator
- Cavity interior will be inspected for defects

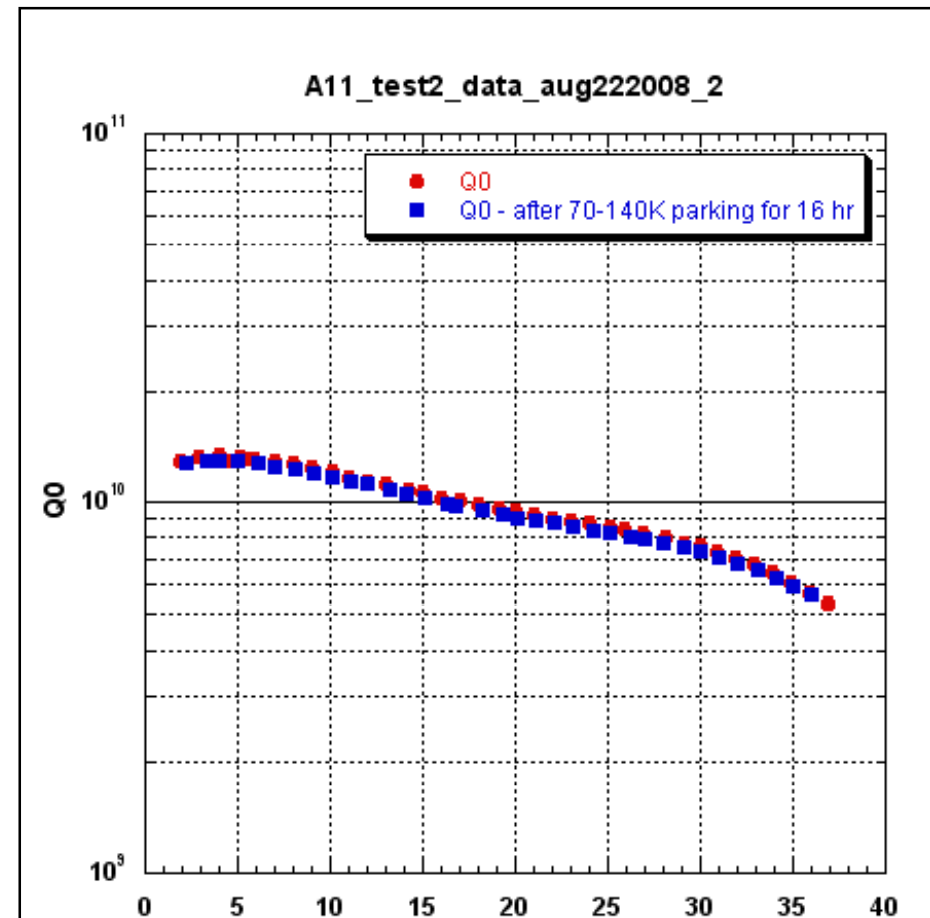
- Q-disease has been ruled out for the low Q observed in A11 (see graph). Some magnetized hardware is found in A11 testing; some elevated residual magnetic field is observed in testing dewar. We have solutions to these issues and plan to re-test A11.
- First RF test of J2 (one of the JLab built new fine-grain niobium 9-cell) reached 30 MV/m. A Q-drop beginning at 26 MV/m was observed. This is correlated with a less-perfect bulk EP. We will perform a T-mapping test next and then another light EP. The cause of less-perfect EP parameters is under investigation - focusing on finding possible water leak into the acid.
- A12 is under preparation for cleaning and assembly and shipping to FNAL under vacuum.

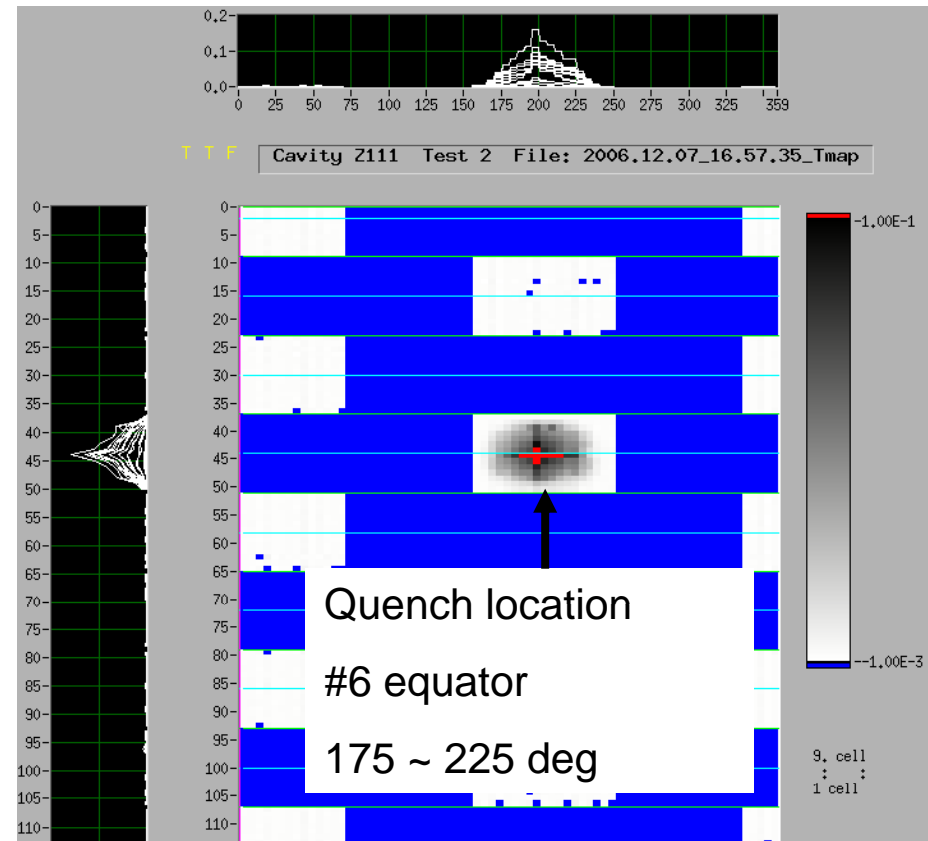
T-map data in test 2, 16.0 MV/m

group of beads(?) with 1.5mm wide were observed.
