GDCC status

GDCC specification

GDCC board

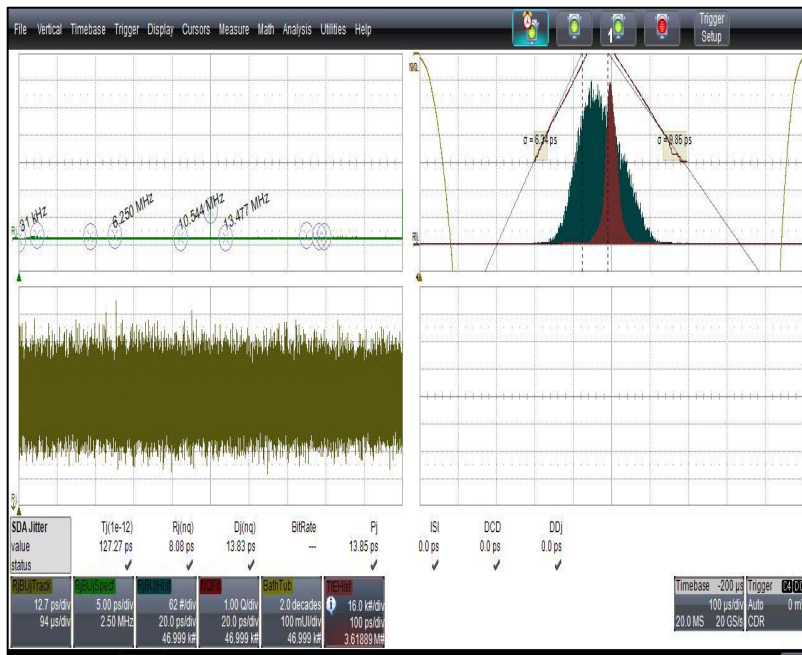
Clock at the output of GDCC

- Some results of signal integrity
