AHCAL Electronics

Status of HBU, EBU and SM_HBU

CALICE meeting Annecy, Sept. 10th, 2013

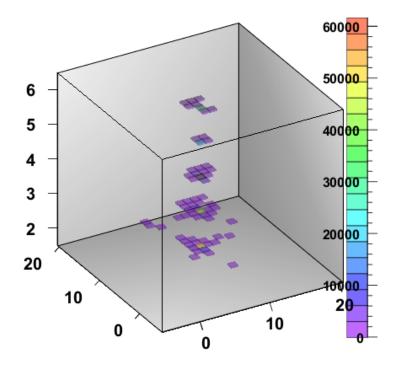
Shower in 5 AHCAL layers (DESY testbeam)

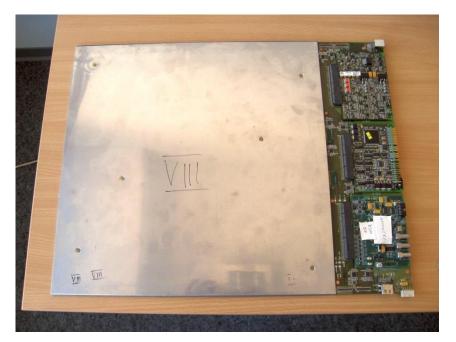
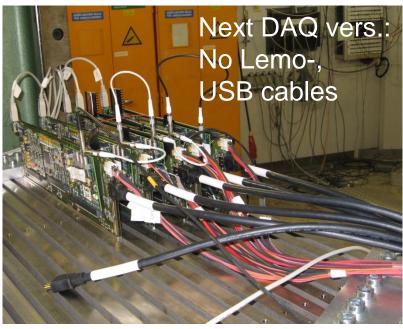
AHCAL operation in ILC-like environment

- Operation for the first time in steel cassettes with final dimensions and in absorber stack.
- No increased noise, no obvious shift of MIP position with respect to lab setup.
 => dense EUDET mechanical concept validated!

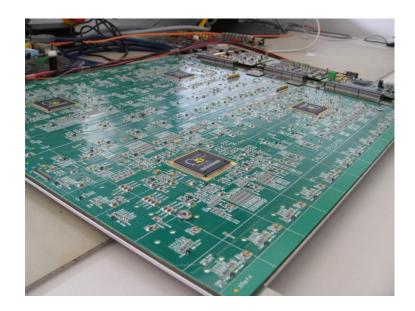
New 8 HBU2 boards

- All 8 new HBU2s have been tested and work fine.
- Problem: Significant spread of board dimensions within the 8 boards. Landmarks differ up to 0.4mm (0.1mm was specified).
- Problems during PCB assembly and with the steel cassettes (individual cassettes needed).

From the discussion with PCB manufacturer: For the next order, there will be a pre-compensation process step for the inner pcb layers before the pressing operation. This will solve the problem as it did for the first 6 HBUs.

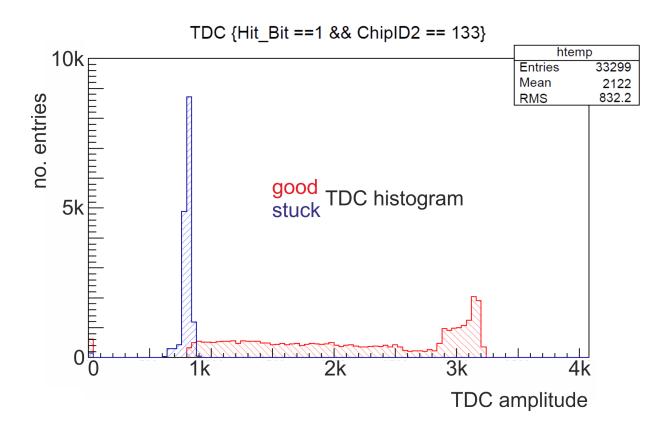
Detector Power-Up Problem

- Arbitrary operating conditions in multilayer setup (very seldom in single-layer setup): Stuck TDC, spontaneous noisy channels, shifted MIP position.
- > SPIROC reset does not help, only re-powering helped.

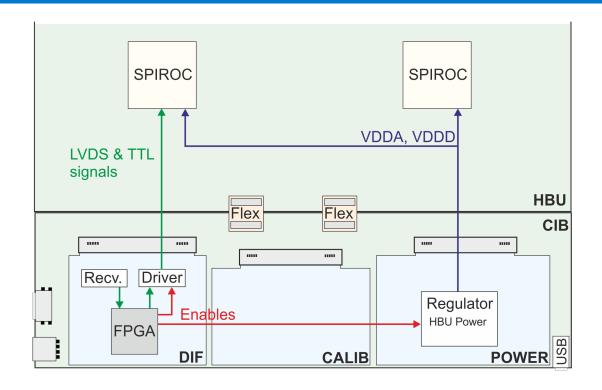
Solution for Power-Up Problem

- Problem identified: After power-up and booting, the DIF FPGA sets TTL lines to SPIROCs before enabling SPIROC's power. => SPIROCs get power through protection diodes of input channels.
- New switch-on order cured the problem.

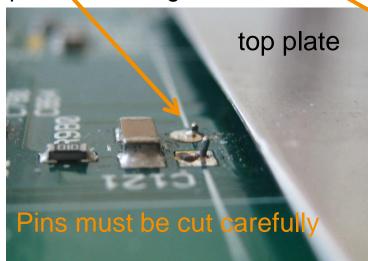
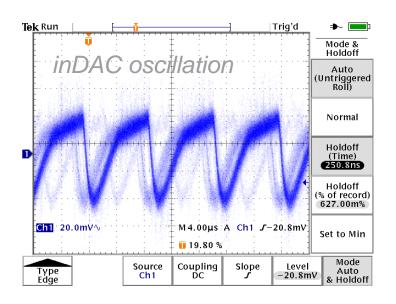
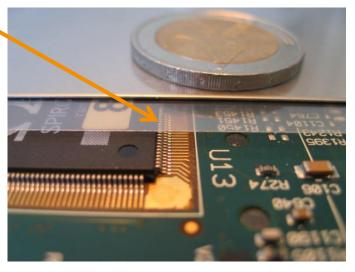
Broken SPIROCs in testbeam

- During testbeam 6 out of 20 SPIROCs on three HBU2s have been damaged.
- Damage is the same for all chips: oscillating input DACs.
- Best explanation so far: SiPM pins have damaged the isolating foil and touched the steel cassette's top plate. => Stronger foil ordered.

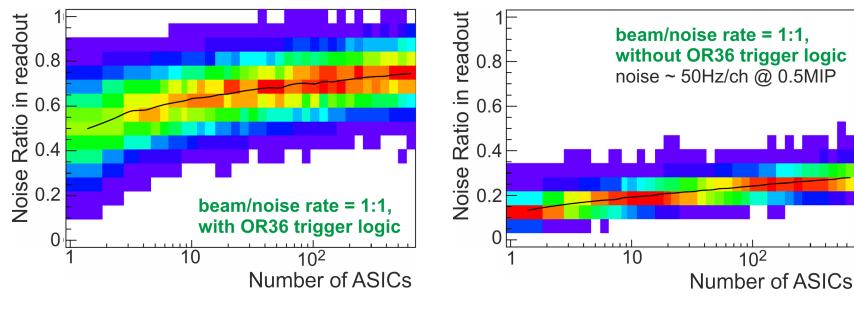
Beam rate to noise rate considerations

Can we operate 1m³ (~600 SPIROCs) with current SiPMs and ASICs?

- Simulation studies of beam/noise-rate started to investigate the amount of noise events in the AHCAL detector for various operation conditions.
- Exponential distributions for noise- and beam rates assumed. Different trigger architectures and memory depths under study.
- > First conclusion: First memory cell problem (ADC data "0") must be solved (low occupancy in last layers). Was solved for SP2c already.

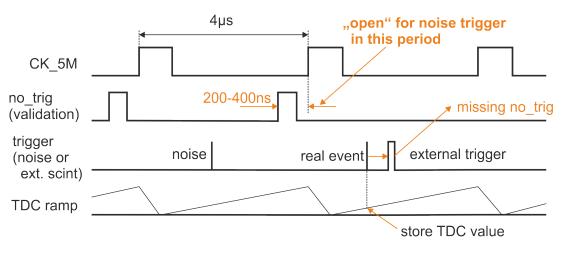
Trigger Validation (Testbeam mode)

Only stores events that are validated by an external trigger signal

- Validation works fine: Histogram only shows MIP events without noise/pedestal contributions.
- Problem: Validation does not work for noise hits between no_trig and rising CK_5M edge (200-400ns). Triggers in this period should be rejected (=> dead time).
- Now: Factor 10 noise reduction. Improve 400ns window size.

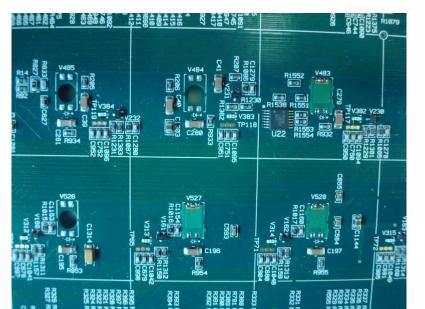
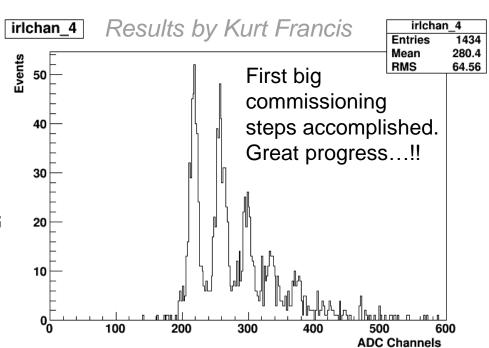
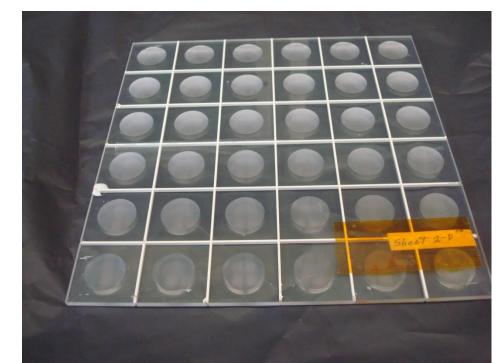
Integrated Readout Layer

- Uses HBU2 FE
- Hamamatsu MPPC mounted on small flex circuits
- Scintillator "Megatile" with 3 x 3 cm cells optically isolated with white epoxy
- Cells have a concave dimple improve the uniformity of the response and to direct light through hole in board onto MPPC
- Easier to assemble, does not need WLS optical fiber

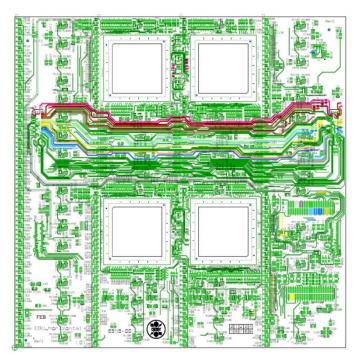
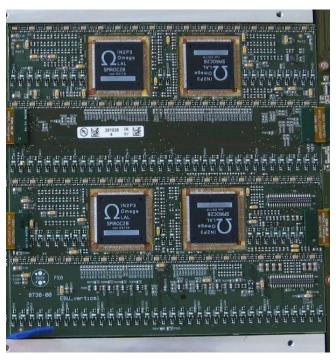
EBU status (ScECAL)

- EBU-vertical (right): 4 boards realized
- EBU-horizontal (left): 4 boards in production, expected beginning of October:
- Final ScECAL module assembly from Shinshu at DESY in close coorporation.

EBU-horizontal requires long flexleads for EBU/EBU connection (in layout design).

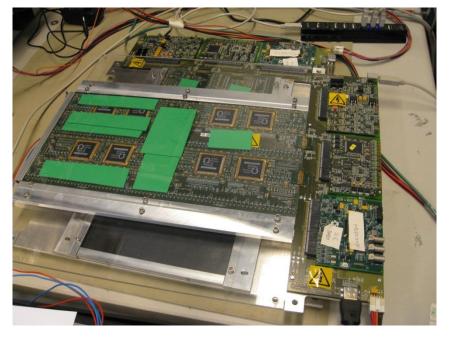
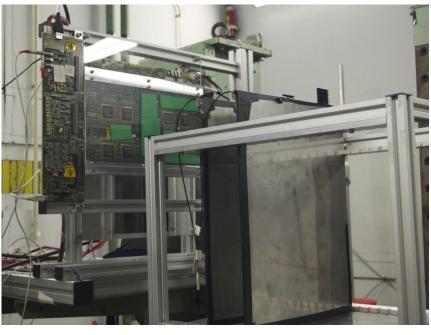
EBU status (ScECAL)

- 2 ScECAL layers in lab, perpendicular strip orientation
- 1 setup with 2 EBUs in a row,1 setup with 1 EBU

- Two ScECAL layers with two AHCAL layers together in DESY testbeam, operated synchronously and together by the AHCAL DAQ.
- For results see Shinshu talk.

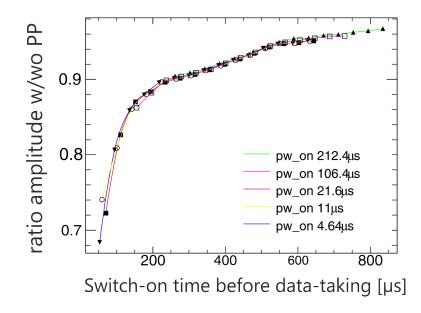
Power and Power Pulsing (PP)

- Aim: Switch on as short as possible before data taking starts (initial idea: 20µs).
- Results with charge injection show a decreased amplitude response with PP.
- Single-Pixel Spectra measurements show a reduced amplitude with PP.
- Aimed power dissipation of 20µW per channel not reached yet.

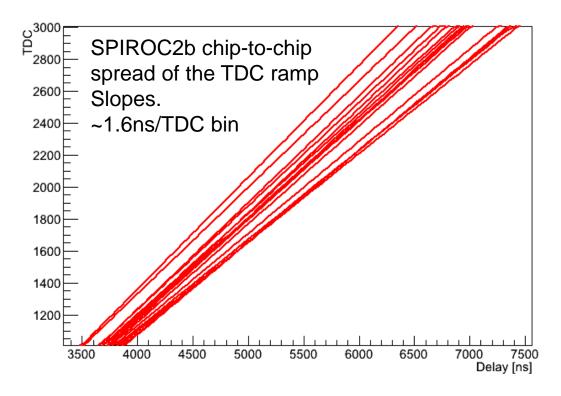
TDC Calibration – CERN Module

- Calibration of all 16 SPIROC2b ASICs of the CERN Testbeam-module with charge injection.
- Chip-to_chip spread of the TDC ramp slopes: Calibration necessary: TDC (time measurement!).

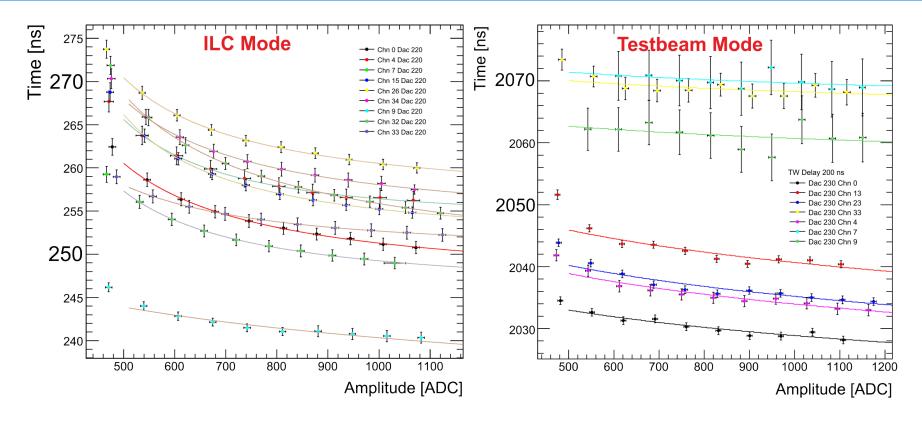
TDC: Time Walk and Channel-to-Channel Spread

- > Amplitude-dependent time-shifts and channel-to-channel differences.
- Difficult to parameterize because of different behaviours. Channel-wise TDC calibration necessary as for ADC (MIP calibration)?

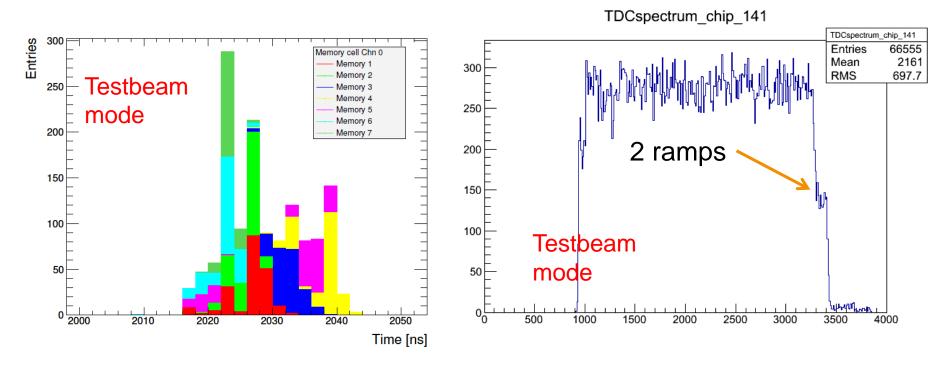
TDC: Memory Cell Dependence and "2-Ramp" Problem

- TDC result depends on memory cell
- The SPIROC2b internal TDC ramps have different amplitudes and for a specific event it cannot be identified with which ramp the TDC result has been achieved (known problems).

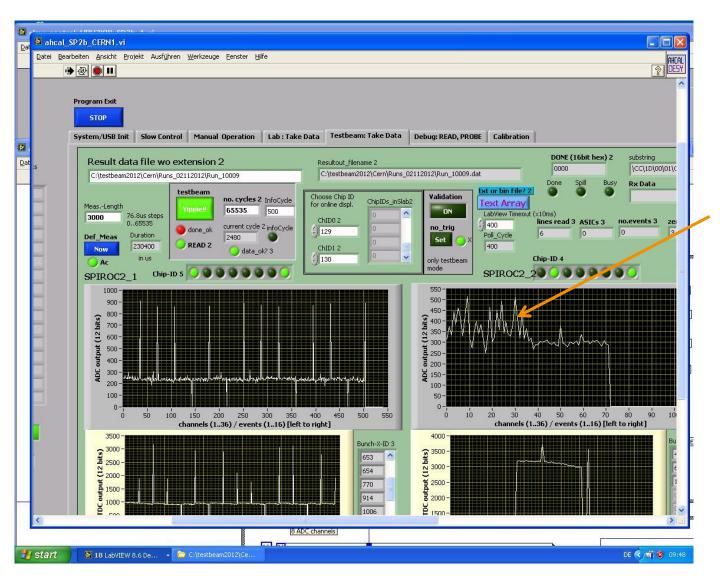
Start-Run Problem

CERN testbeam

High noise on pedestal for first 1-2 readout cycles

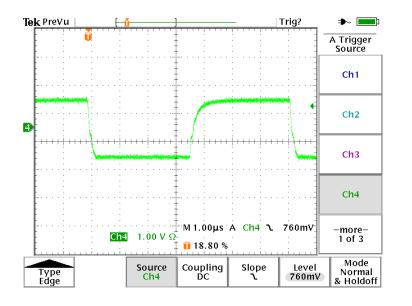
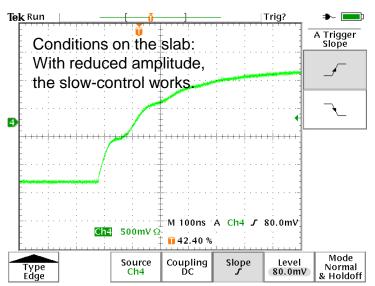
Slow-Control Problem

For longer AHCAL slabs, the slow-control programming is instable. Reason: Slow-control clock, special pulse-shape needed (series R, termination R, block-C)

- Although the slow-clock looks fine, the configuration does not work.
- Analysis ongoing, I2C in SPIROC3.
