Jlab Electropolish Update 8/30/06

J. Mammosser

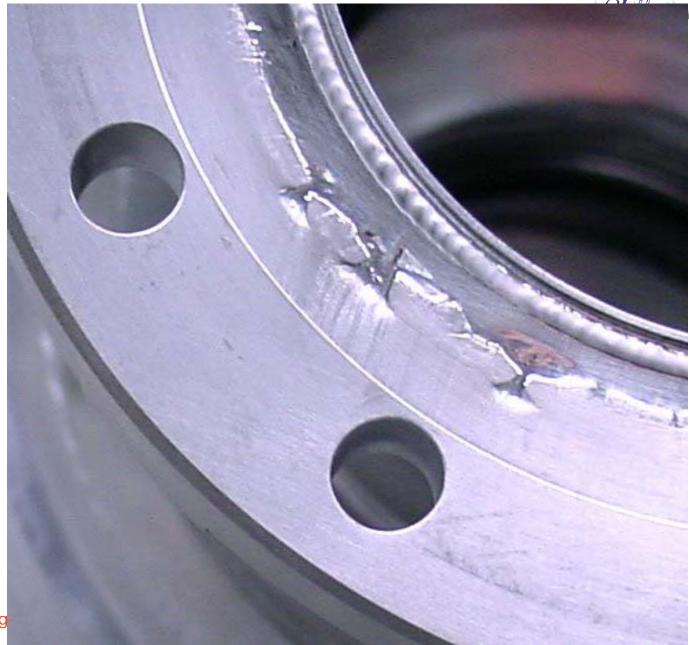
- During the bulk chemistry I discovered a problem with the beamline seals which resulted in multiple leaks during the chemistry and heavily damaging the beamline flanges
 - Round seals were used which left a gap at the flange ends
 - Endgroup areas were electrically shielded to reduce etching in the endgroups
 - This allowed for low current density in these areas and caused flange gaps to be most likely in active dilution instead of polishing
- Problem was solved for final chemistry with increasing the cathode surface area in the end-group area
- Flange sealing surfaces were mechanically polished to recover them

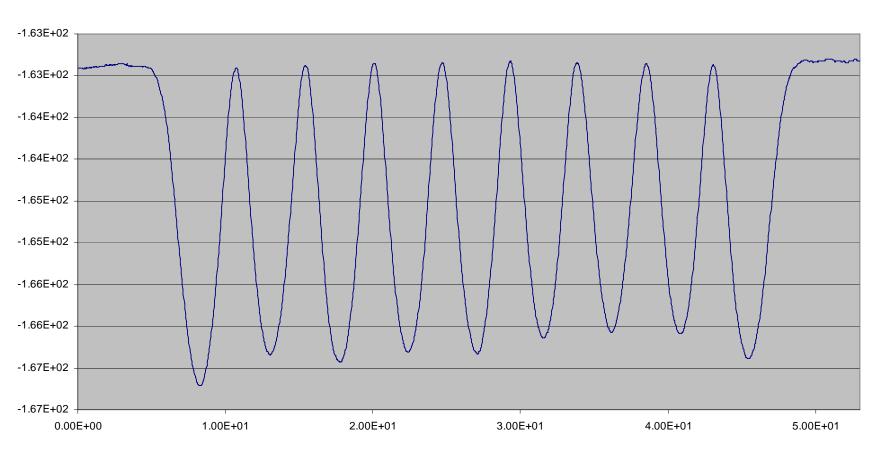
A6- as received from Accel

CW Freq = 1298.961 MHz 08/30/06
