CLIC Fabrication

International Workshop on Future Linear Colliders (LCWS19), Sendai, Japan

Summary

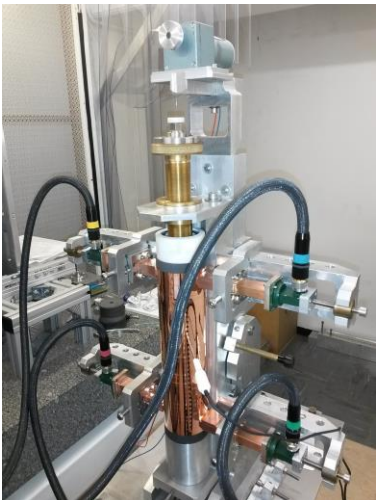
Bead Pull measurements before bonding are better than we usually see. Phase advance (N1) nearly fulfils the requirements after tuning. Due to extremely good quality Also due to the good alignment and RF contact of the tooling.

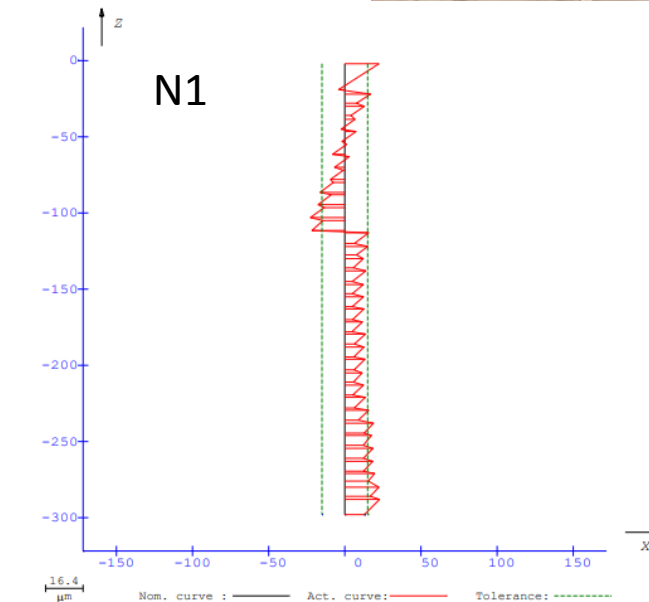
TD31 – N1 and N2

- Diffusion bonding executed at Bodycote (FR)
 - 1040 °C x 1h 30 min x 0.06MPa x H2

✓ No banana effect
Reduced disc to disc alignment

! Straightness: 46 μm
A bump during transport

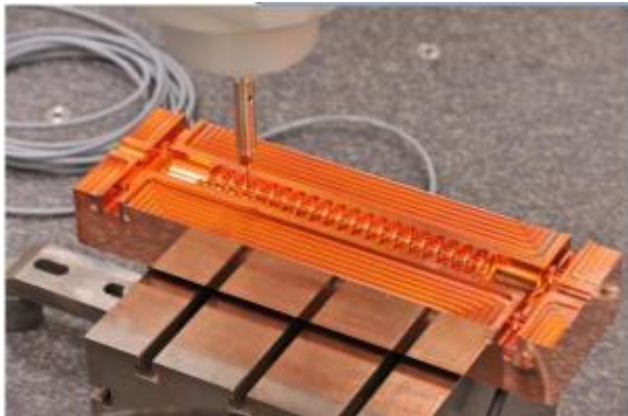
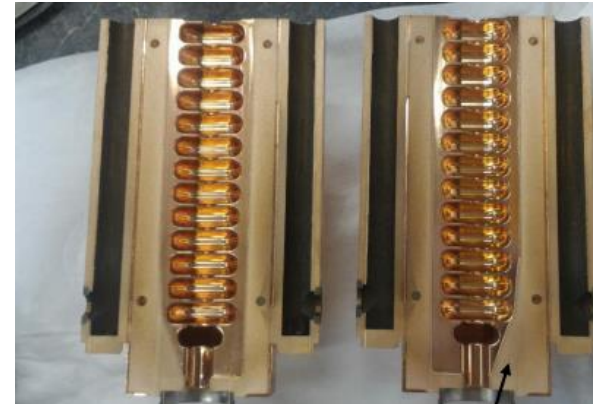
Halves

- Long development process:
 - First trial (bonding - CERN): Good RF before bonding. After bonding, a gap between the halves (10-200 μm) and a shift between the irises of 70 μm (systematic error)
 - Second trial (brazed – SLAC): A gap between irises was introduced to minimize field of filling material leaking to the structure. Alignment with pins. RF conditioning ok. Breakdown activity near the brazing region.
 - A third trial (brazed through irises – SLAC): not yet tested but there is a visual misalignment between the irises.

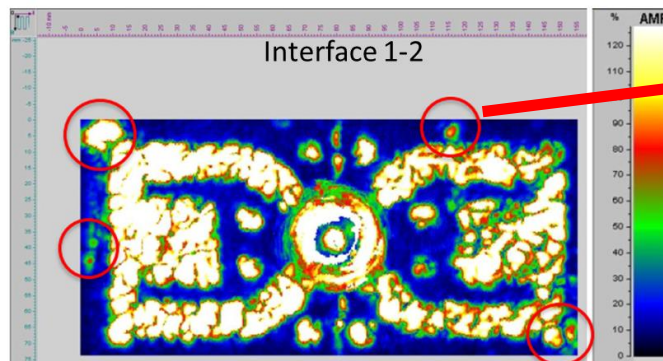
Rectangular discs

- First trial successful at 95% (it was leaking)
 - Caused by the SiC geometry
 - Not related to the bonding problem: the SiC was copper coated.
- Second trial successful at 99% (it was not leaking)

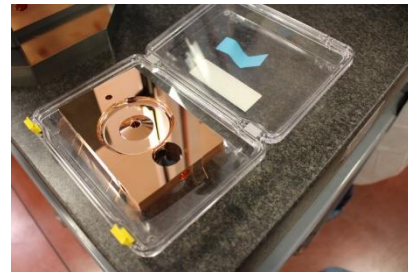
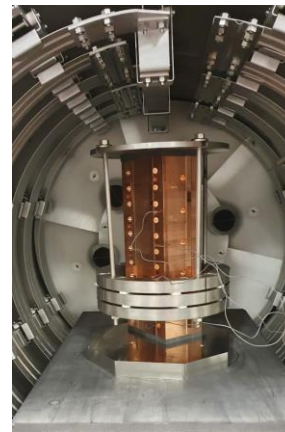
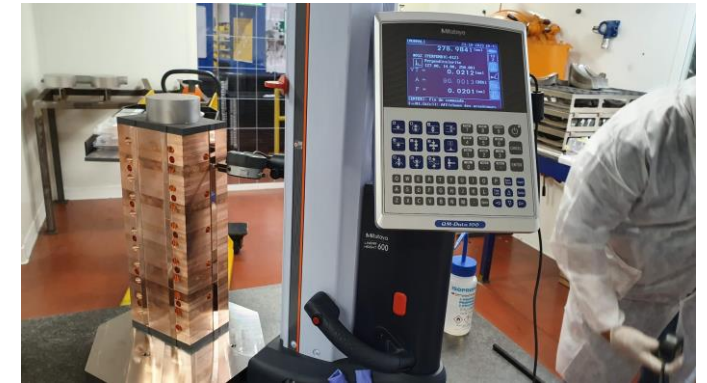
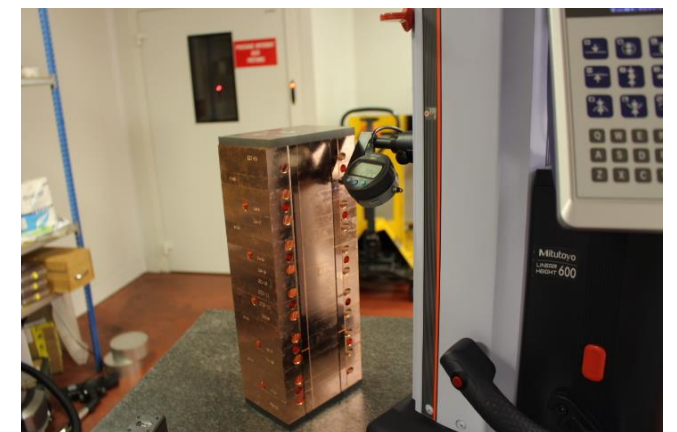
Rectangular discs

- Lancaster University PROton Boosting Extension (PROBE) structure
- High gradient (54 MV/m), side coupled, standing wave, S-Band for Proton Computed Tomography (pCT) scan
- Bonding done. Leak test after brazing of components.
- Straightness of 25 μm

- TD26:
 - N1: Post-mortem finished
 - N4: Brazing operations on-going
- TD31
 - N1 and N2: Brazing operation on-going
- Bonding issues:
 - The diameter reduction (copper sublimation) of 10 μm is confirmed: 6 structures
 - The shape of the nose is changing on both horizontal (collapsing) and vertical shapes (cone shape)
 - The cells are deforming due to bonding
 - Weight is excessive? Already reduced from 0.1 MPa to 0.06 MPa
 - Temperature is too high?
 - Time is too long?
- Halves: Ready for production
- Rectangular discs: Bonding performed on the PROBE structure. Leak test in following weeks.
