SiPM Saturation Study with UV Pulse Laser

Linghui Liu ICEPP, University of Tokyo CALICE Collaboration Meeting at Utrecht Apr. 10-12, 2019

Saturation of SiPMs

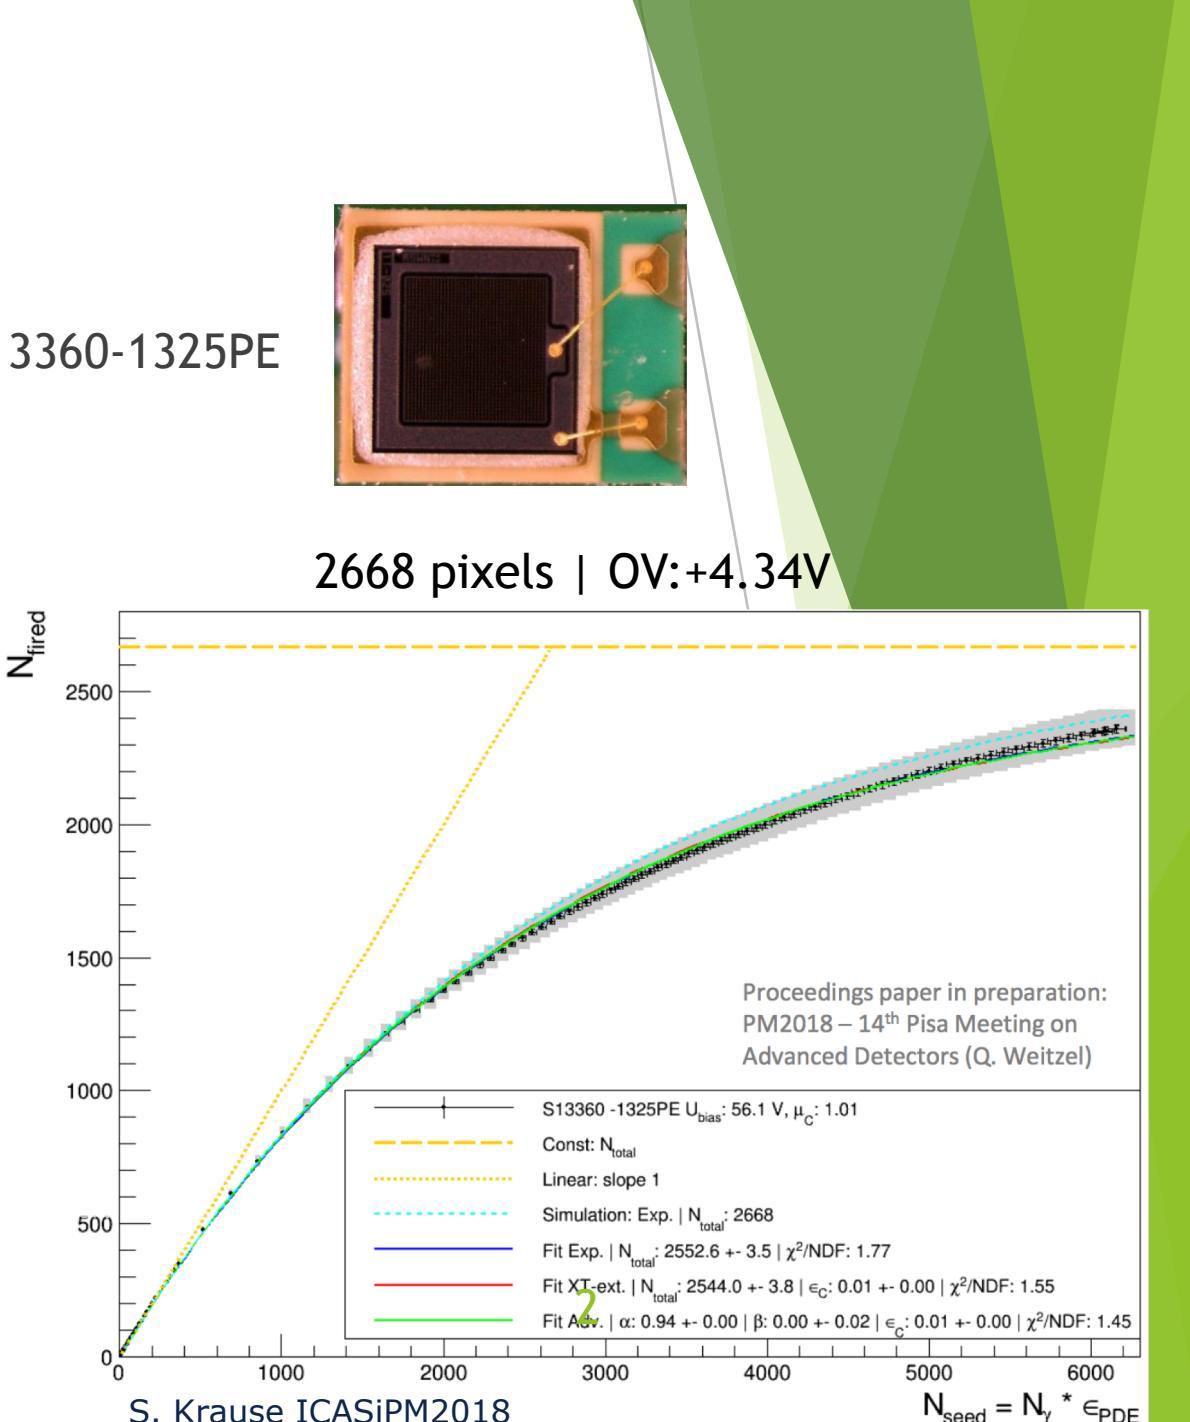
S. Krause ICASiPM2018

- \blacktriangleright Active area : 1.3 × 1.3 mm²
- Pixel pitch : $25 \,\mu m$
- 2668 pixels
- MPPC saturation was already measured in the previous studies using fast ps pulse laser with 467 nm wavelength (S. Krause, ICASiPM2018)
- Time constant of emission of scintillation light (few ns) is not negligible compared to recovery time of SiPM cell (17 ns) Ref: JINST 10 (2015) P10031
 - Expected smaller saturation
- Our idea is to measure the SiPM saturation with scintillation light
 - It can be directly used for saturation correction

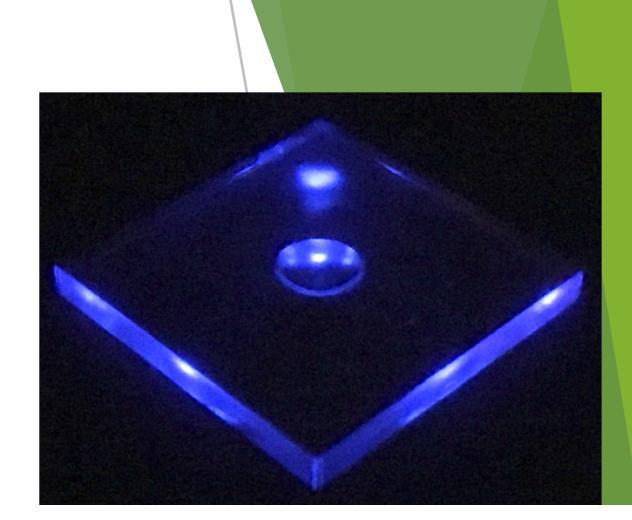
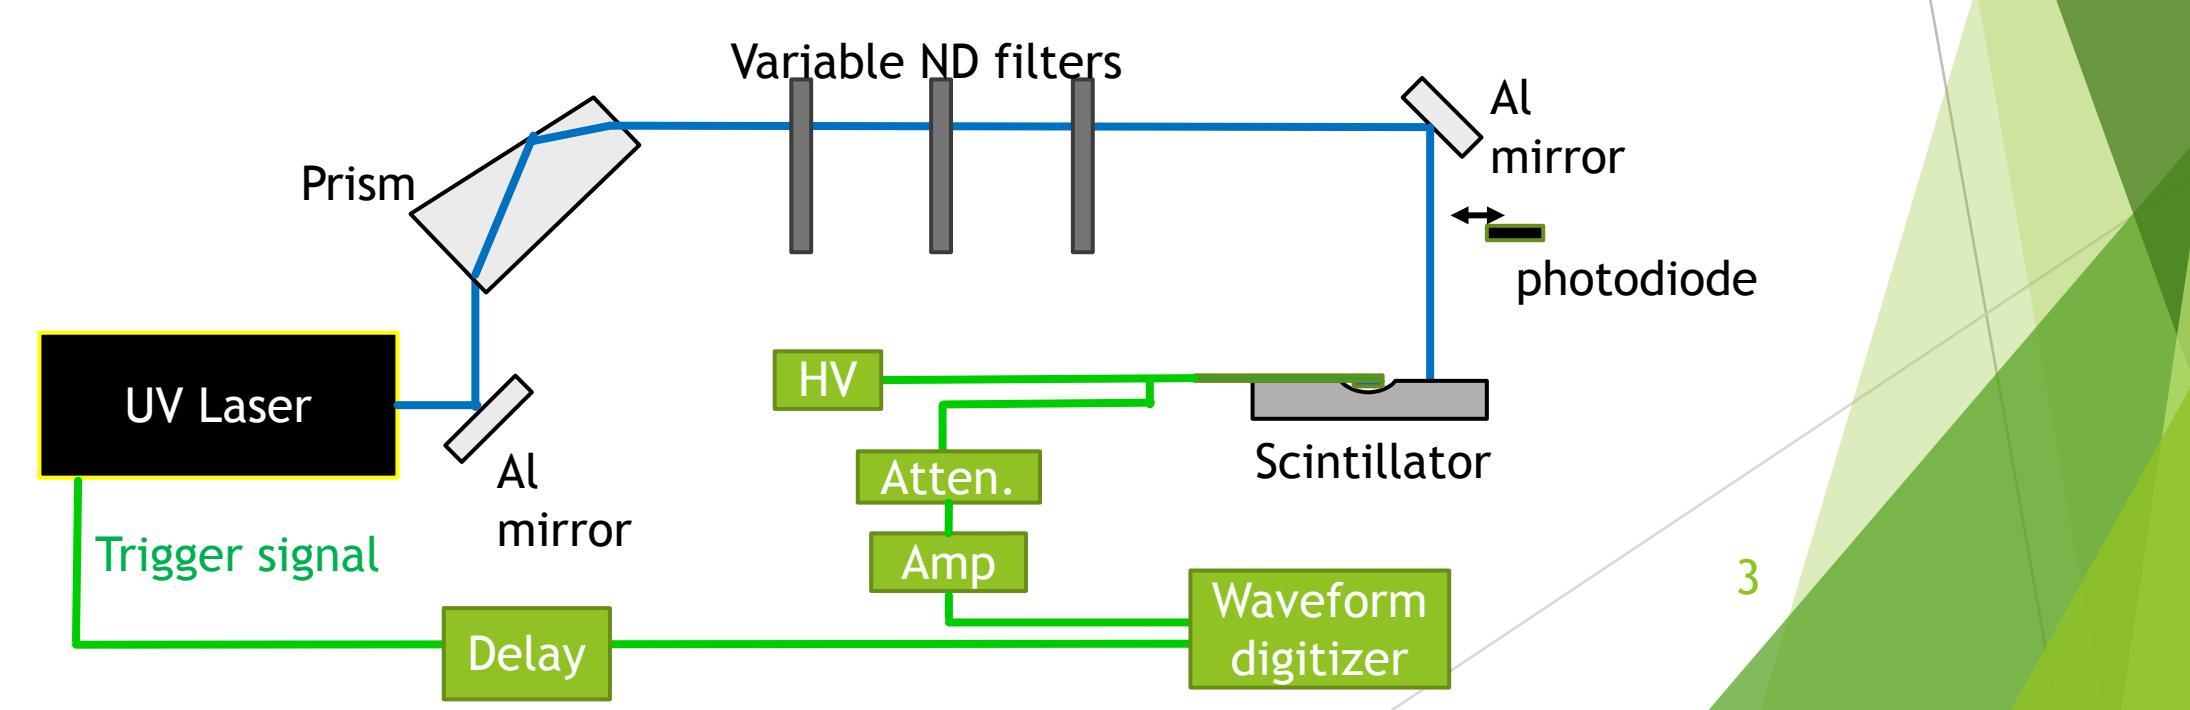
- Excite scintillator with fast fsec UV pulse laser
 - Standard 30 × 30 mm² scintillator tile used for large prototype (provided by a courtesy of E. Garutti)
 - 190 nm wavelength -> invisible to MPPC
 - Different attenuations (10 40 dB) applied depending on the light intensity
 - MPPC S13360-1325PE with over voltage of +5 V
 - Same reflector as in large prototype (3M Vikuiti)

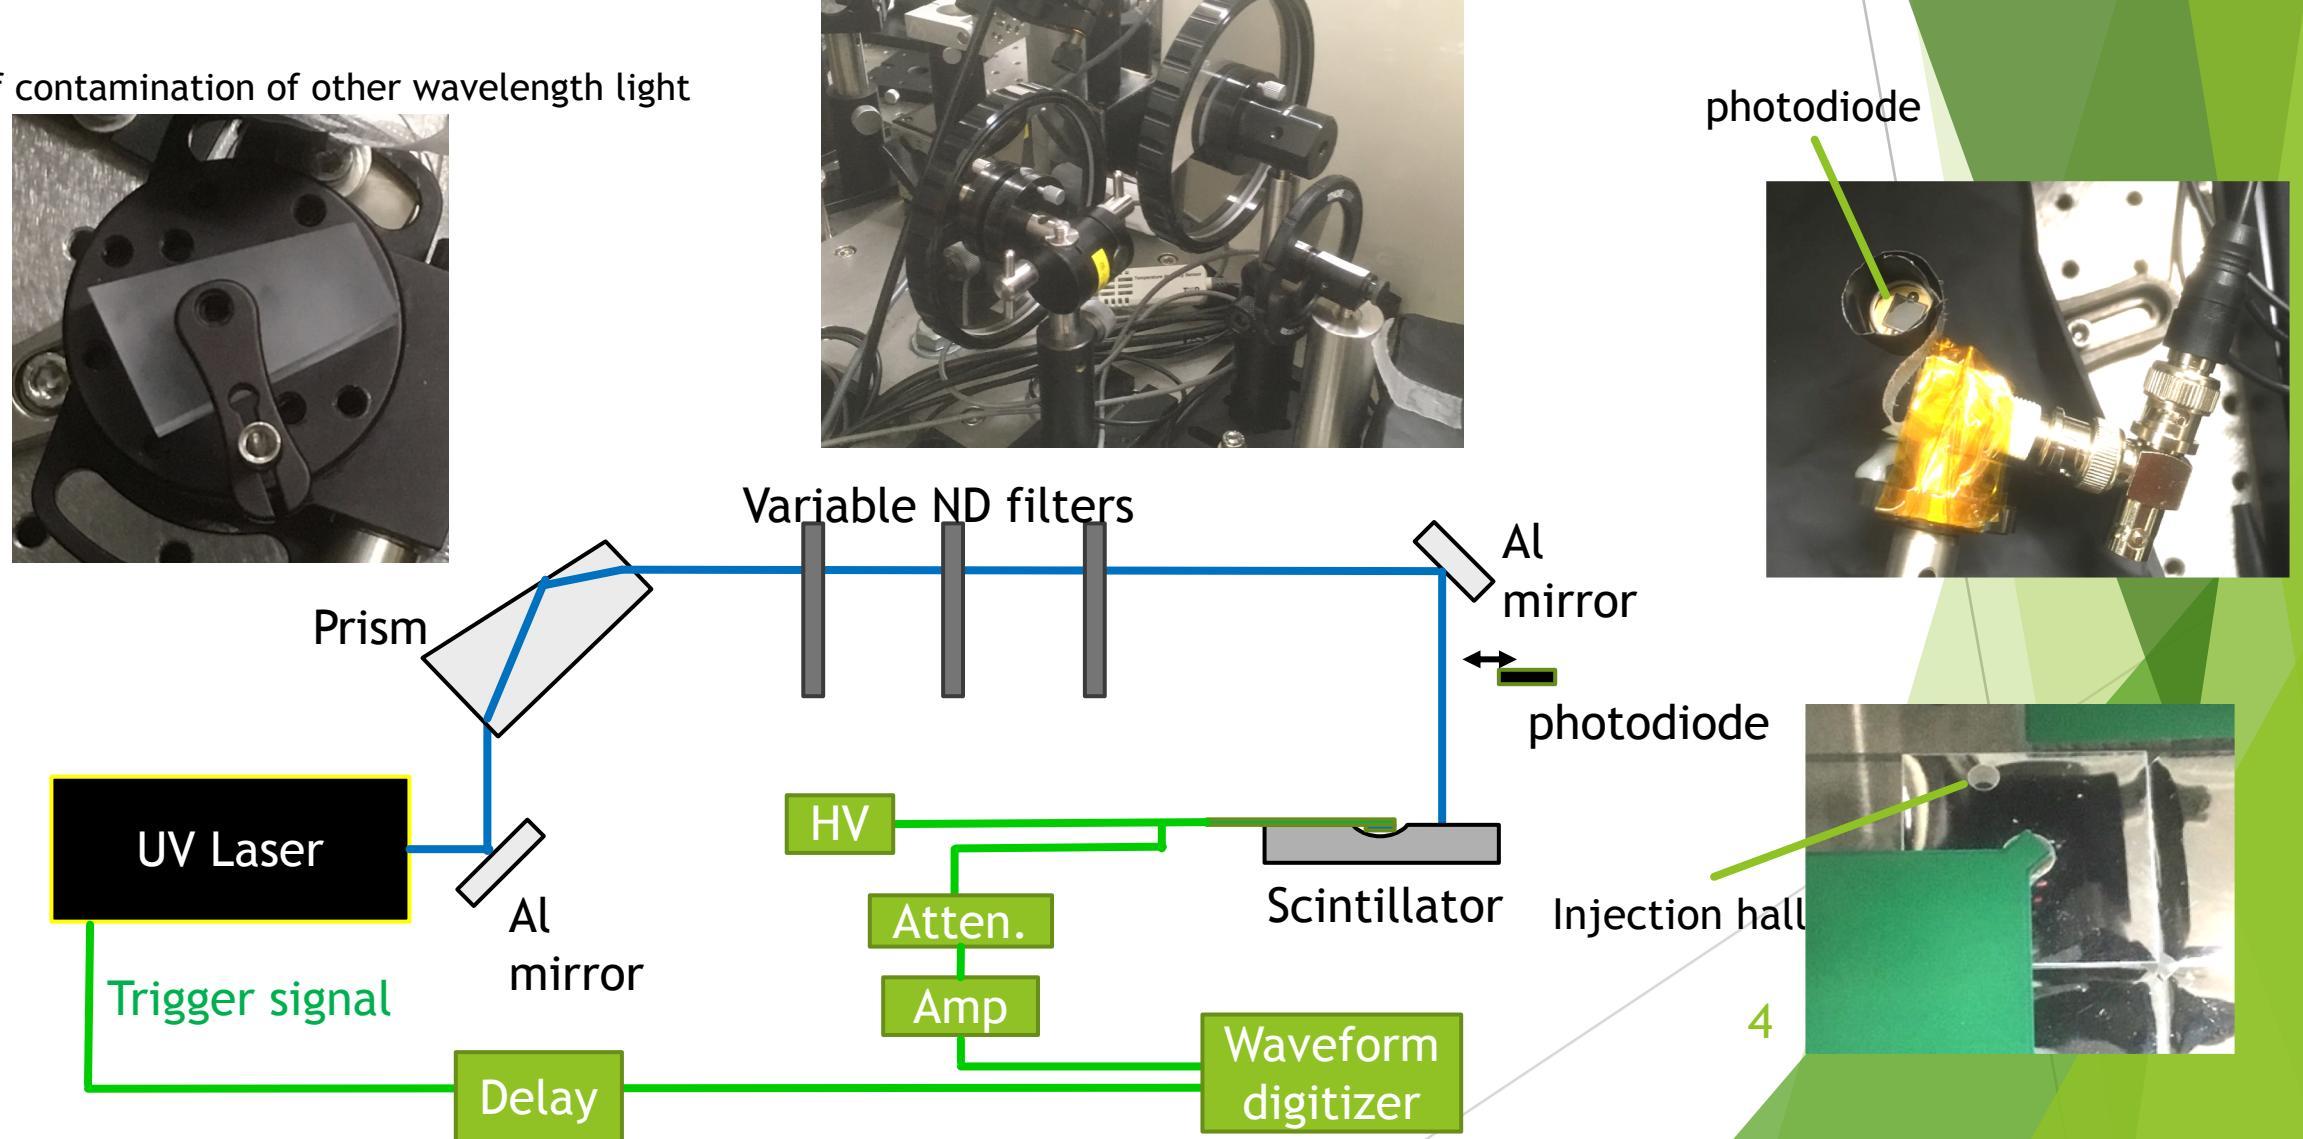
Experiment Setup

Cut off contamination of other wavelength light

Incident light intensity controlled with three ND filters

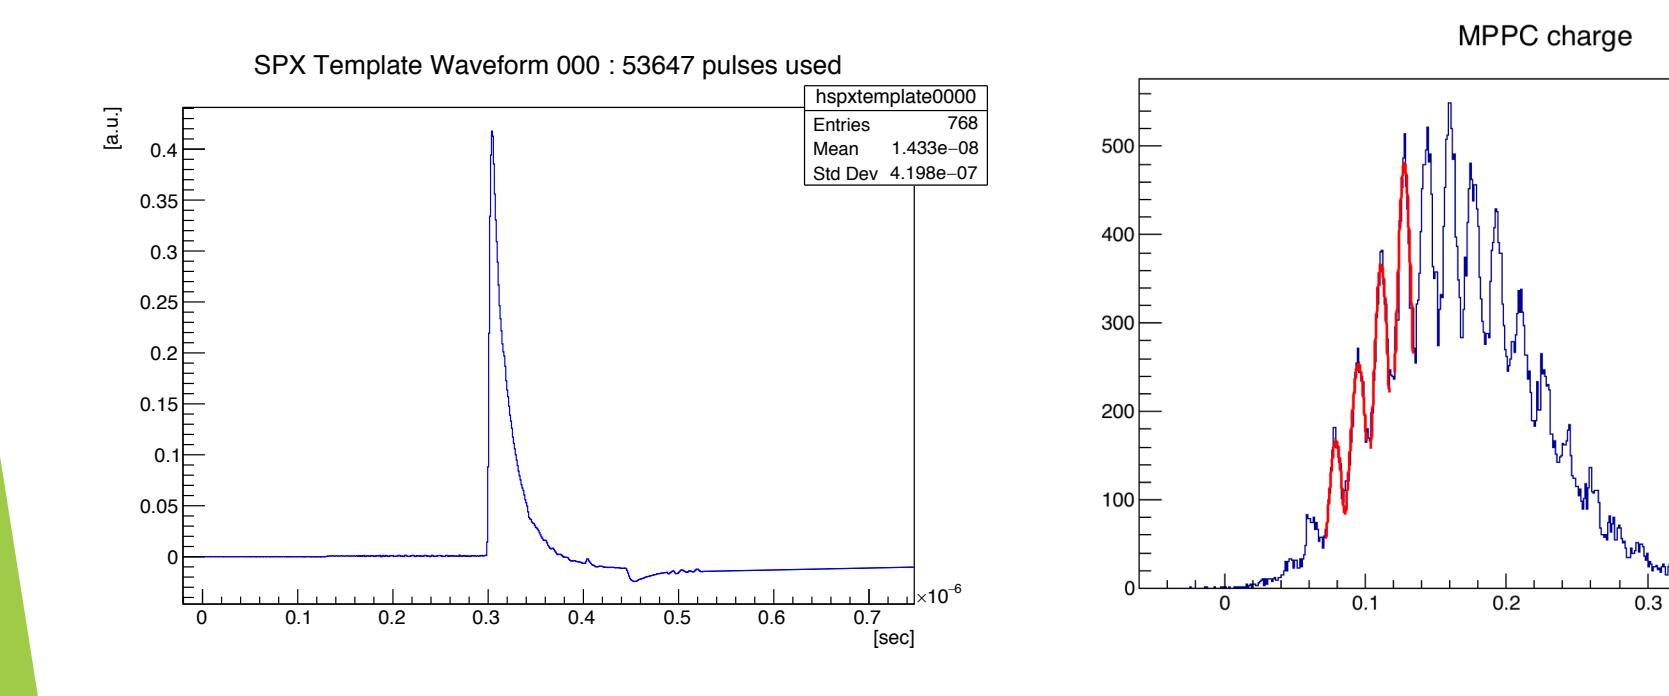
- Digitized waveform is integrated to estimate charge
- The charge is then converted into number of photoelectrons being divided by single photoelectron charge

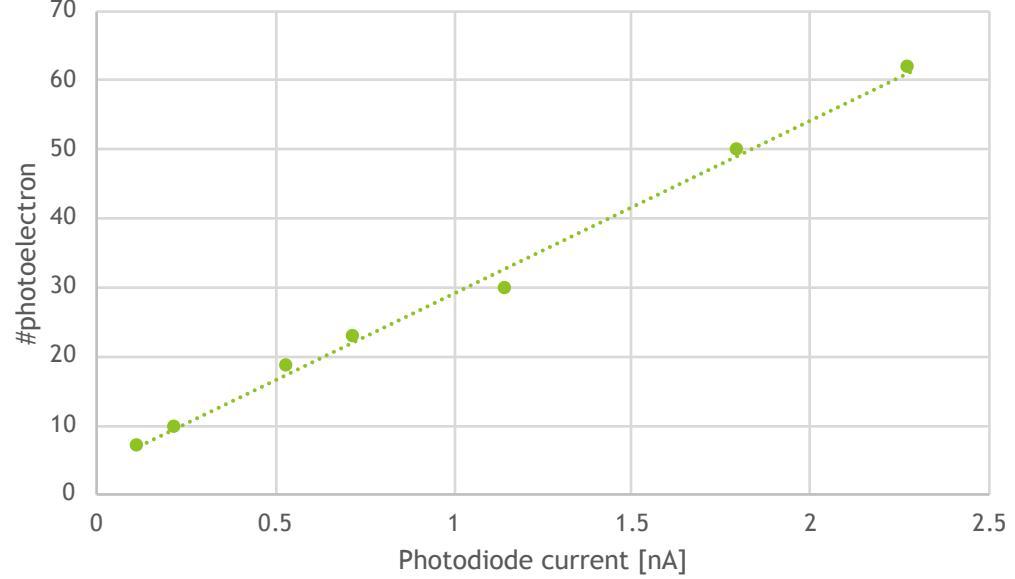
- Incident light intensity is measured with photodiode
 - Measured separately from saturation measurement due to a lack of splitter for UV light
- Relation between Npe and diode current is calibrated at small Npe (e.g. linear) region
- Effect of crosstalk and after-pulse not subtracted

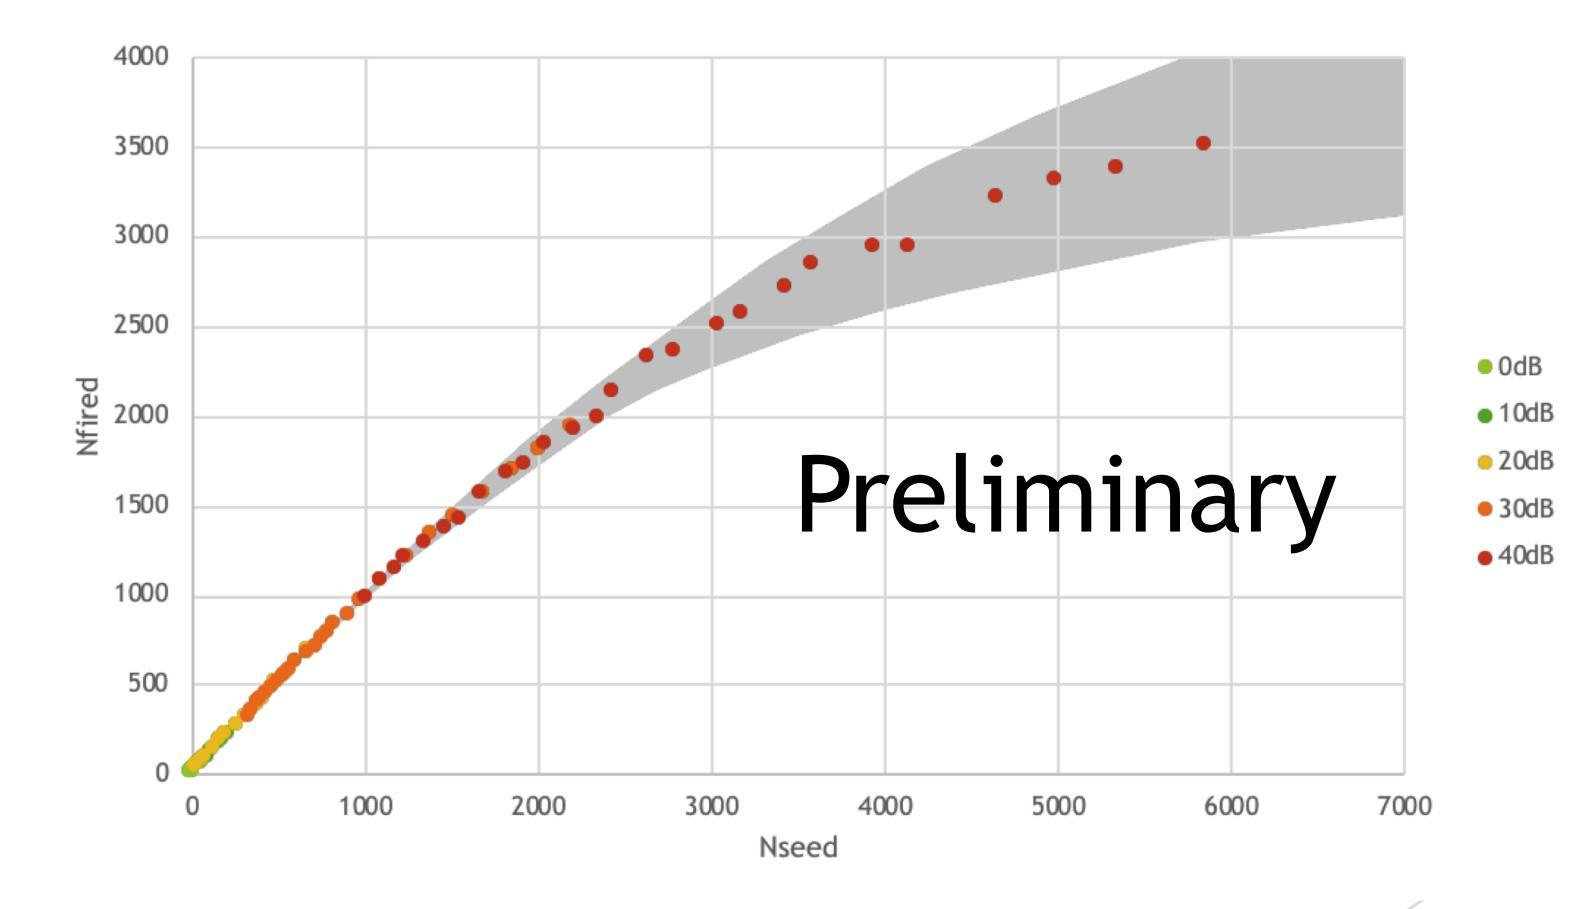
Saturation still has uncertainties of attenuation factor and photodiode calibration

► The uncertainties will be resolved through next measurements

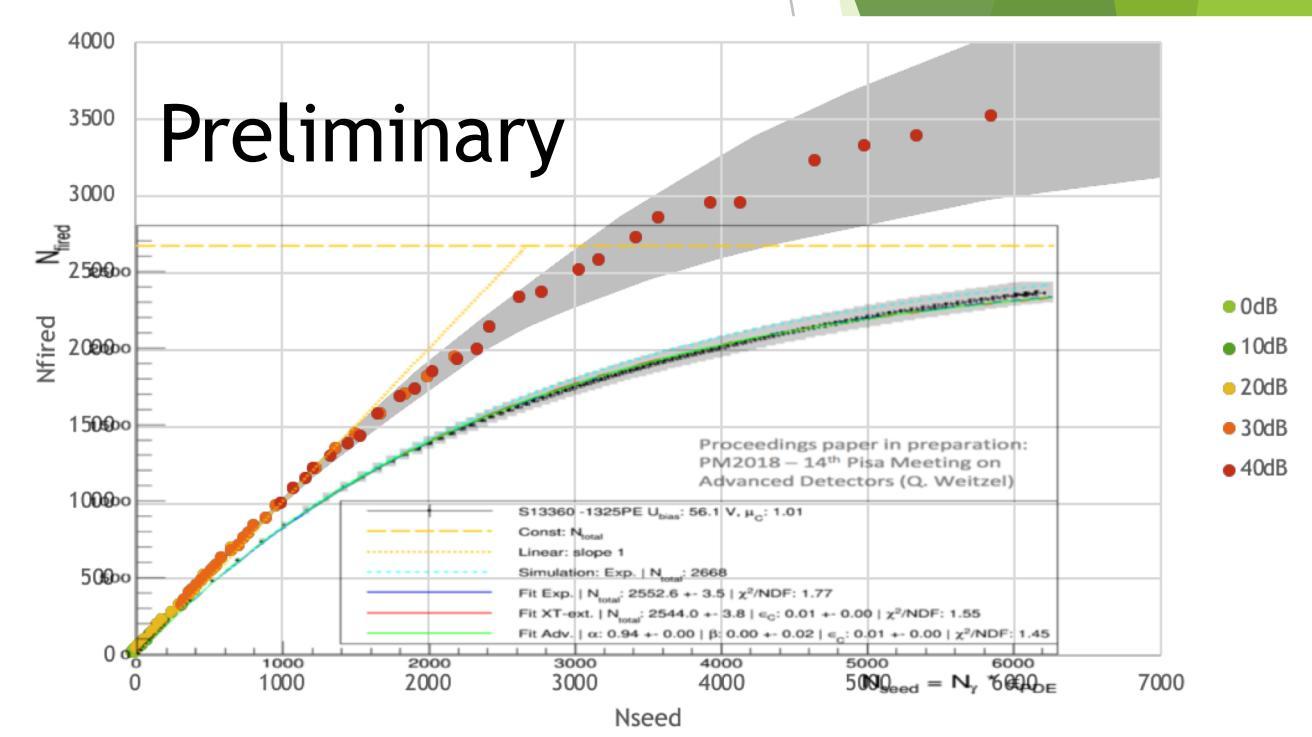
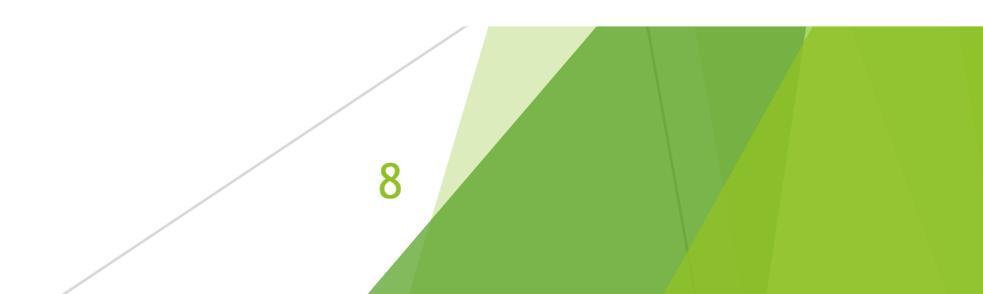
- Comparing the measured saturation with the previous study
- Very large saturation recovery observed even at minimum of the band
- Still a few things to be checked
 - Resolve the uncertainty of the curve
 - Possible excitation of scintillation light in surrounding materials?
