Faraday Rotation System Update

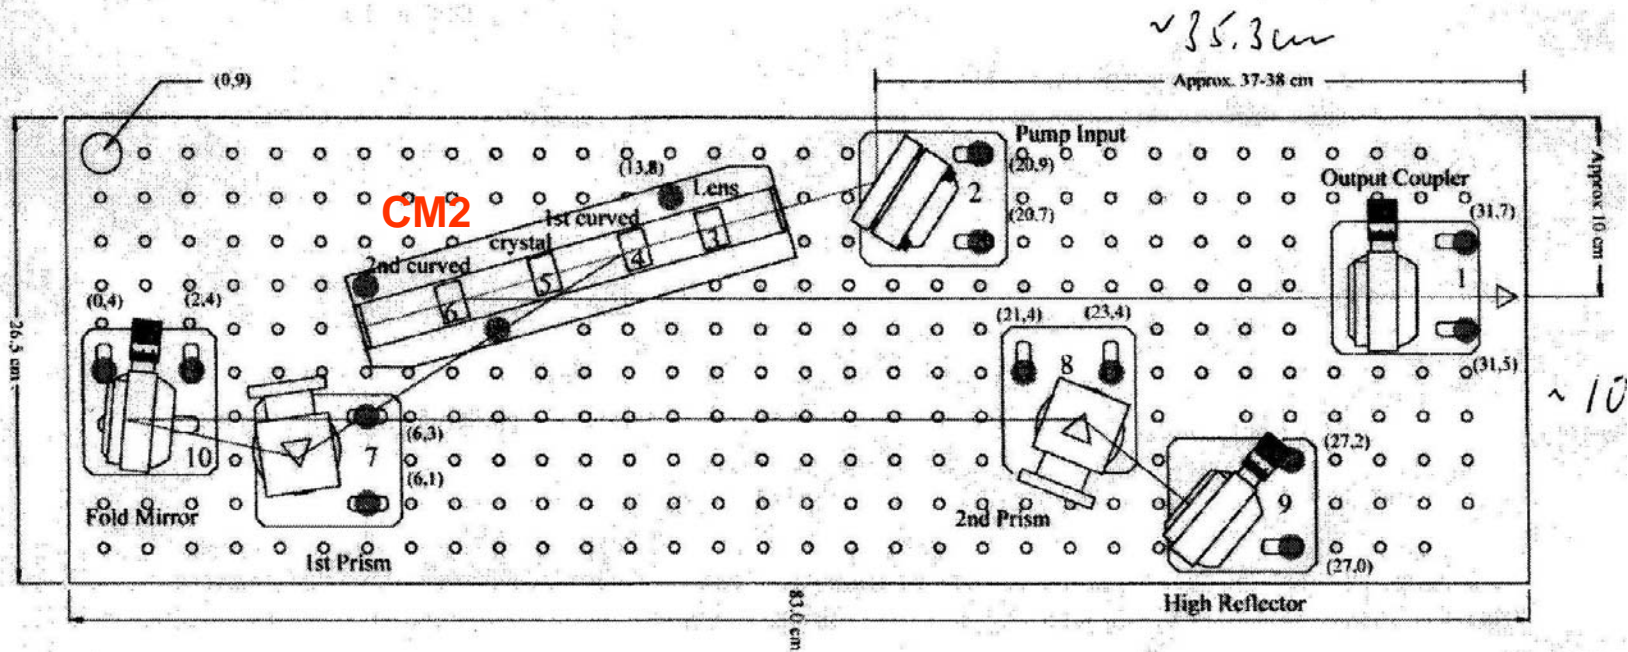
- CM2 misaligned during shipment from KMLab to Wisconsin.
- CM2 misaligned again during shipment from Wisconsin to SLAC.
- Fold Mirror found misaligned as well – the laser beam is near the base at Prism #2 and is at the edge at High Reflector.

- Laser safety finally approved on Nov. 16.
- Argon Ion laser is in good shape.
- KM Laser
 - Runs in CW mode
 - Not run in mode-lock due to a misalignment
