PCB Irradiation Test - Next Analysis Steps

Roman Pöschl

LAL Orsay
Calice Ecal Meeting
1/12/08

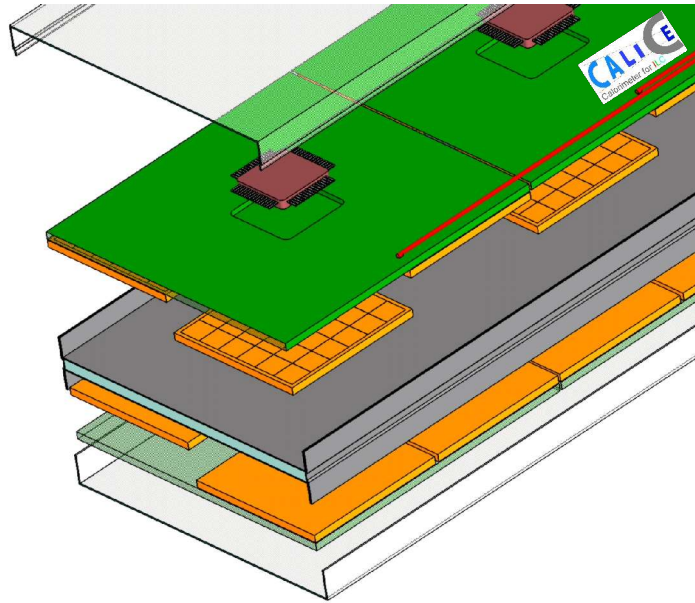
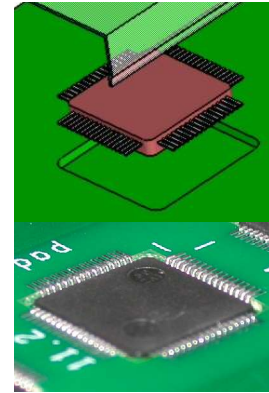
Calorimeter Electronics to be interleaved with layer structure

Do high energetic showers create signals directly in electronics ?
If yes, Rate of faked signals ?

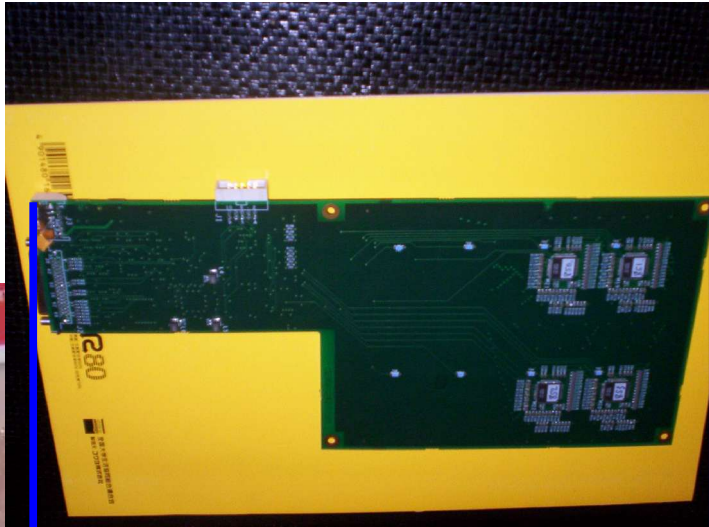
Test PCB
- equipped with
PHY3 Chip Set

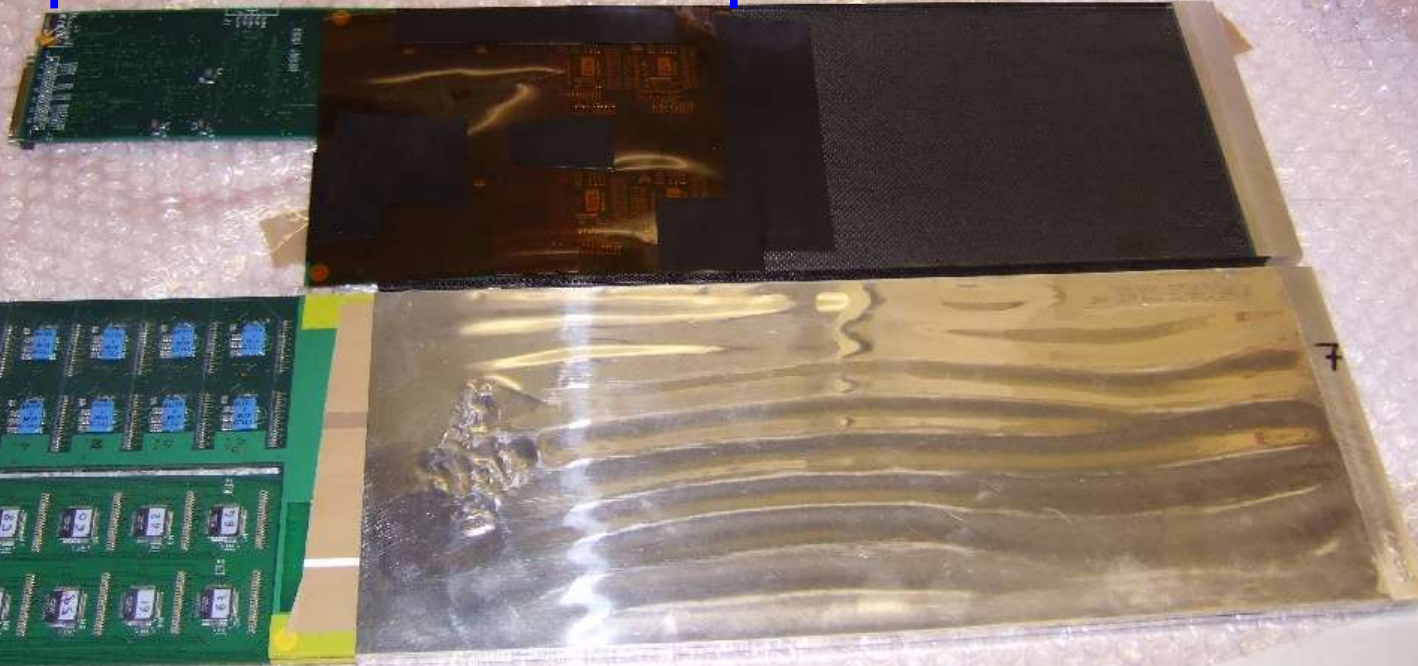
Prepared Slab
- W dummy
- capton and paper
for electrical shielding

Usual Slab

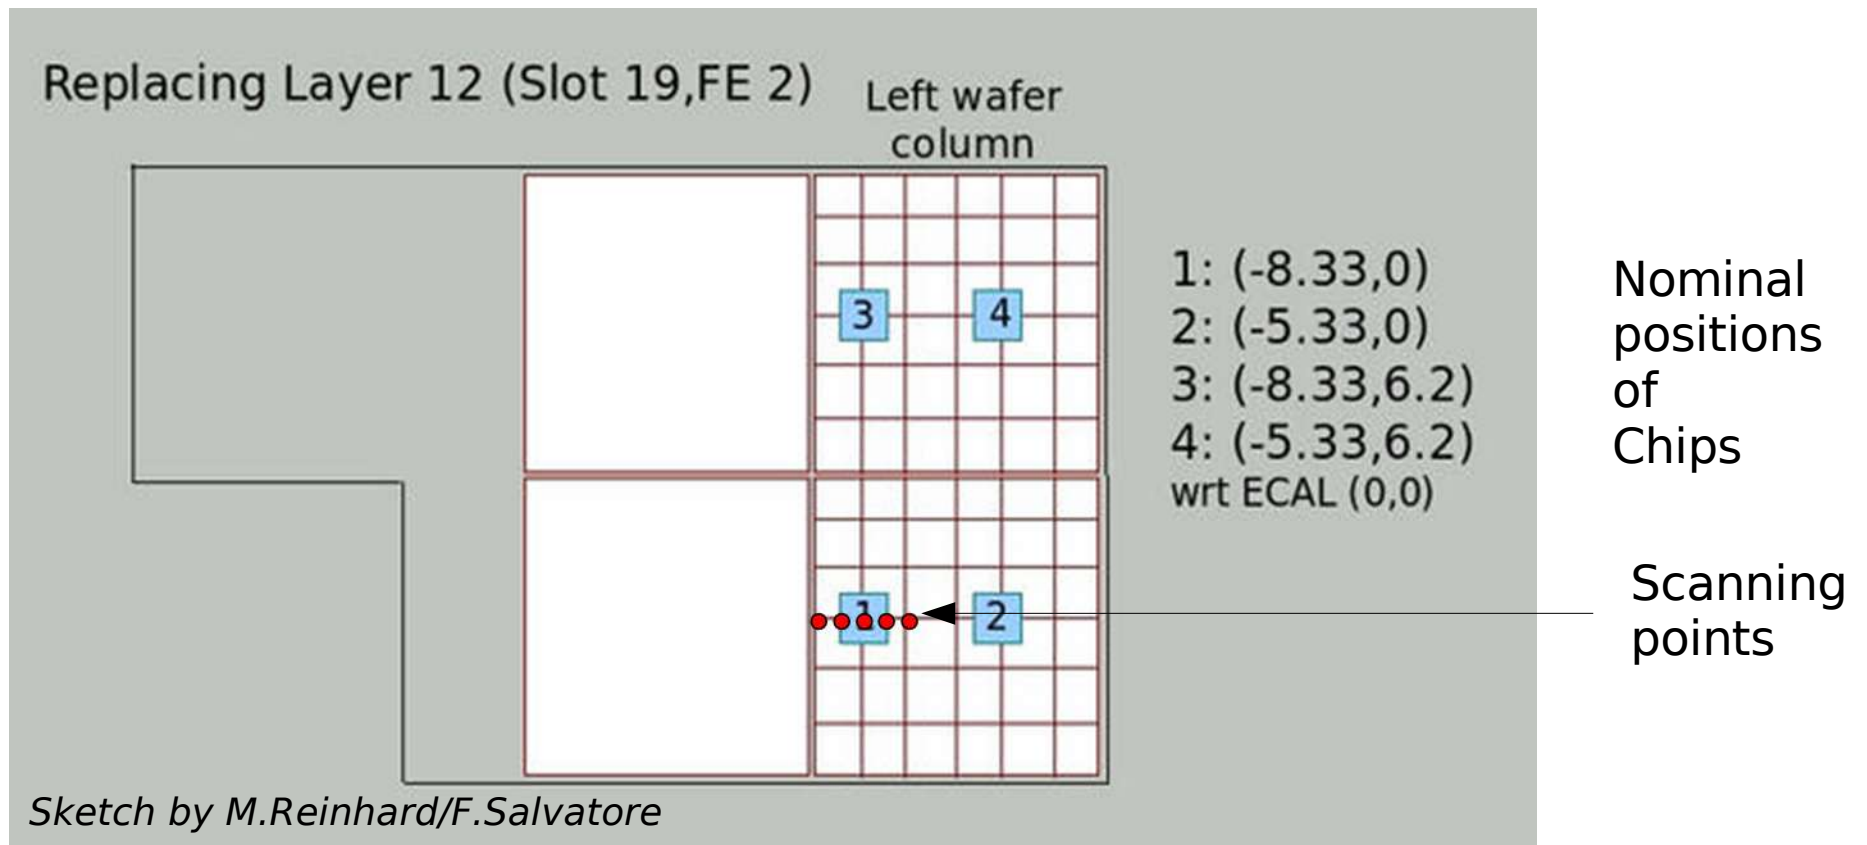
- PCB positioned at place of layer 12 in Ecal ~ shower maximum
x,y position identical to layer 2
- Schematic view of test PCB - 'Expect' signals from 72 pads, $4 \times 18 = 2$ Wafer

- $7 \cdot 10^6$ Triggers with 90 GeV Electrons (- $1 \cdot 10^6$ with 70 GeV Electrons)
At least 250 K at each scanning point
Runs 331462 – 331518
Today: Analysis of 10k Events per analysed run
- Runs were subject to the same data processing chain as 'usual' runs

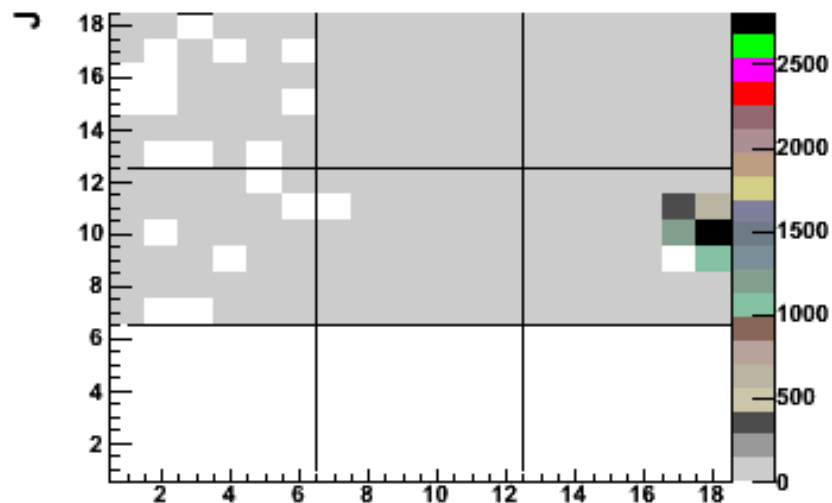
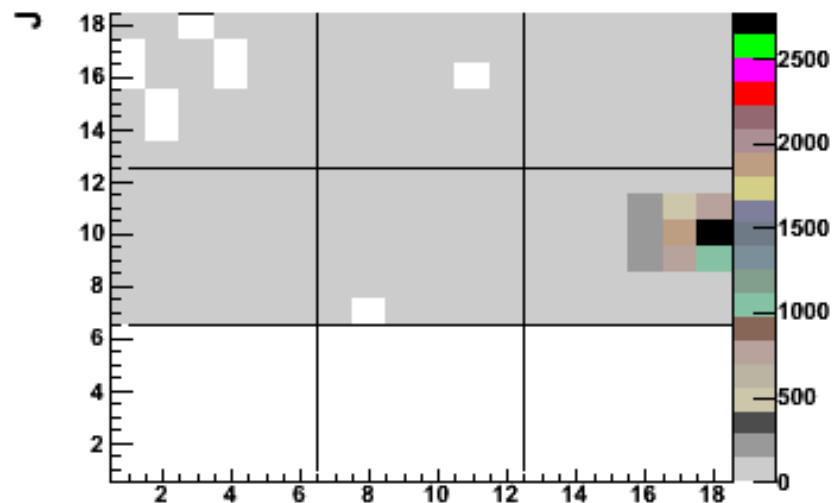
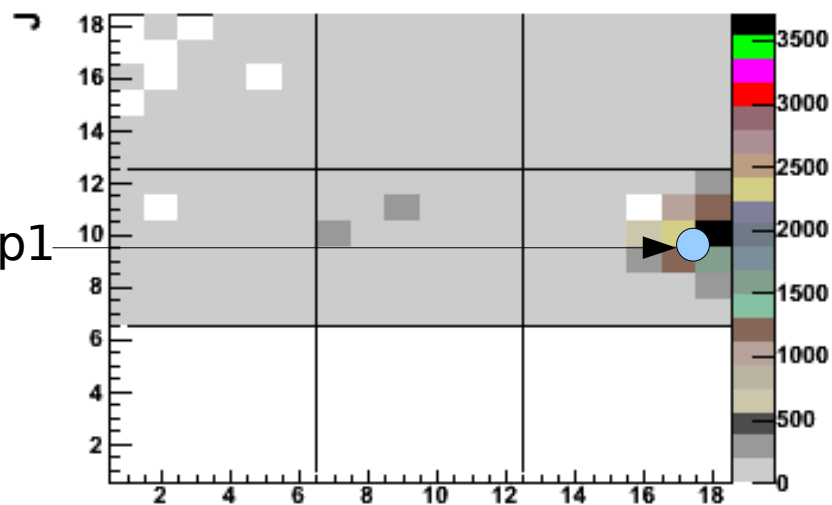
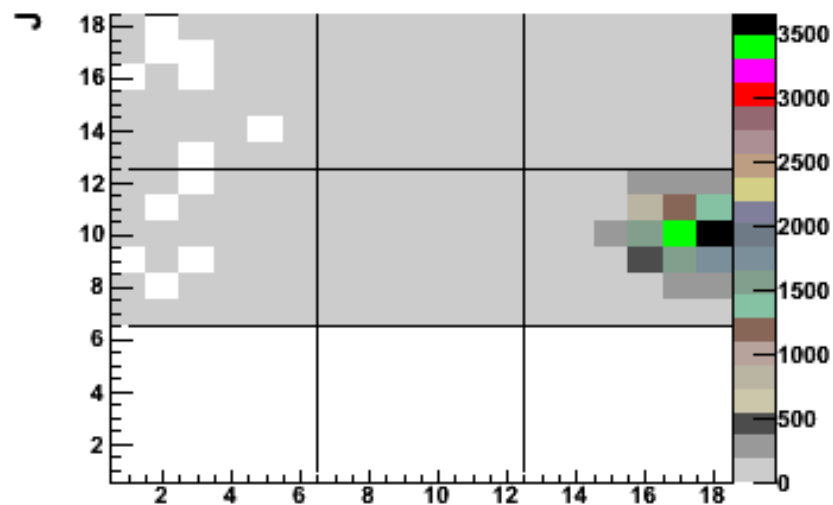
Beam Impact at nominal center of Chip 1 (-8.33,0) cm

Projection of
Center of Chip1
onto layer 2

Looks like we've shot a bit too high and too close to the Ecal Border

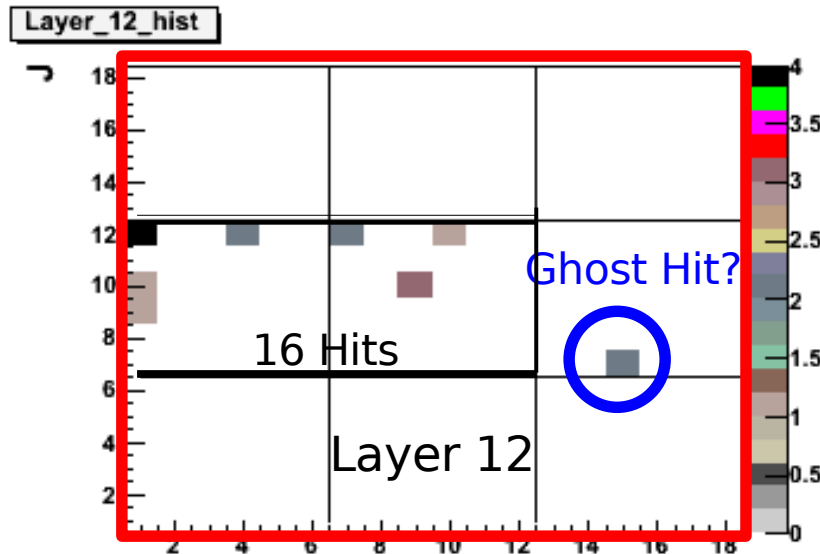
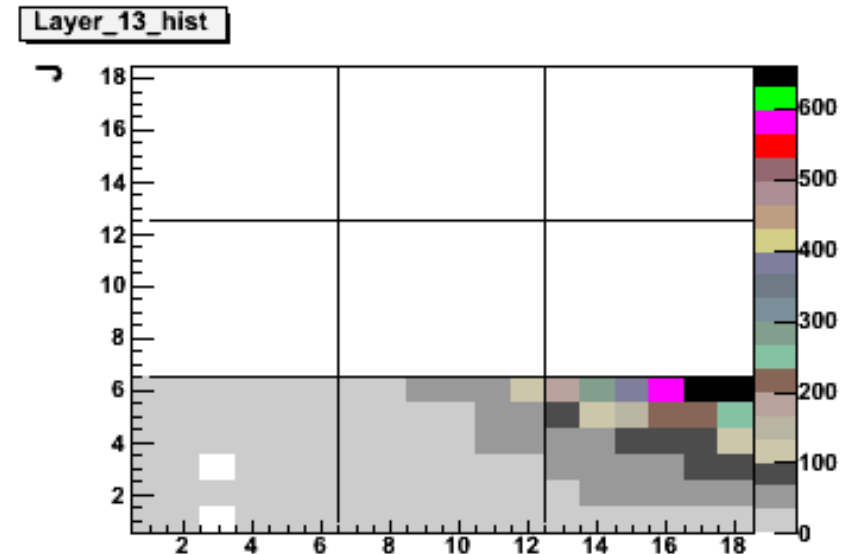
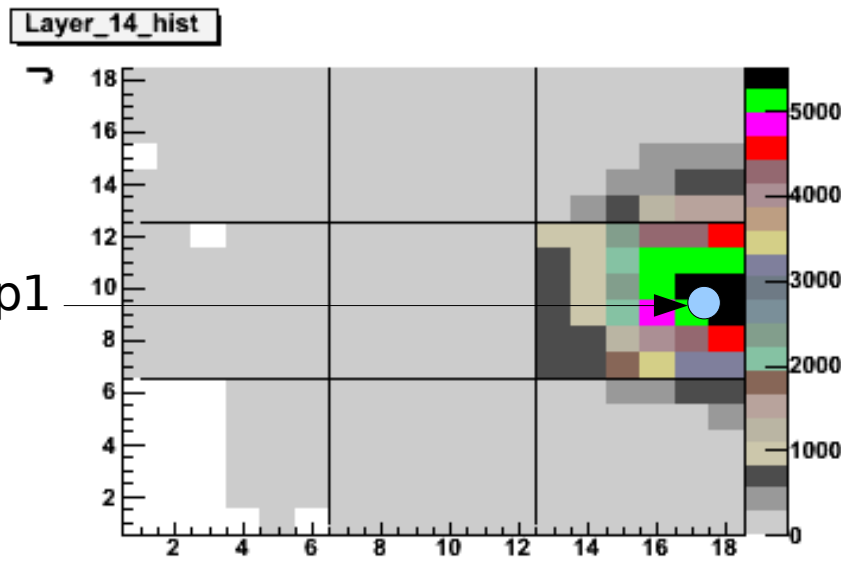
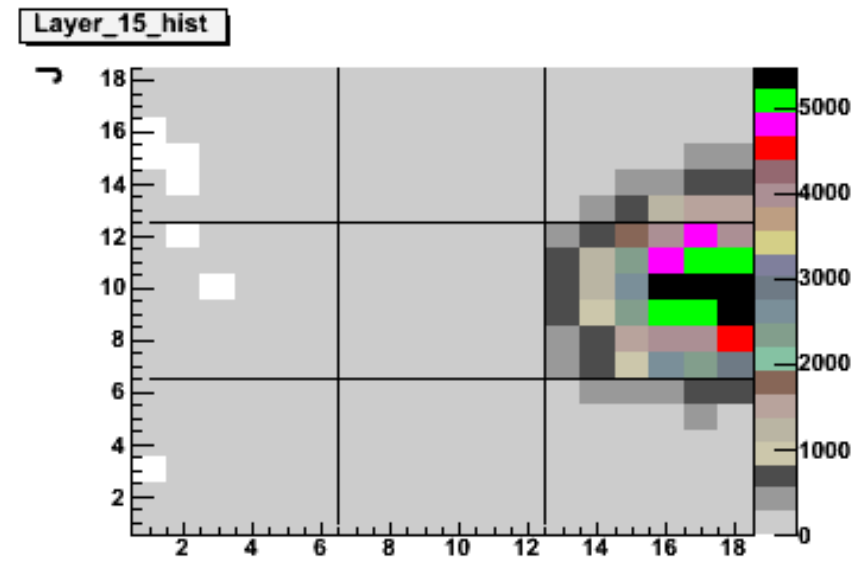
70 GeV e⁻ - Beam Impact at nominal center of Chip 1 (-8.33,0) cm

Projection of Center of Chip1 onto layer 14

- Chip 1 well 'touched' by shower maximum
- Small Activity in Layer 12

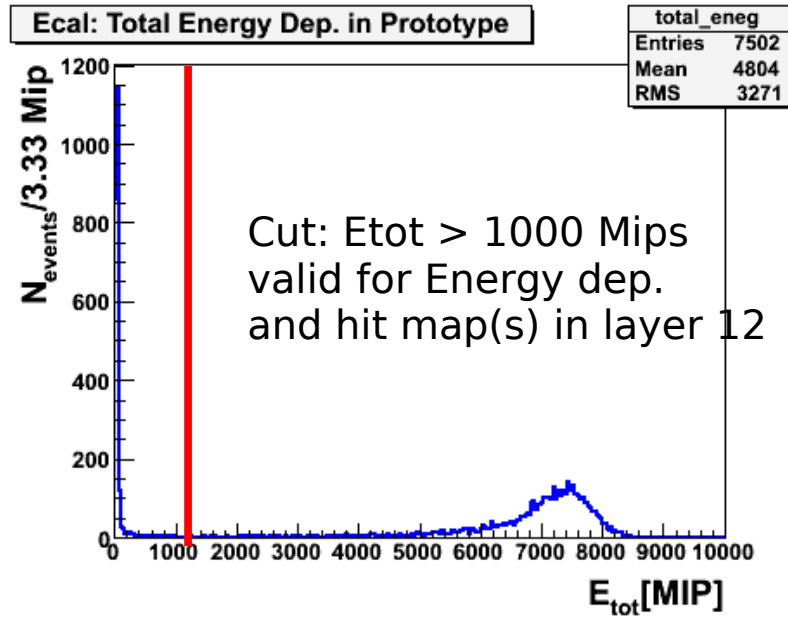
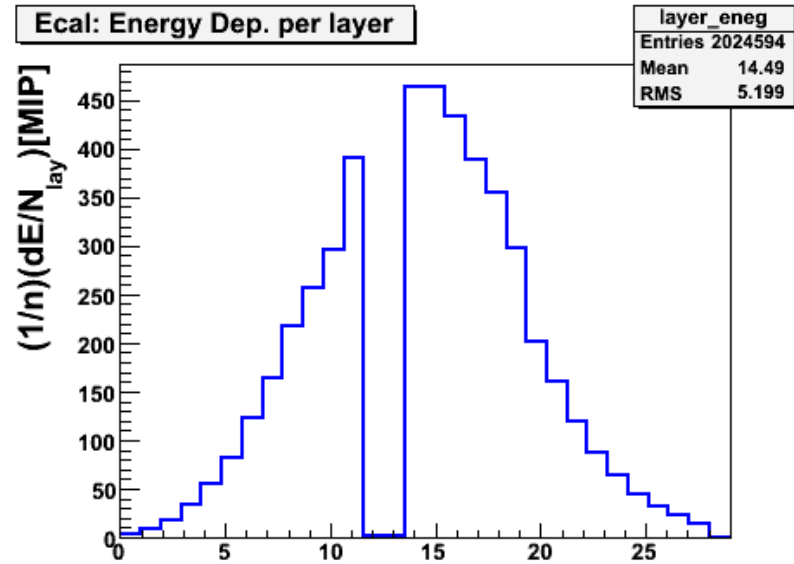
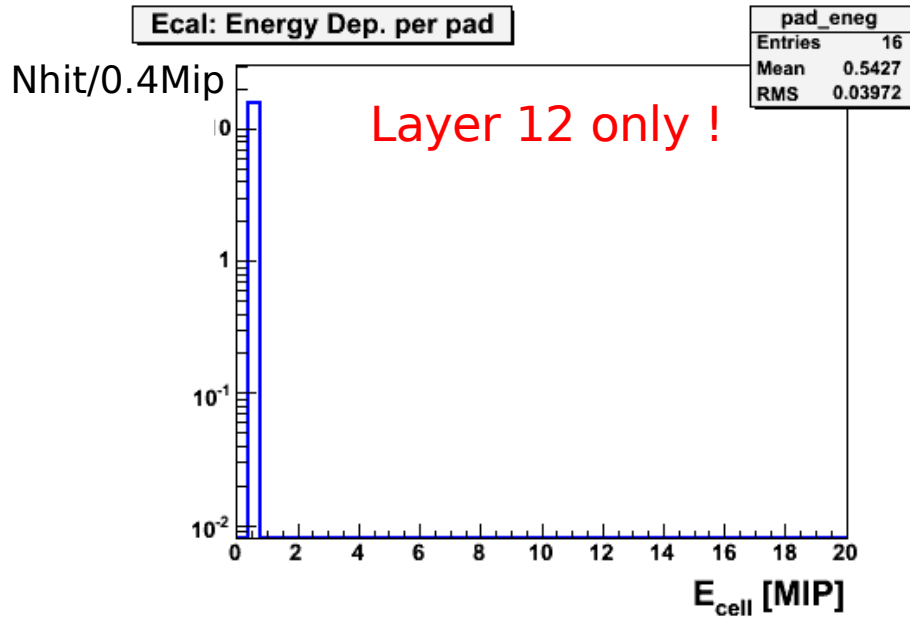
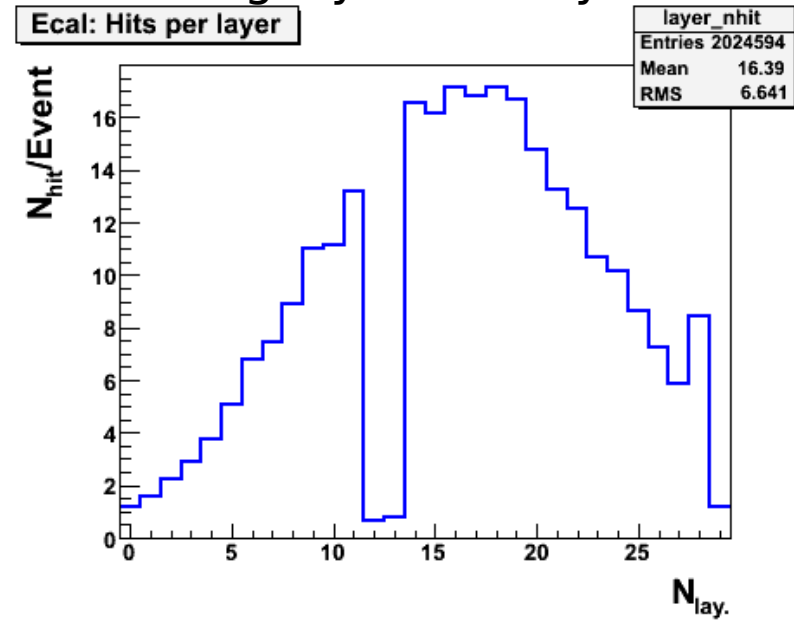
Basic Spectra

Missing layers clearly visible

No signal beyond 1 MIP!!!

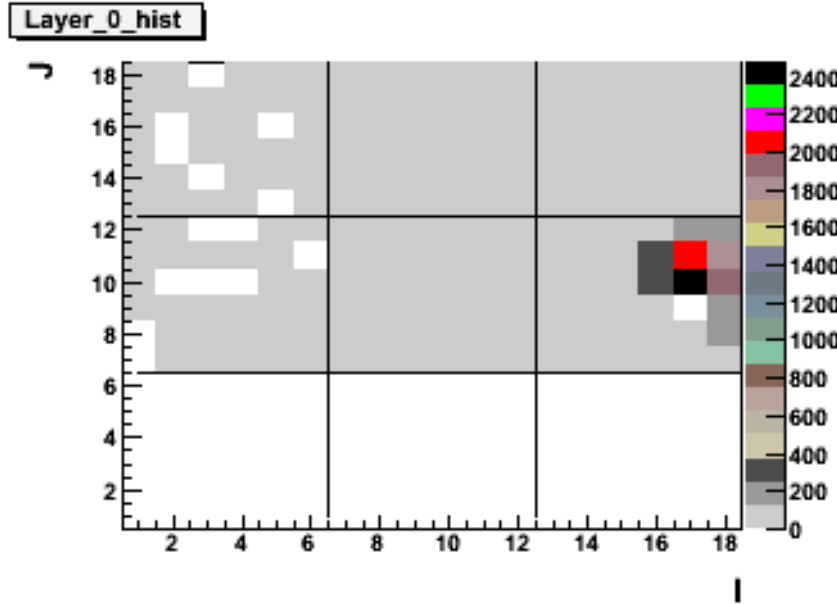
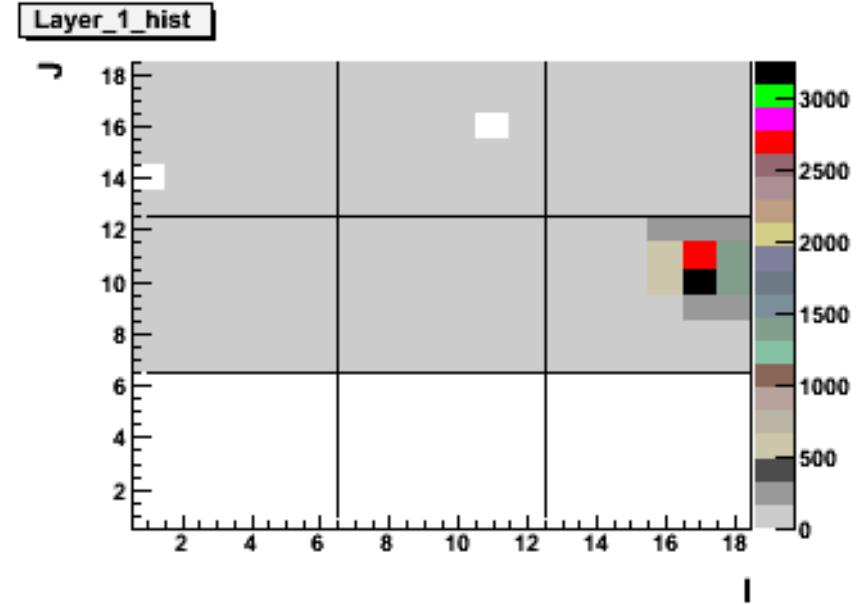
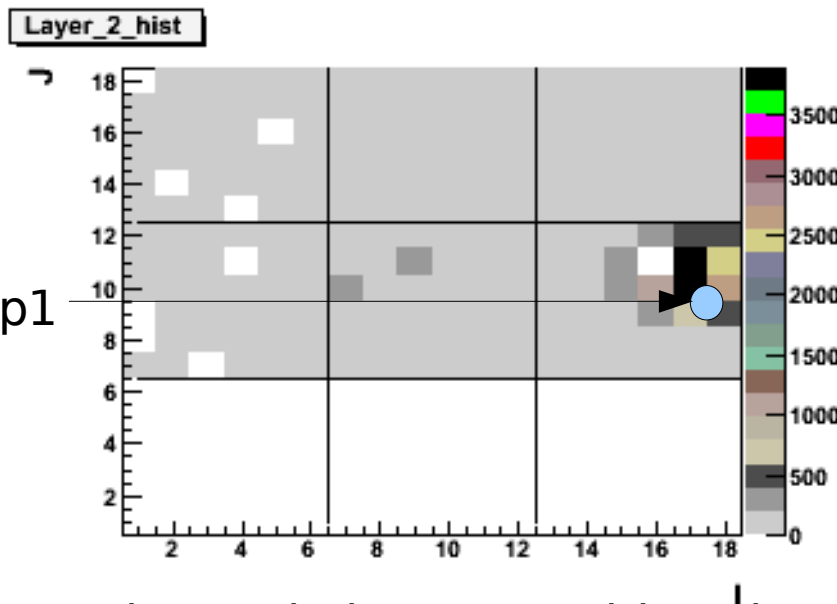
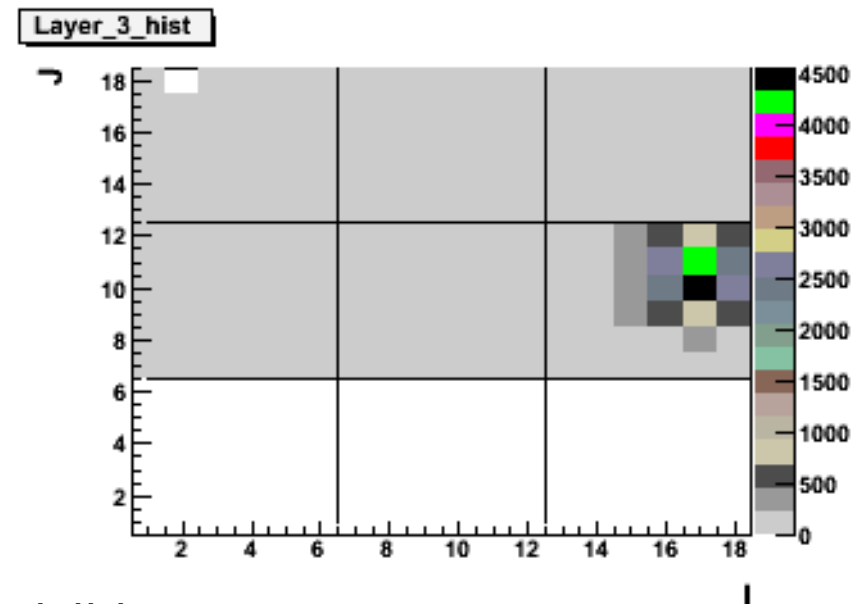
Moving towards Center of Ecal (-7.8,0) cm

Projection of Center of Chip1 onto layer 2

Change in impact position clearly visible

'Beam Spot too far left and too high ? - More detailed study needed !

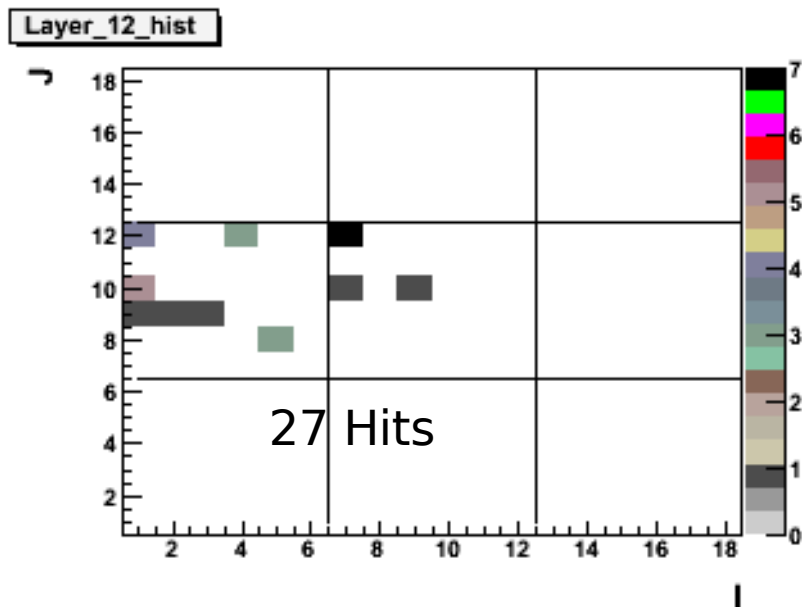
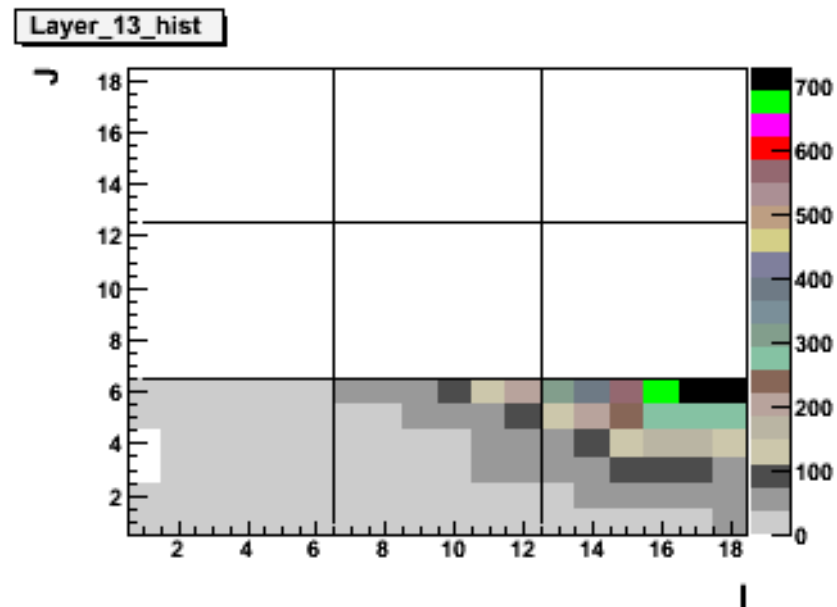
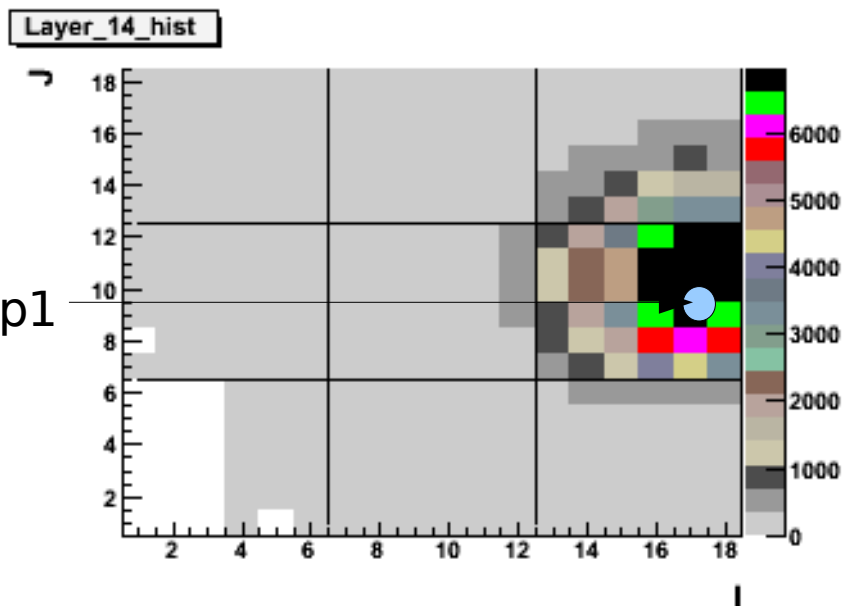
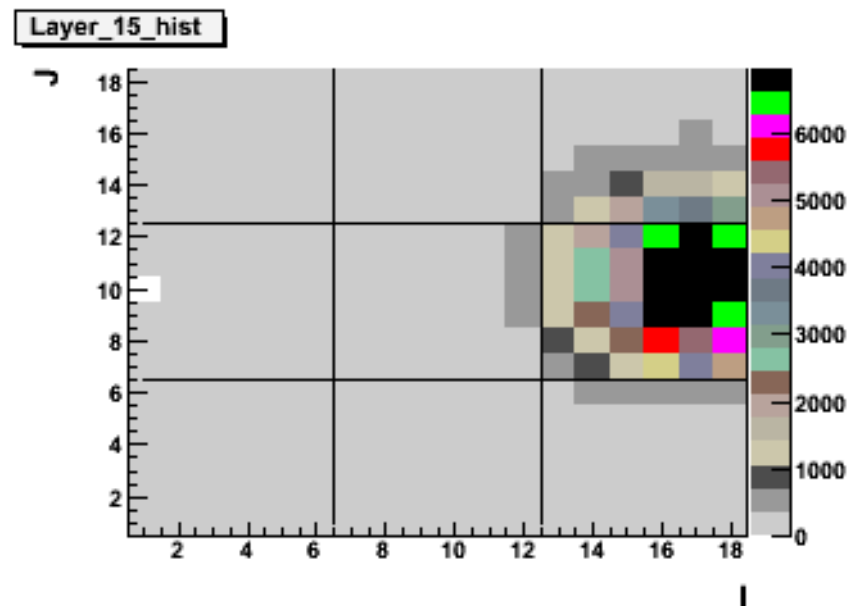
90 GeV e⁻ - Moving towards Center of Ecal (-7.8,0) cm

Projection of Center of Chip1 onto layer 2

- Chip 1 well 'touched' by shower core
- Small Activity in Layer 12 (bit larger than for 70 GeV and 'nominal' Center)

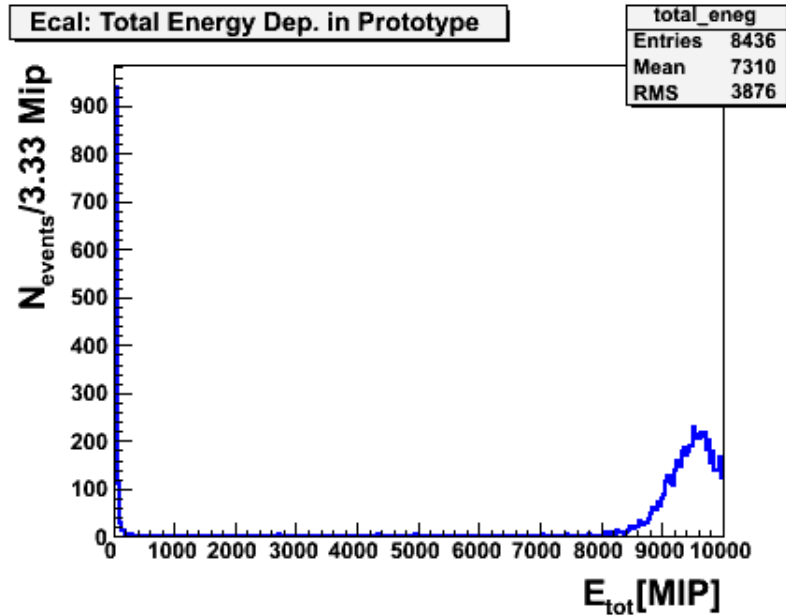
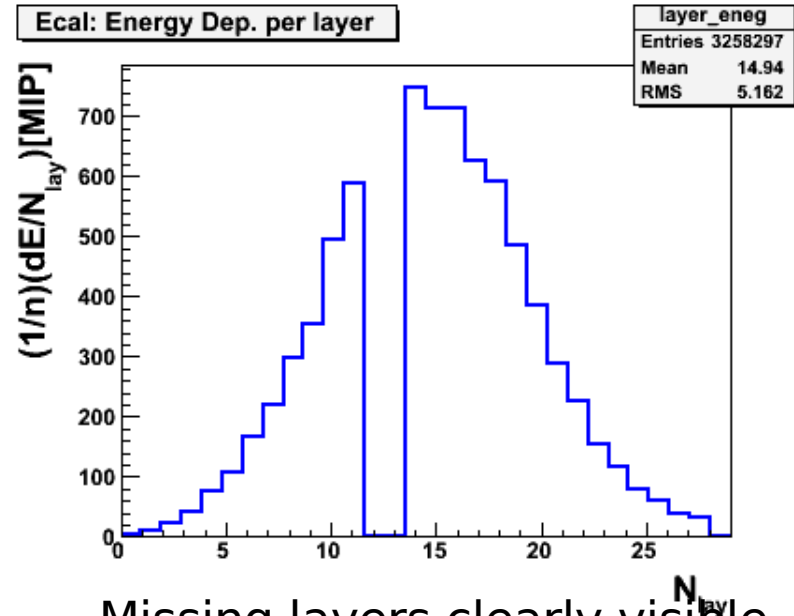
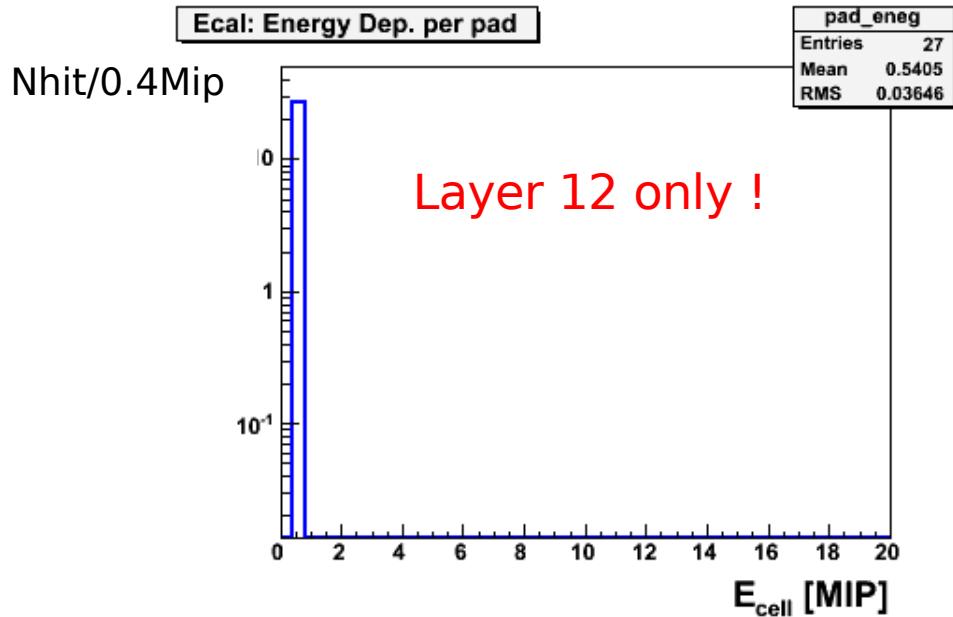
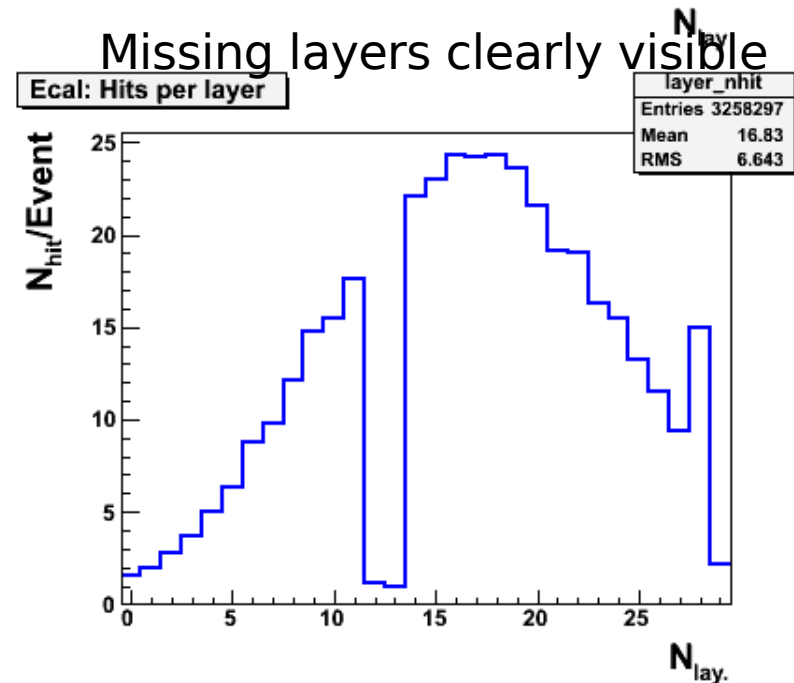
Basic Spectra

No signal beyond 1 MIP!!!
70 GeV -> 90 GeV Layer 12 outside of shower maximum

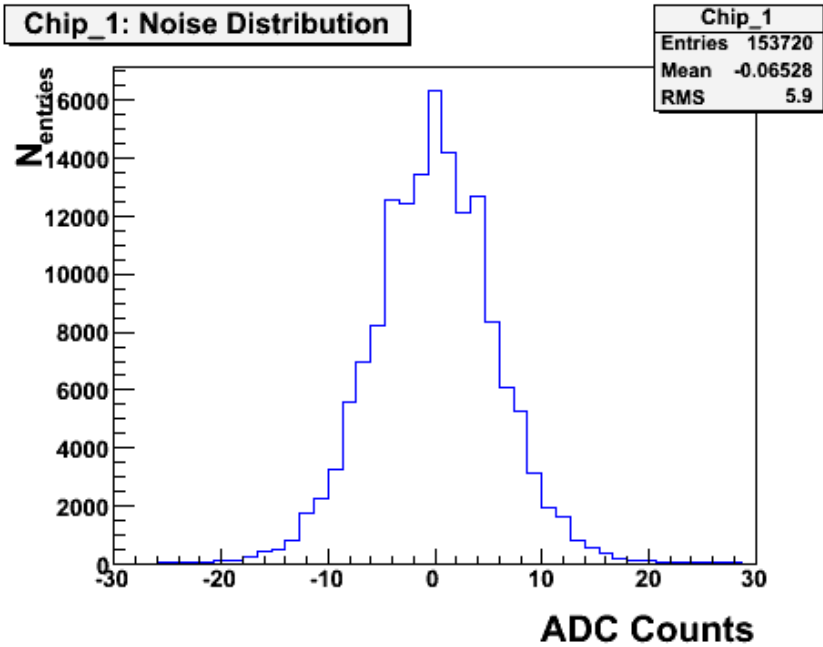
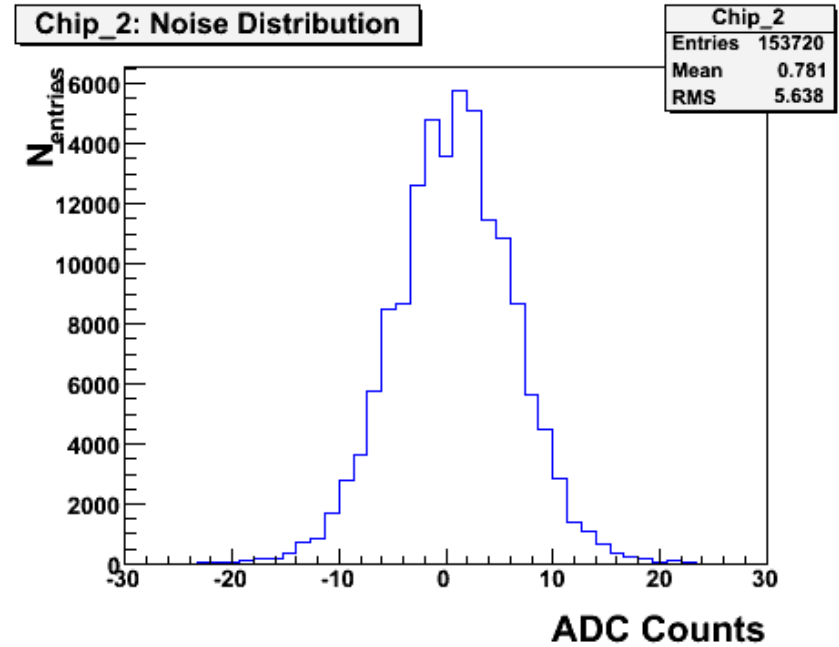
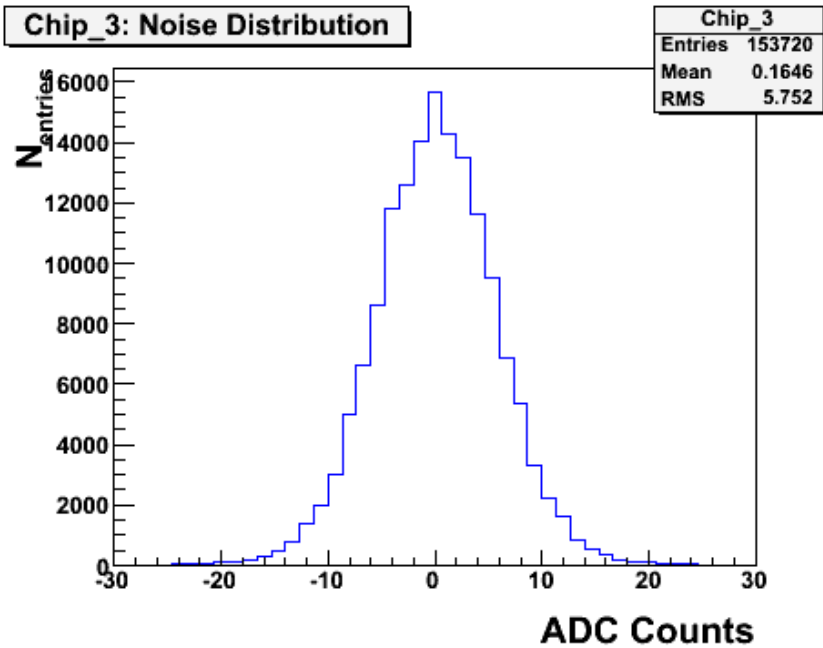
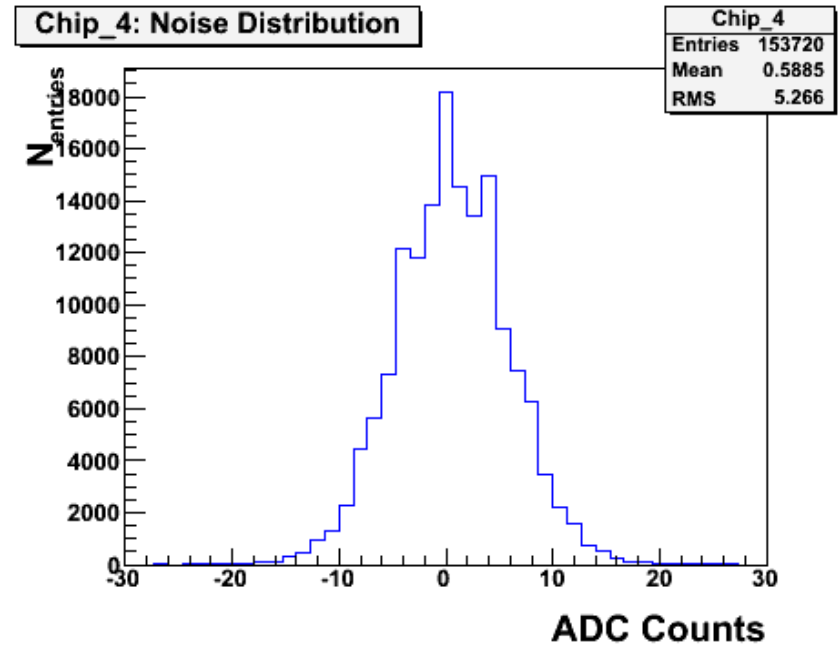
Typical Noise Distribution - "Signal Events" (Run331498 -6.3cm,6.2cm)

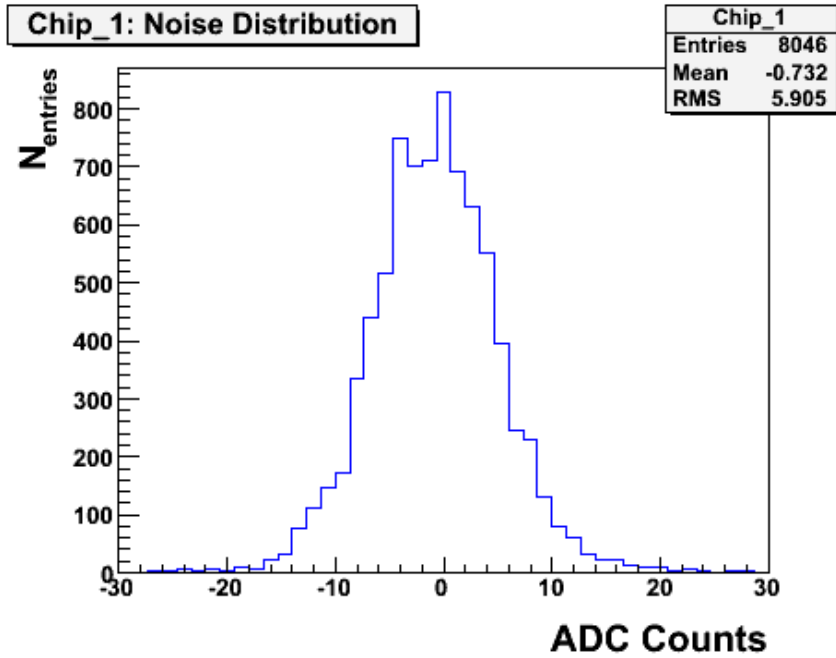
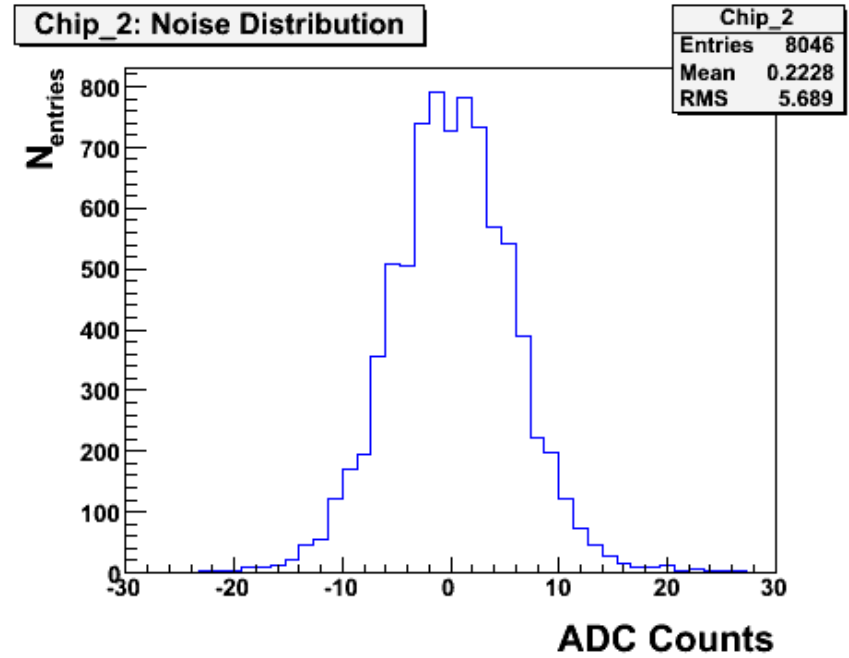
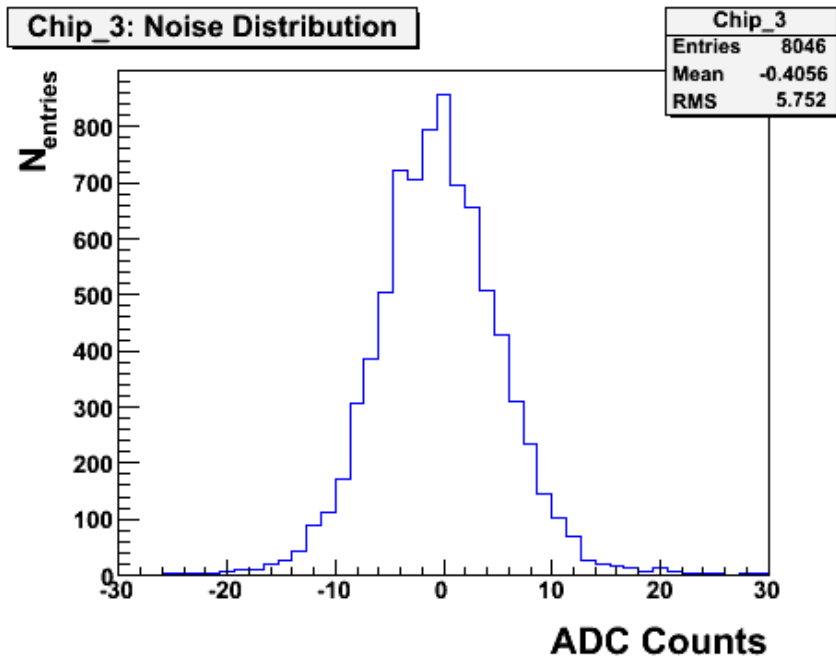
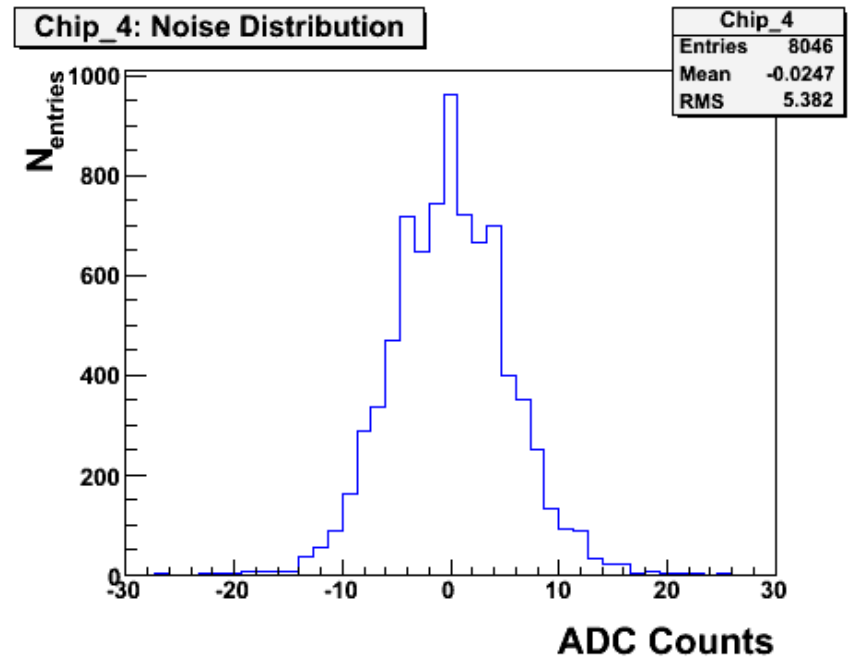
Typical Noise Distribution - "Pedestal" Events (Run331498 -6.3cm,6.2cm)

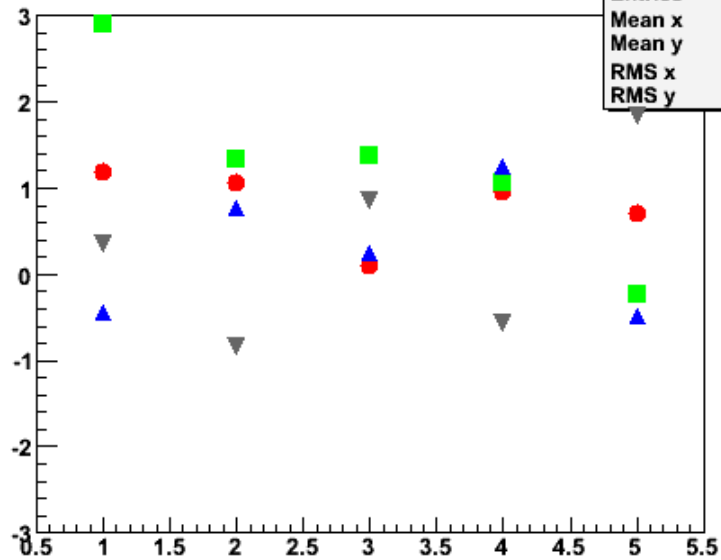
Mean in Signal Events Scan_2

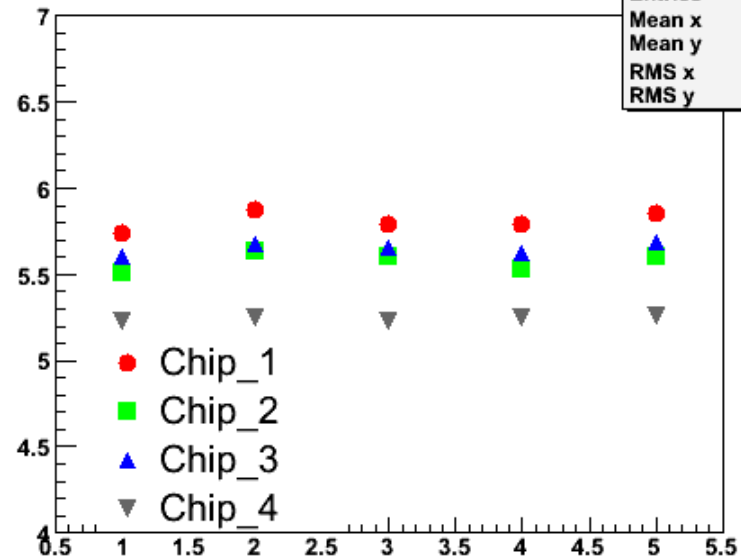
RMS in Signal Events Scan_2

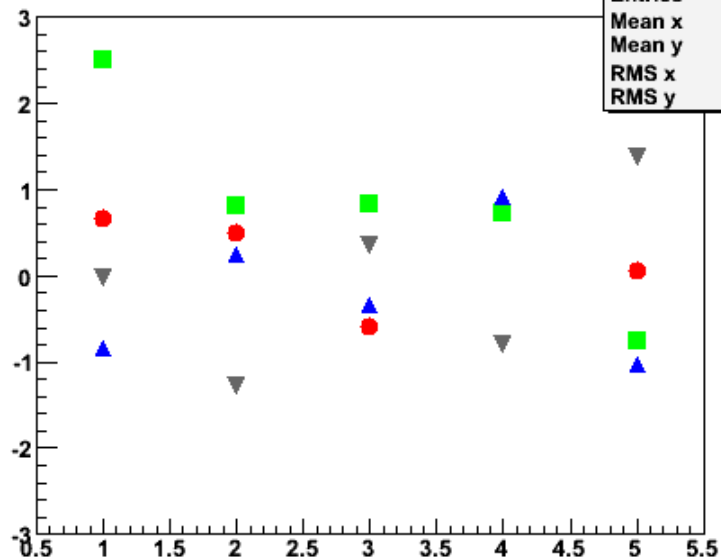
Mean in Pedestal Events Scan_2

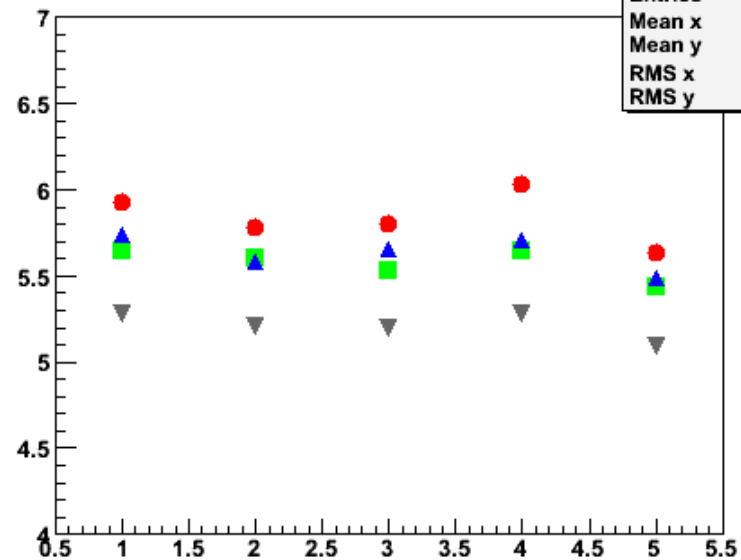
RMS in Pedestal Events Scan_2
