EU Status

2nd sound during quench in AC74

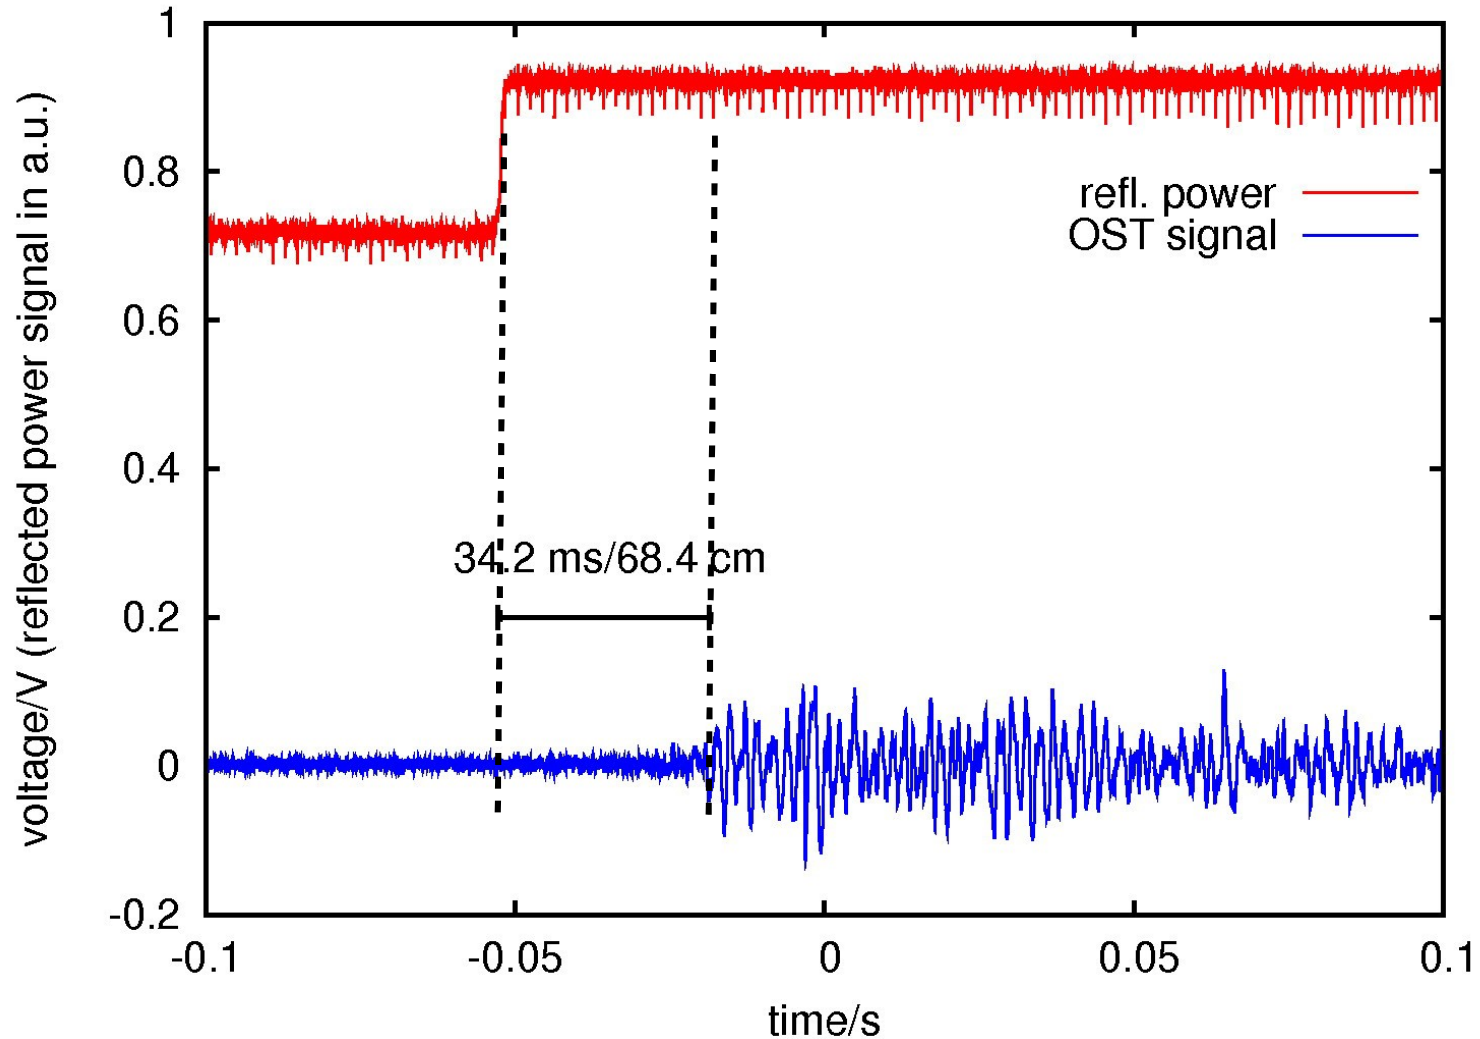
- 2nd sound observed for first time at DESY on 9th of March
- Simultaneously measured to T-map test of AC74
- 4 OSTs placed at insert
- One OST was producing signals

AC74, $2\pi/9$ -mode, quench at 21 MV/m
