Module PXFEL2_1

Initially assembled and tested at DESY

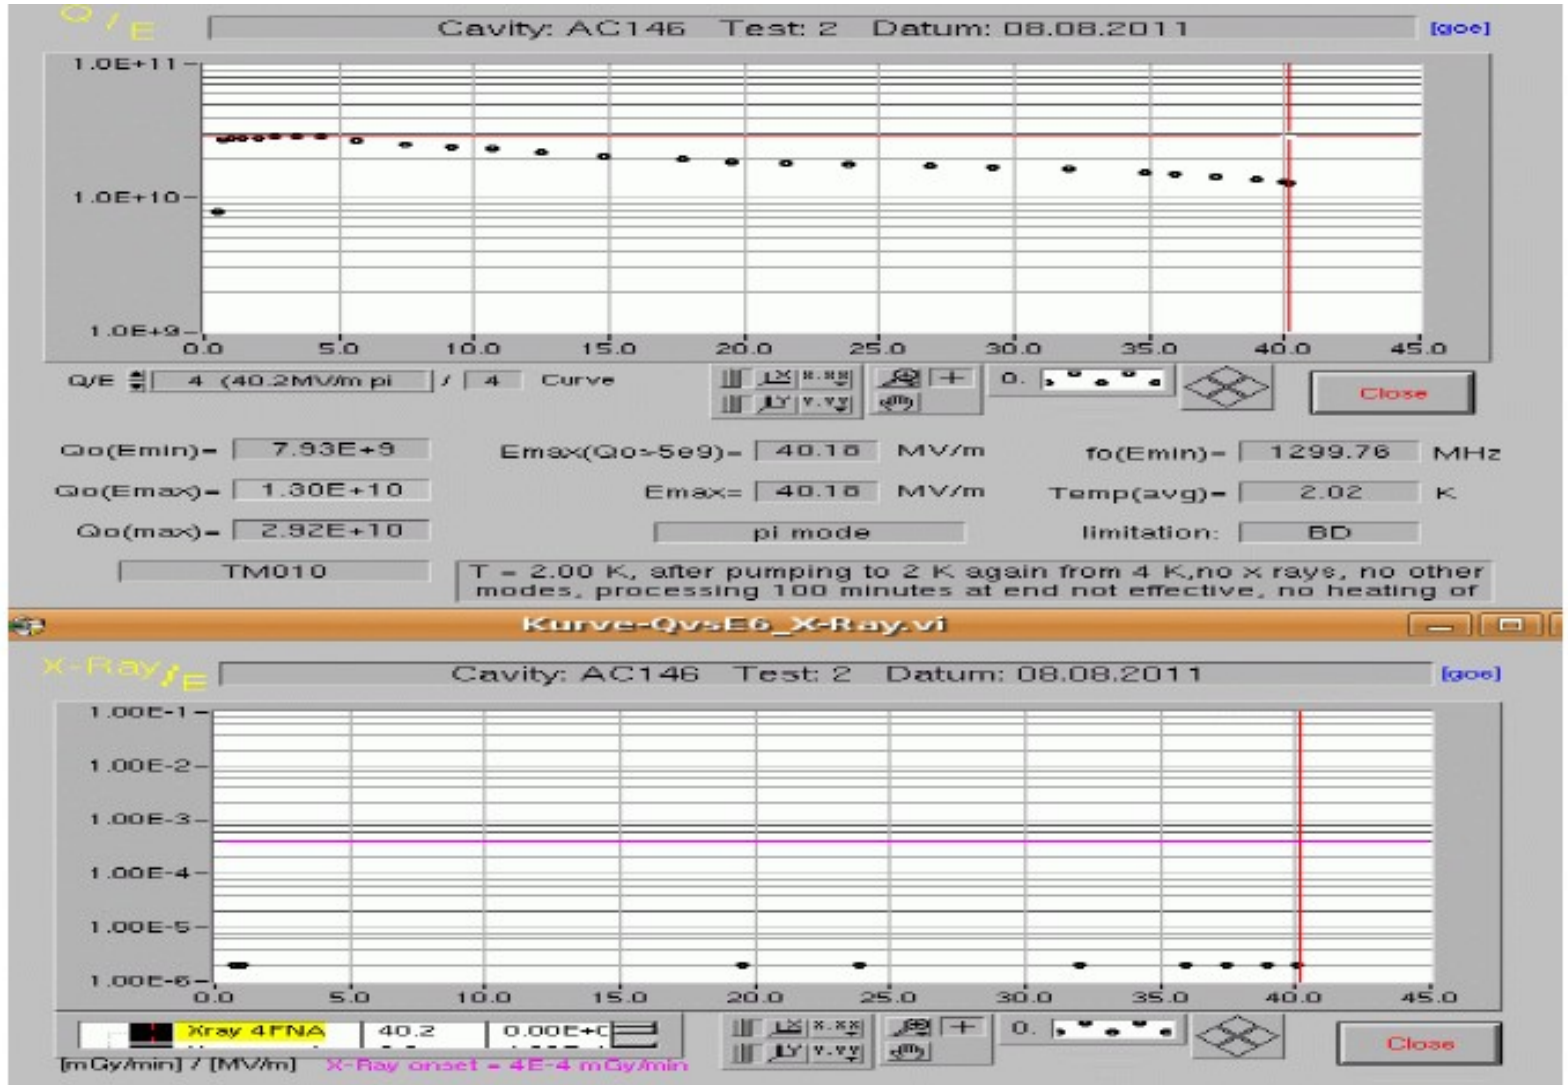
History: Test 1

- **26.1 MV/m with strong FE**

Test 2

- **After additional HPR**
- **40.2 MV/m**

- Test 4 (additional 120 um EP)
- **45.8 MV/m, Q=1.3E10, no FE**
